# MC 600 - Curtain Wall System CWCT – Standard for systemised building envelopes – 2005

**Smart Systems Ltd**

**Test Report No. R4791391132 Rev 2**

DATE: February 4, 2025

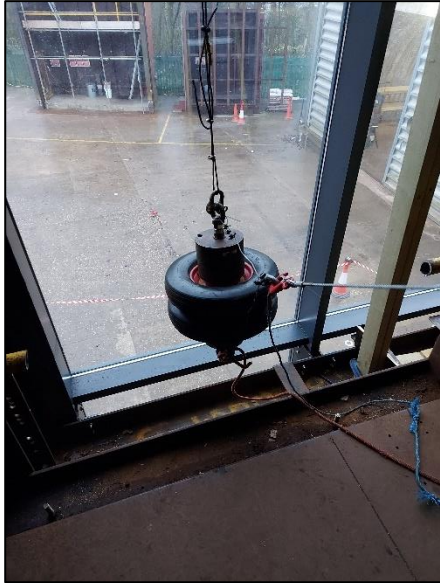
Photograph No. 3 - Showing impactor during internal testing

Photograph No. 4 - Showing impactor during internal testing

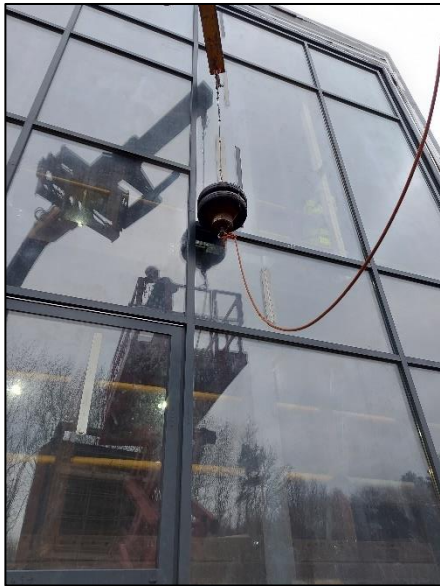
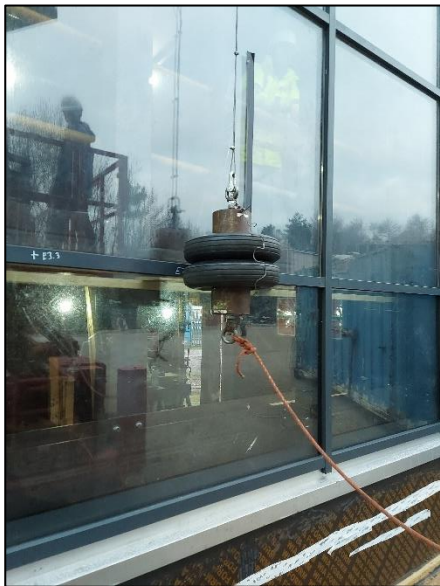
Photograph No. 5 - Showing impactor during external testing

Photograph No. 6 - Showing impactor during external testing

| Impact Reference | Test Classification | Drop Height (mm) | Observations | Result |
|---|---|---|---|---|
| E1 | E 5 | 950<br>100 | Dented Capping<br>No Further Damage | Pass<br>Pass |

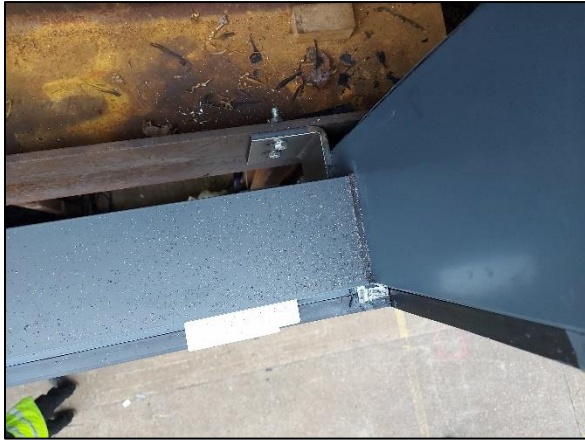
Photograph No. 9 - T connection with glazing removed showing glazing packers

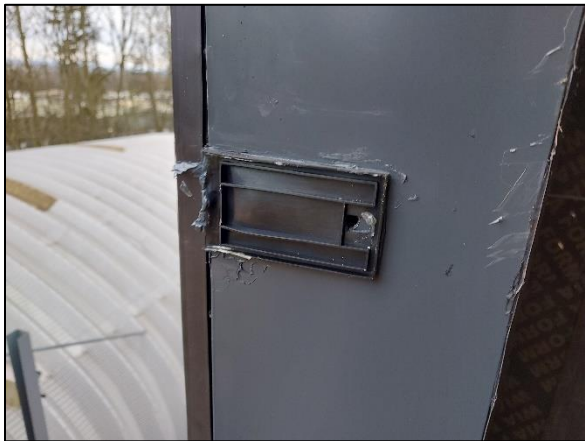
Photograph No. 10 - Transom connection on mullion

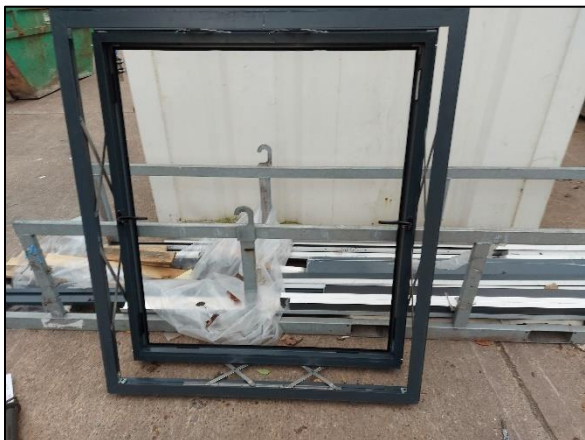
Photograph No. 11 - Opening vent removed

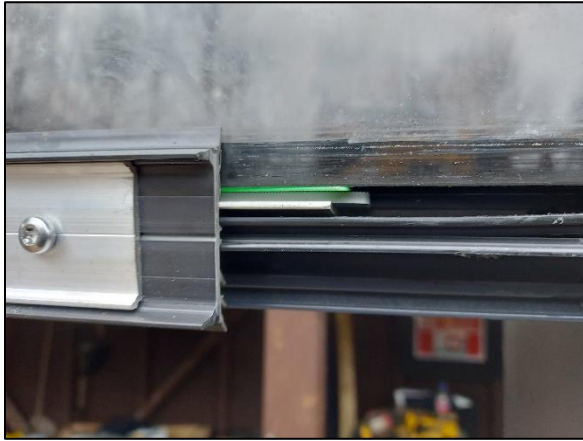
Photograph No. 12 - Glazing packers

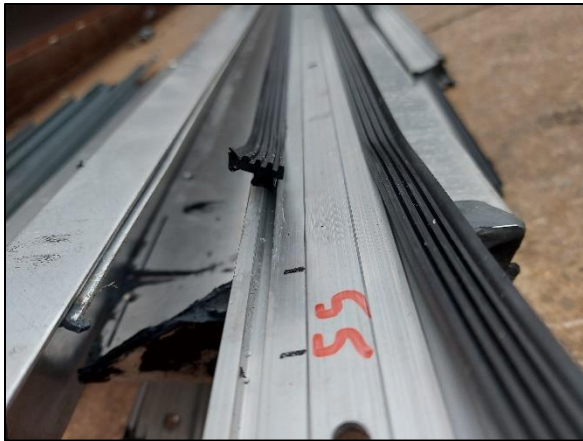
Photograph No. 13 - Pressure plate gasket profile

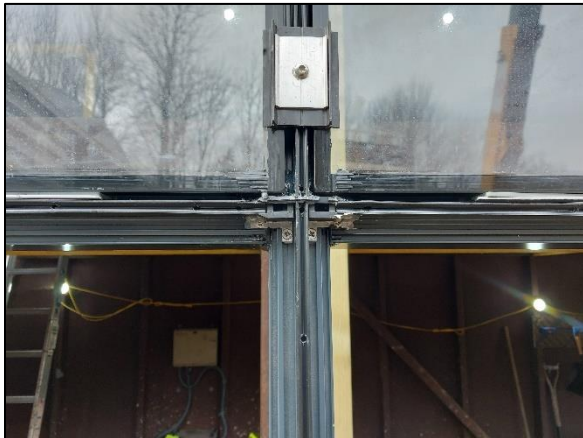
Photograph No. 14 - Cruciform joint details

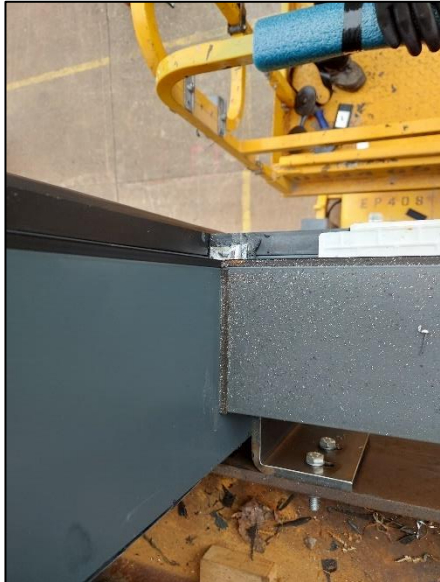
Photograph No. 15 - Transom mullion connection with glazing removed. Please note build up of swarf shown is due to transoms having to be cut-out with electric saws as part of the dismantling process

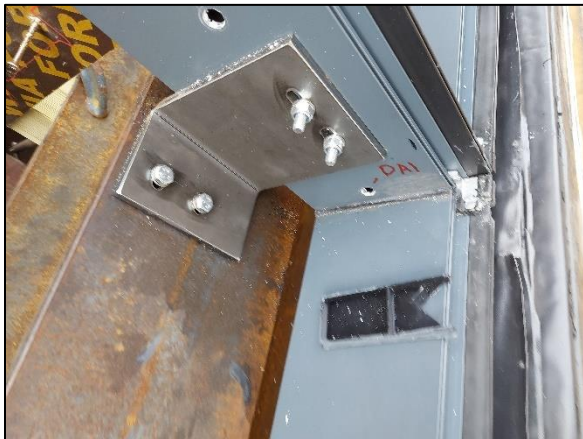
Photograph No. 16 - Bottom mullion transom connection and holes drilled for inspection purposes

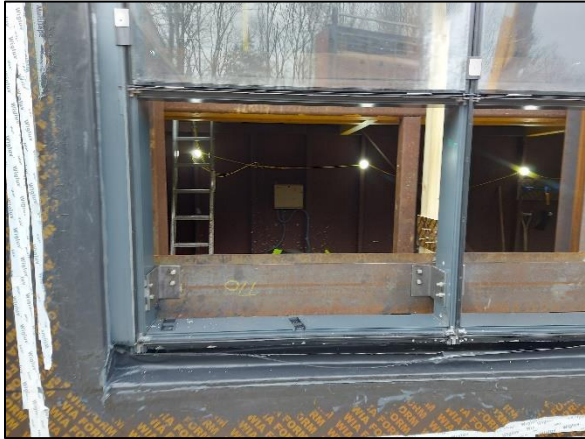
Photograph No. 17 - Bottom LHS with glazing removed

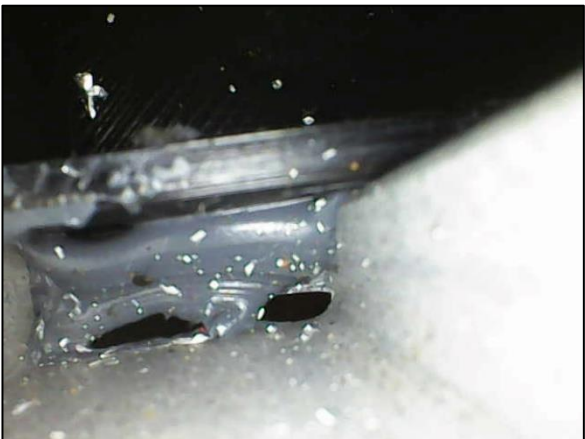
Photograph No. 19 - Sealant inside bottom of mullion

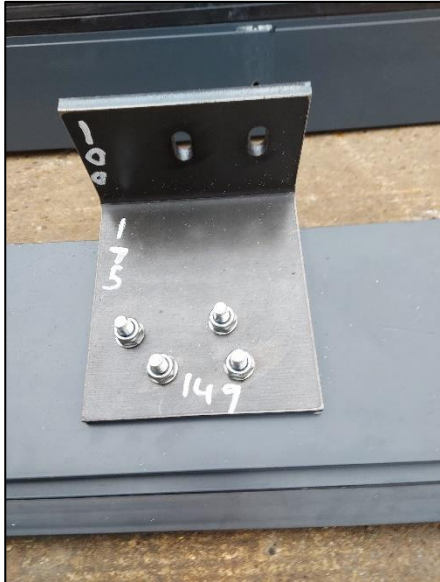
Photograph No. 20 - Floor level bracket 100mm x 195mm x 147mm

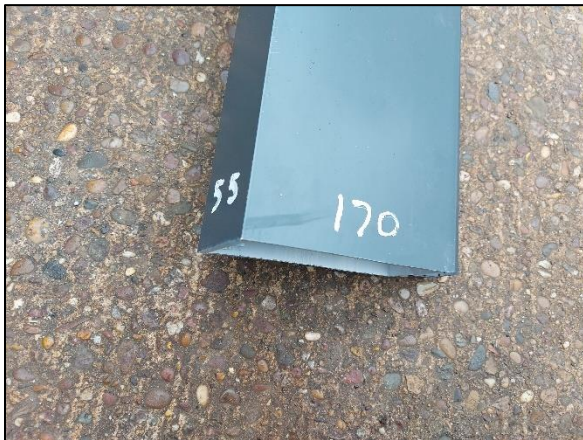
Photograph No. 21 - Mullion 170mm x 55mm

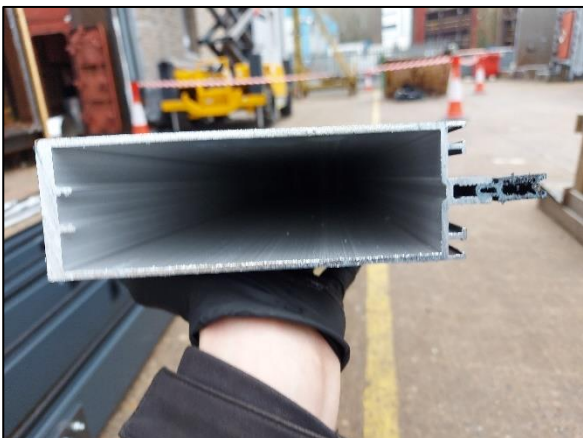
Photograph No. 22 - Mullion profile
