Weathertightness testing of a sample of Smart Systems Curtain Walling

Report No. N950/08/14087

Technical Report

**Weathertightness testing of a sample
of Smart Systems Curtain Walling**

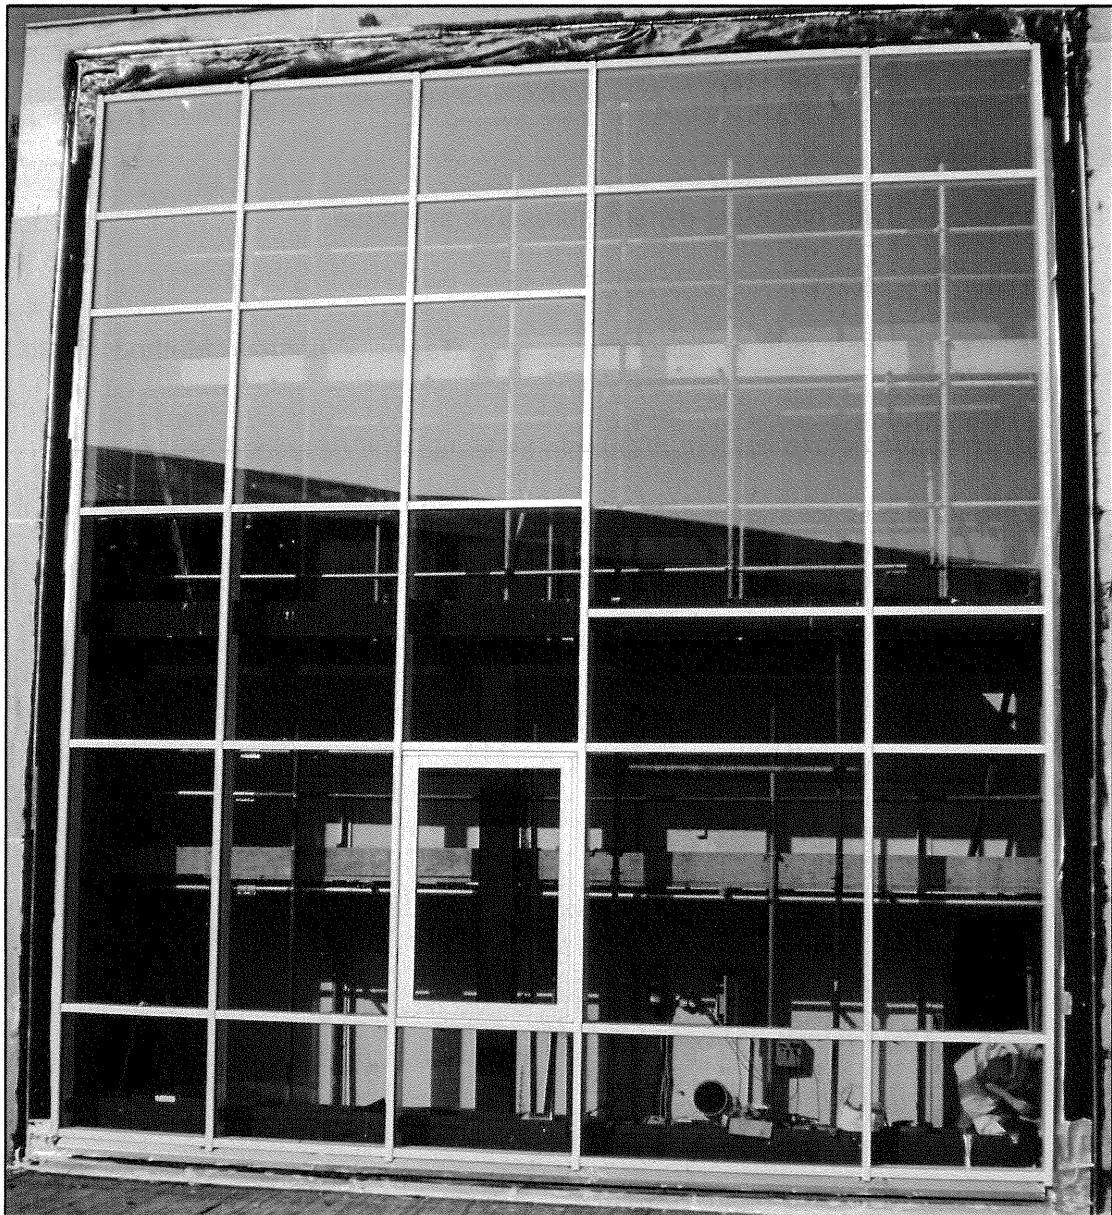
PHOTO 5080047

The sample was as shown in the photo below and the drawings included as an appendix to this report. For details of any remedial work carried out refer to Section 7.

TEST SAMPLE ELEVATION

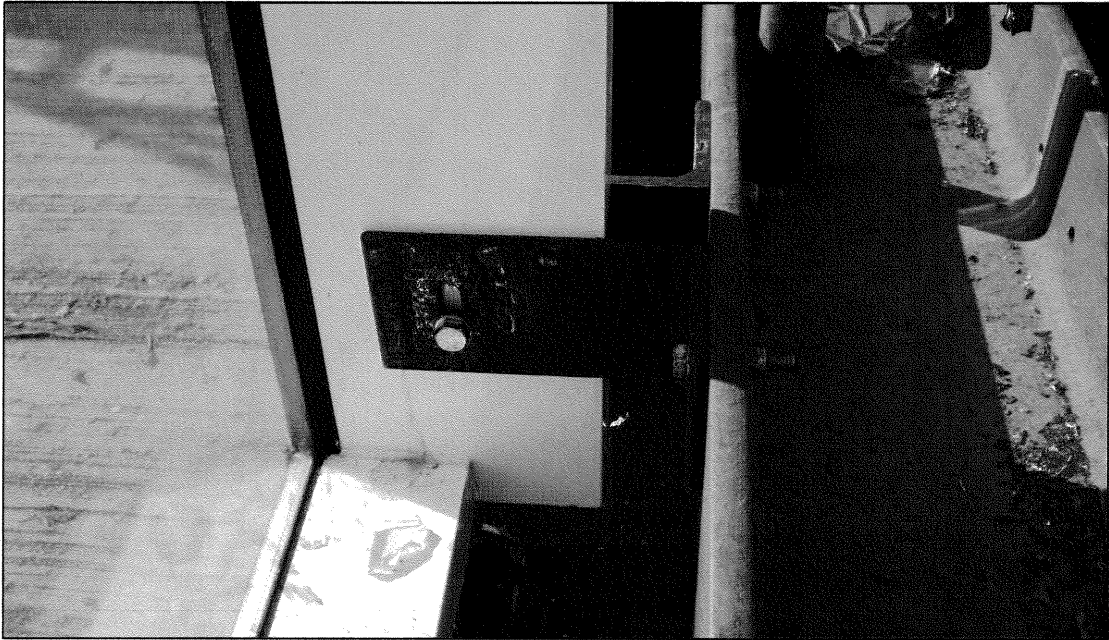
PHOTO 5080047

FIXING BRACKET

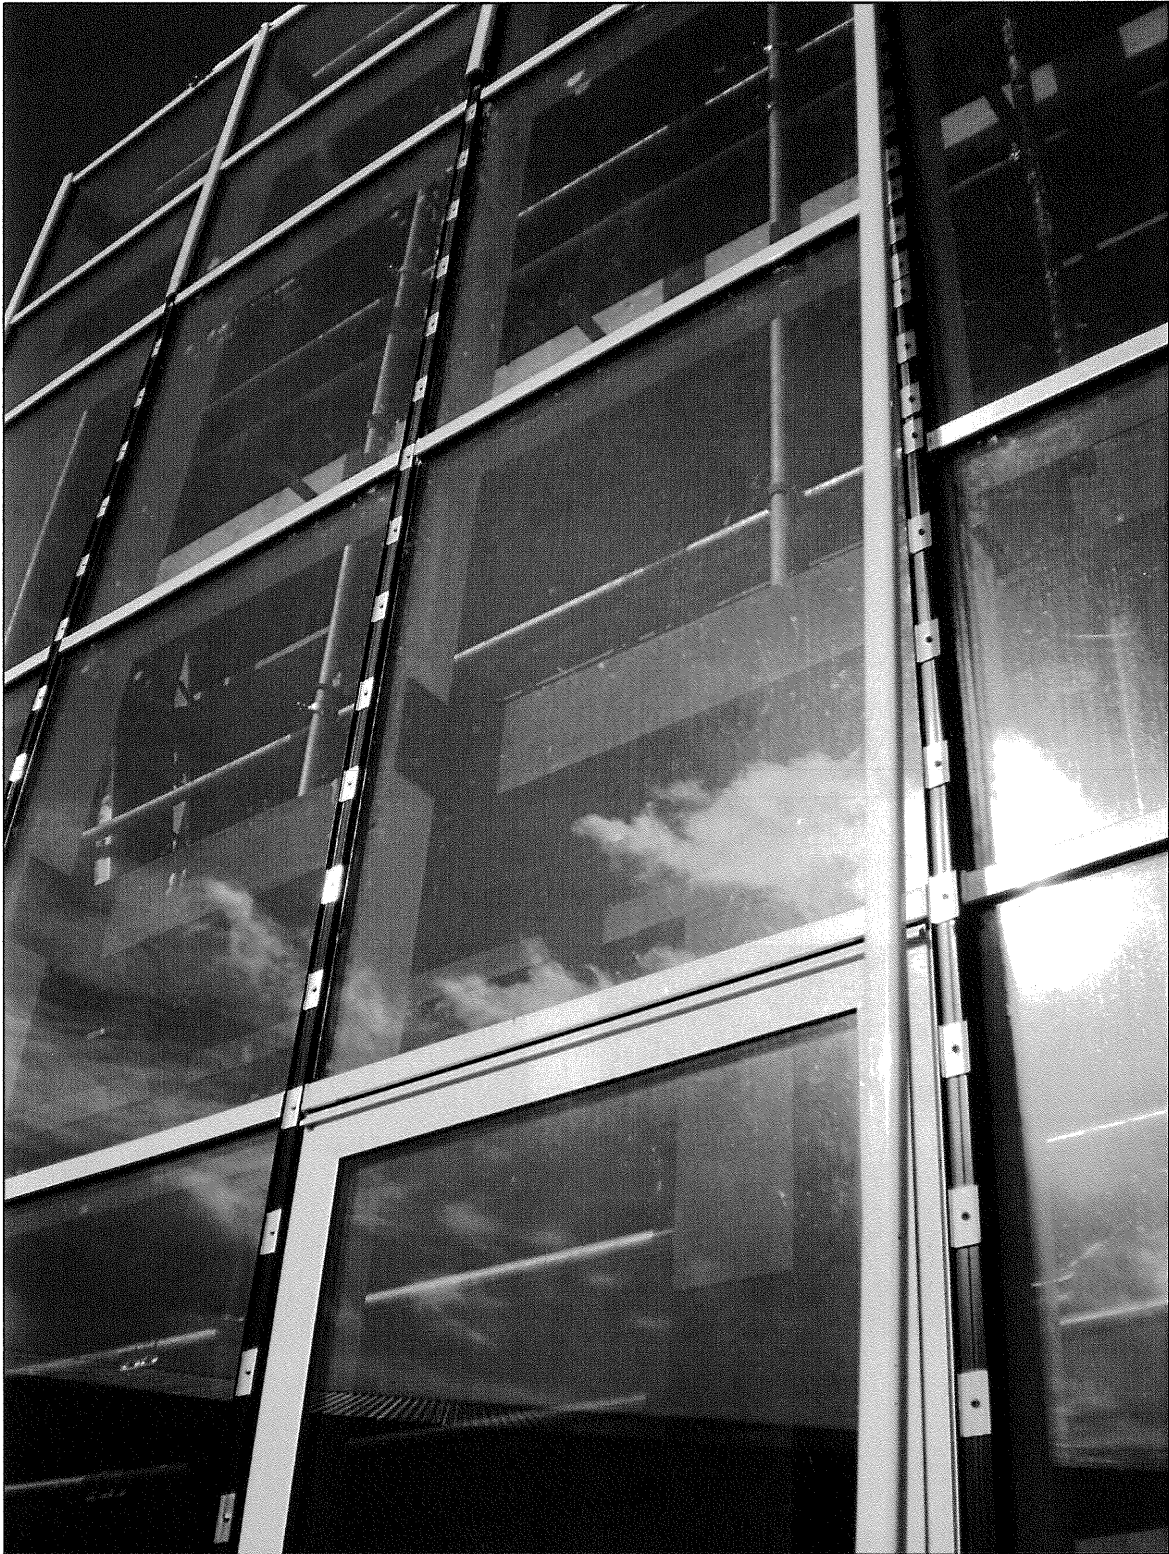
PHOTO 6230072a

PRESSURE PLATES

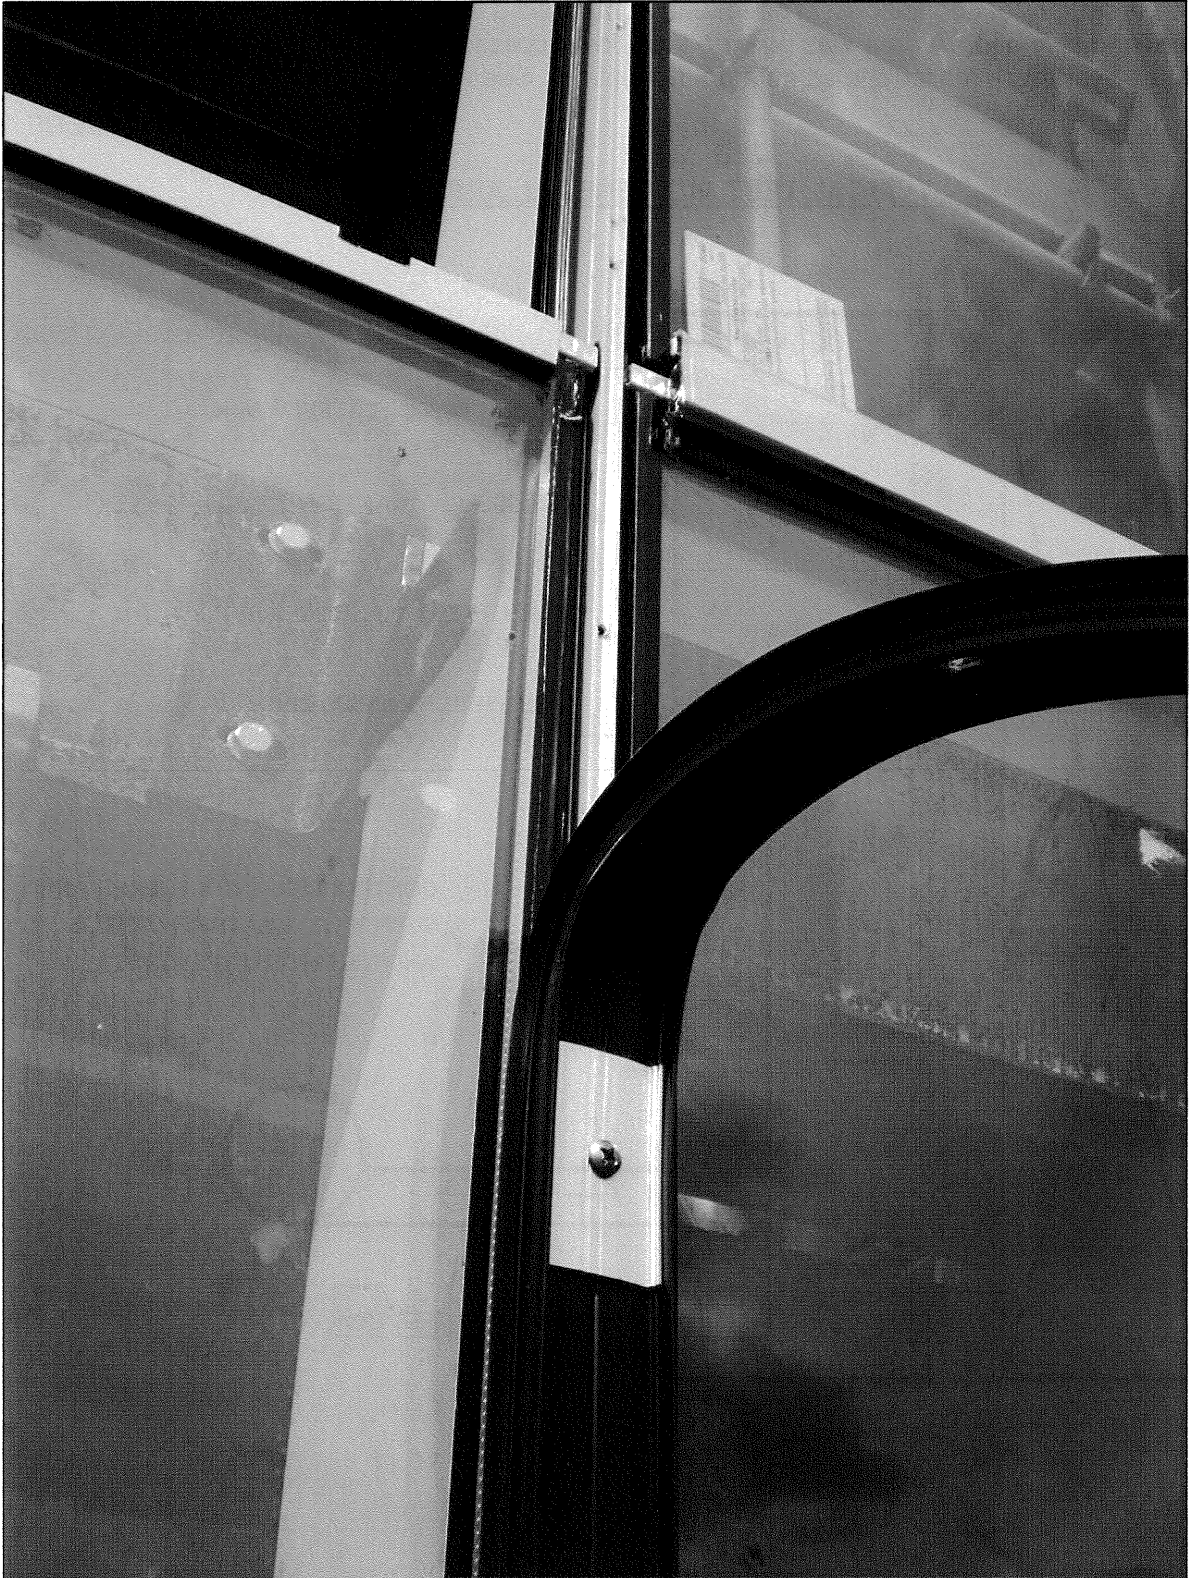
PHOTO 6230078a

GLAZING GASKET

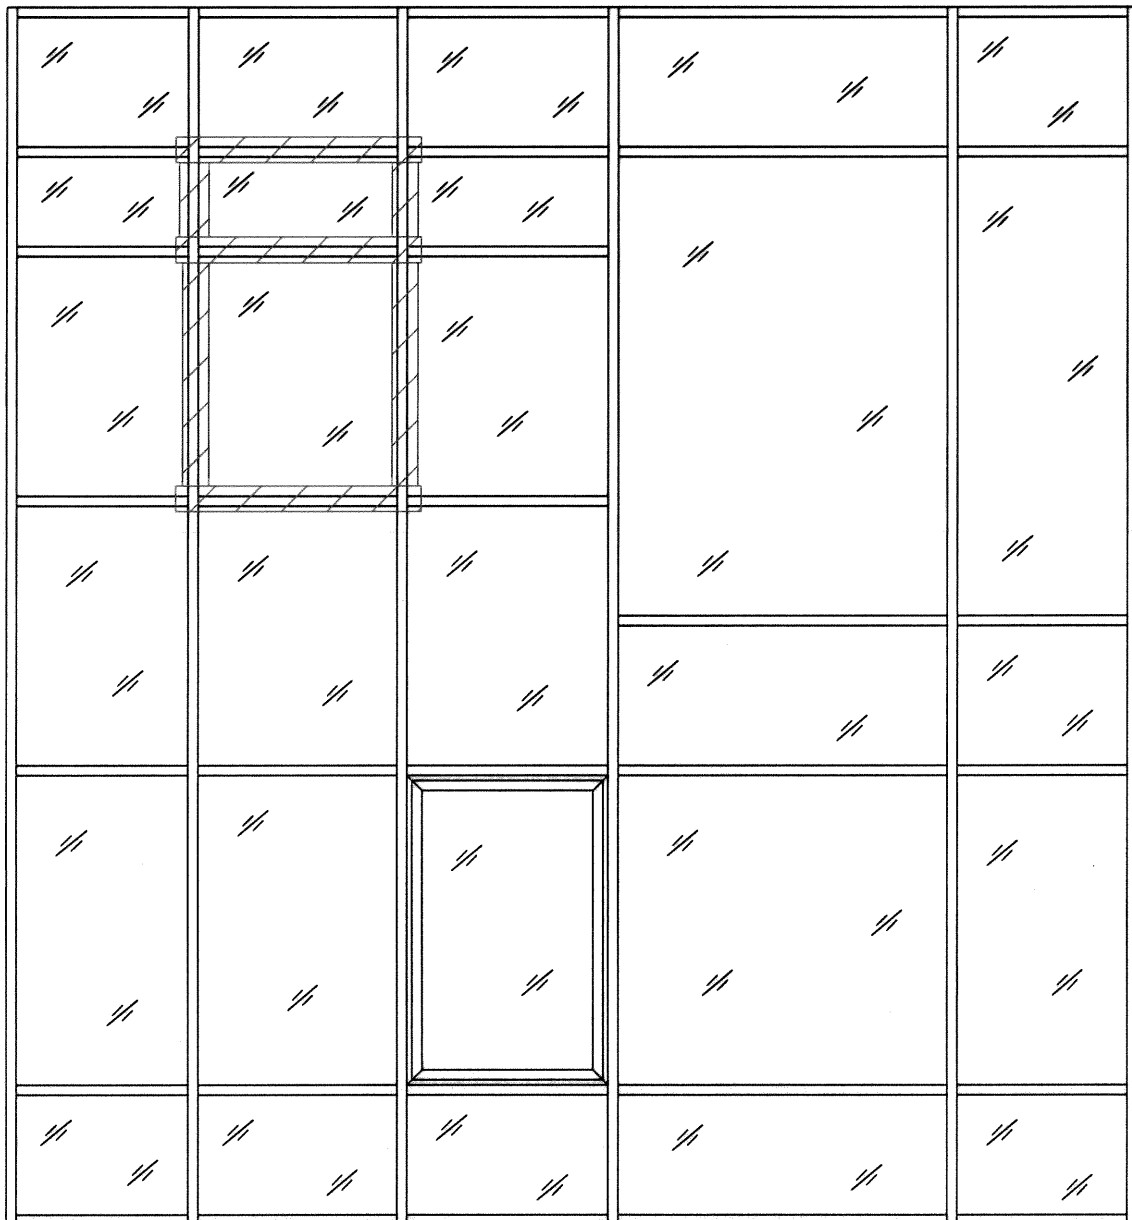
FIGURE 6

HOSE TEST LOCATIONS

External View

joints hose tested

Throughout the test the interior face of the sample was examined for water penetration. The joints tested are shown in Figure 6.

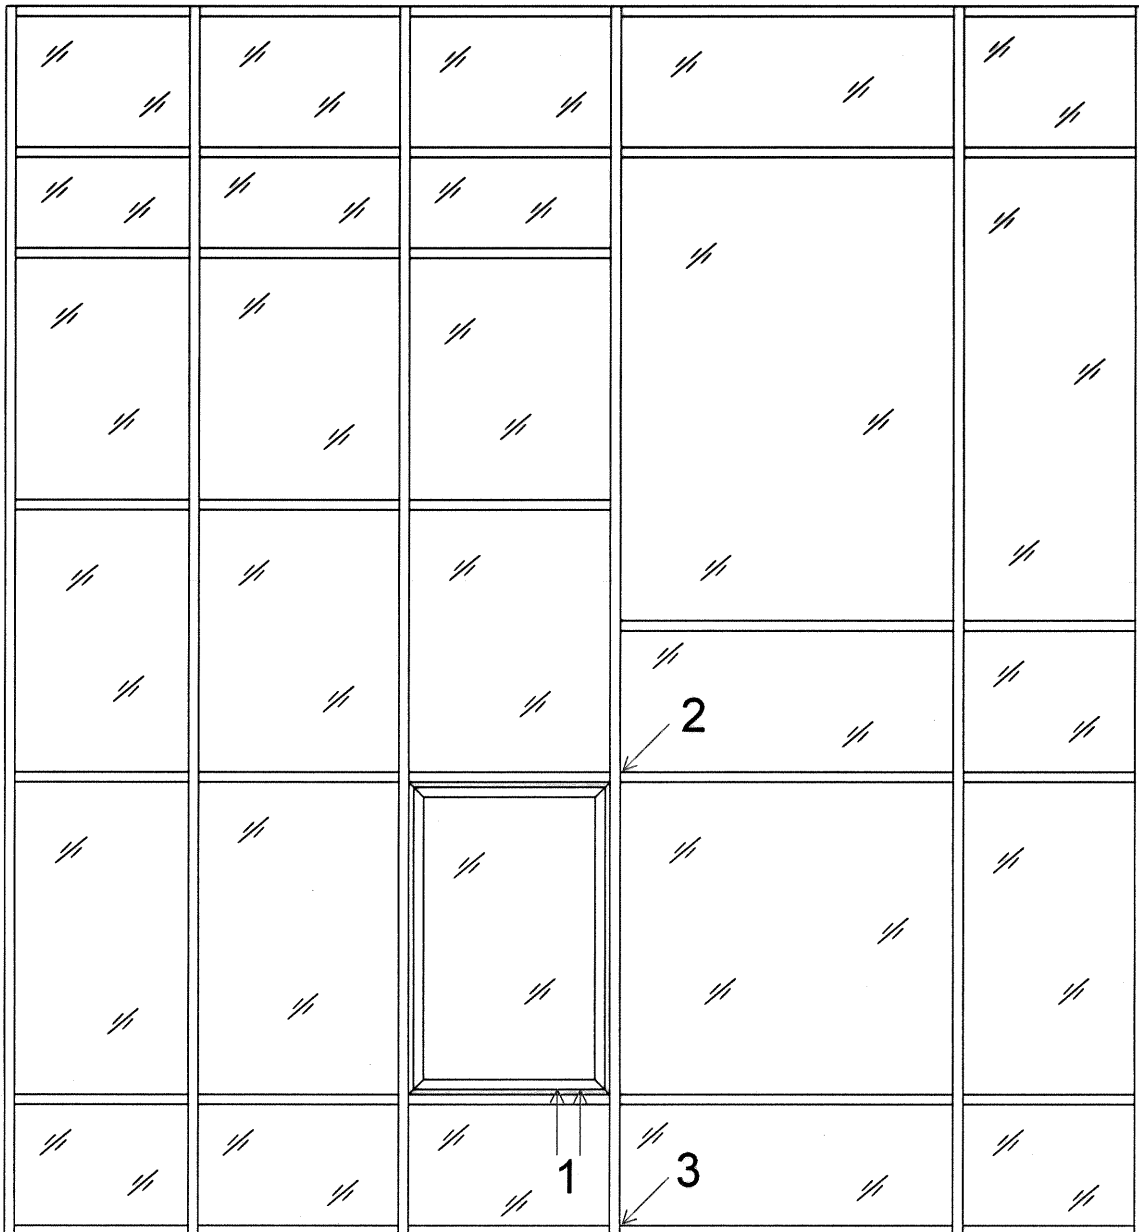
FIGURE 7

WATER LEAKAGE LOCATIONS

External view

Water leakage was observed during the test as described below and shown in Figure 7.

After 4½ minutes at a pressure differential of 450 pascals, steady dripping was observed from bottom of intruder vent frame at location 1. Dripping continued through 600 pascals.

After 4 minutes at a pressure differential of 600 pascals, a pool of water was observed in the glazing gasket corner at location 2. One minute later, a drop of water also appeared in the glazing gasket corner at location 3.
