**Testing of Smart  
Architectural Aluminium  
Limited's Alitherm 700  
Reversible windows to  
the requirements of  
Annex C of PAS 24:2012**

29 April 2014

Test report number 292869b-A

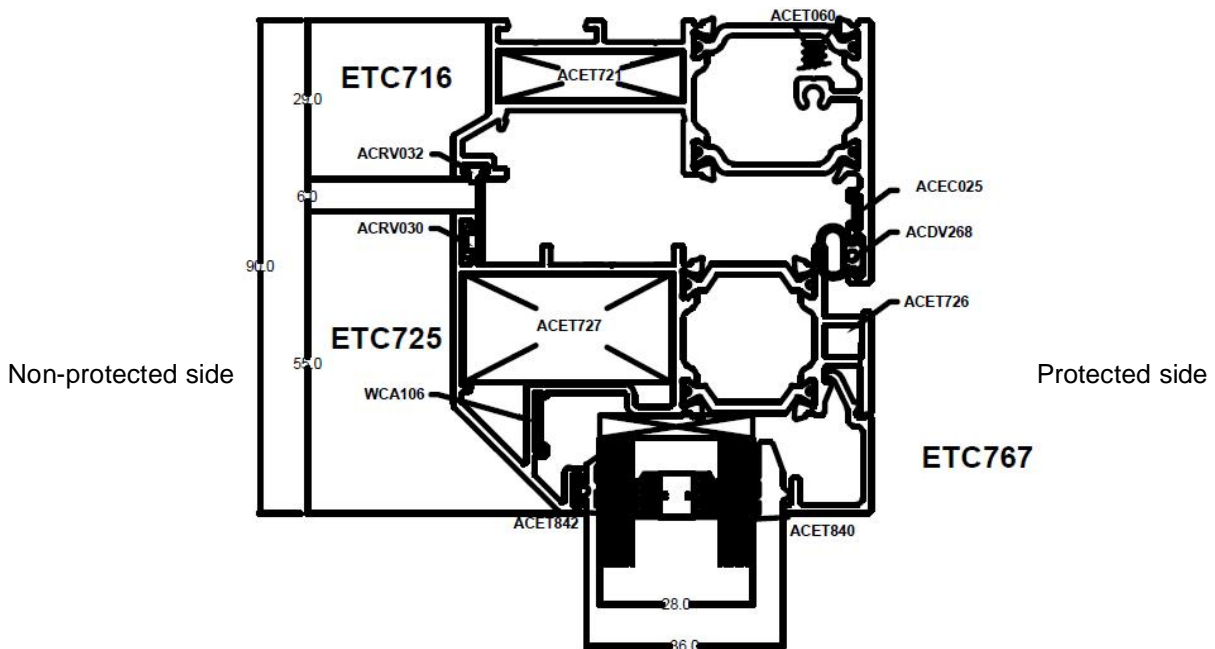
**Figure 1** Cross section through top of sash on specimen 292869b/01

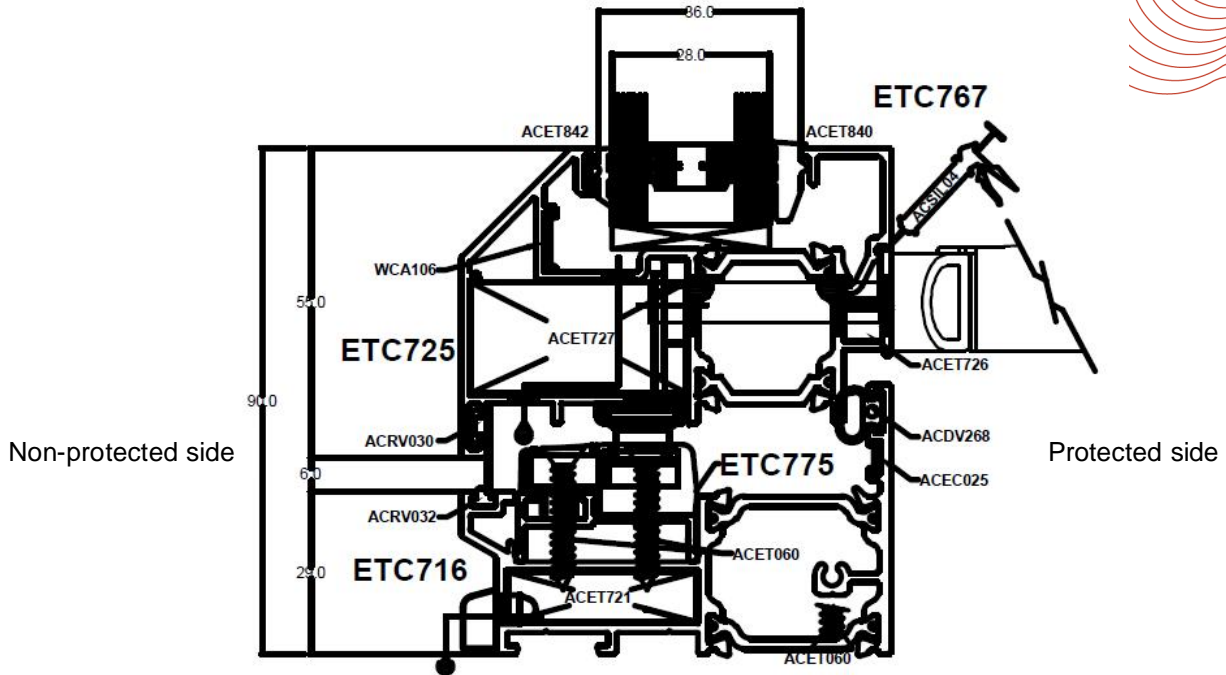
**Figure 2** Cross section through bottom of sash\*

\* The specimen submitted for testing did not incorporate a cill as shown in this figure.

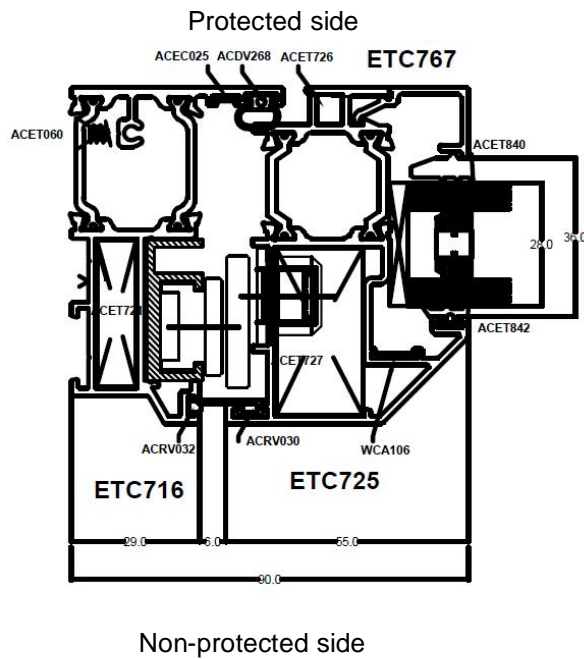
**Figure 3** Cross section through side of sash and frame

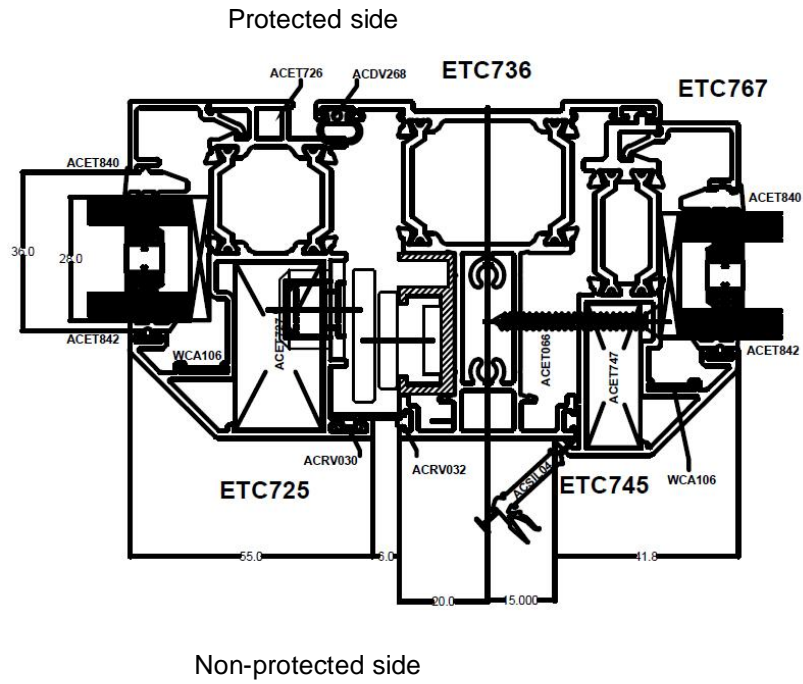
**Figure 4** Cross section through side of sash frame, mullion and side of fixed light

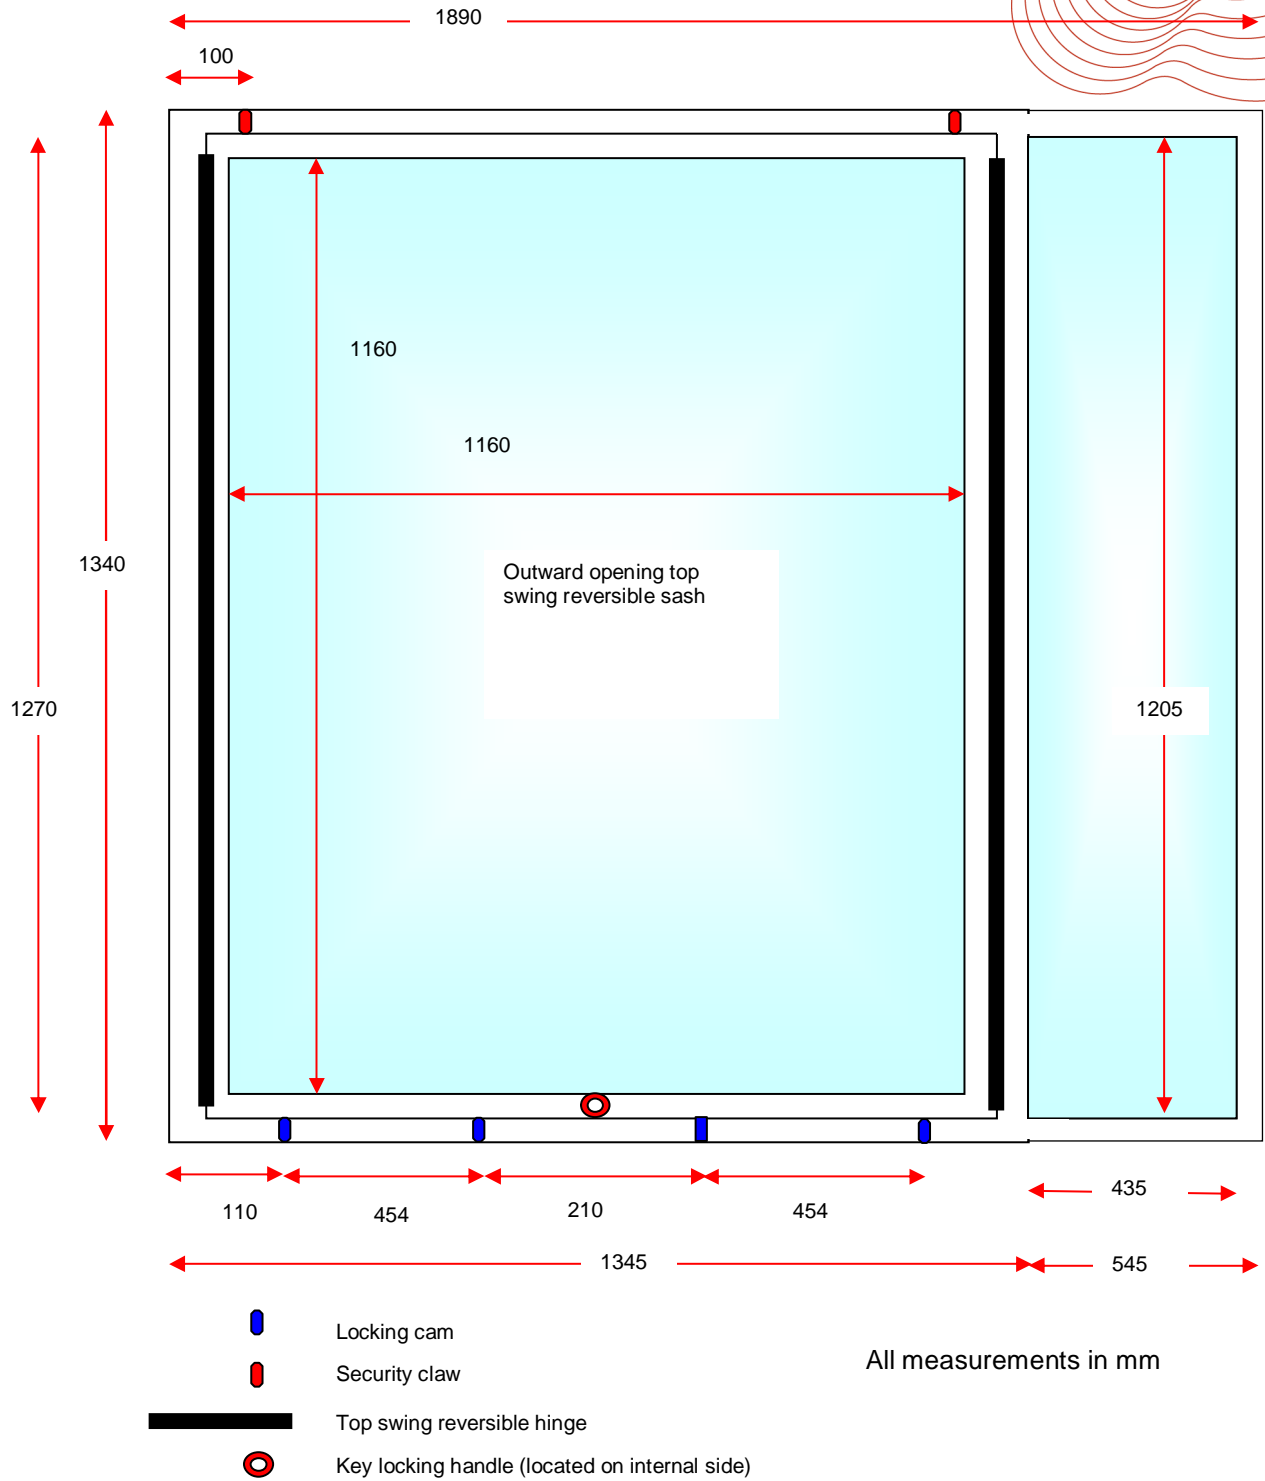
Figure 5 Specimen 292869b/01 (external view)

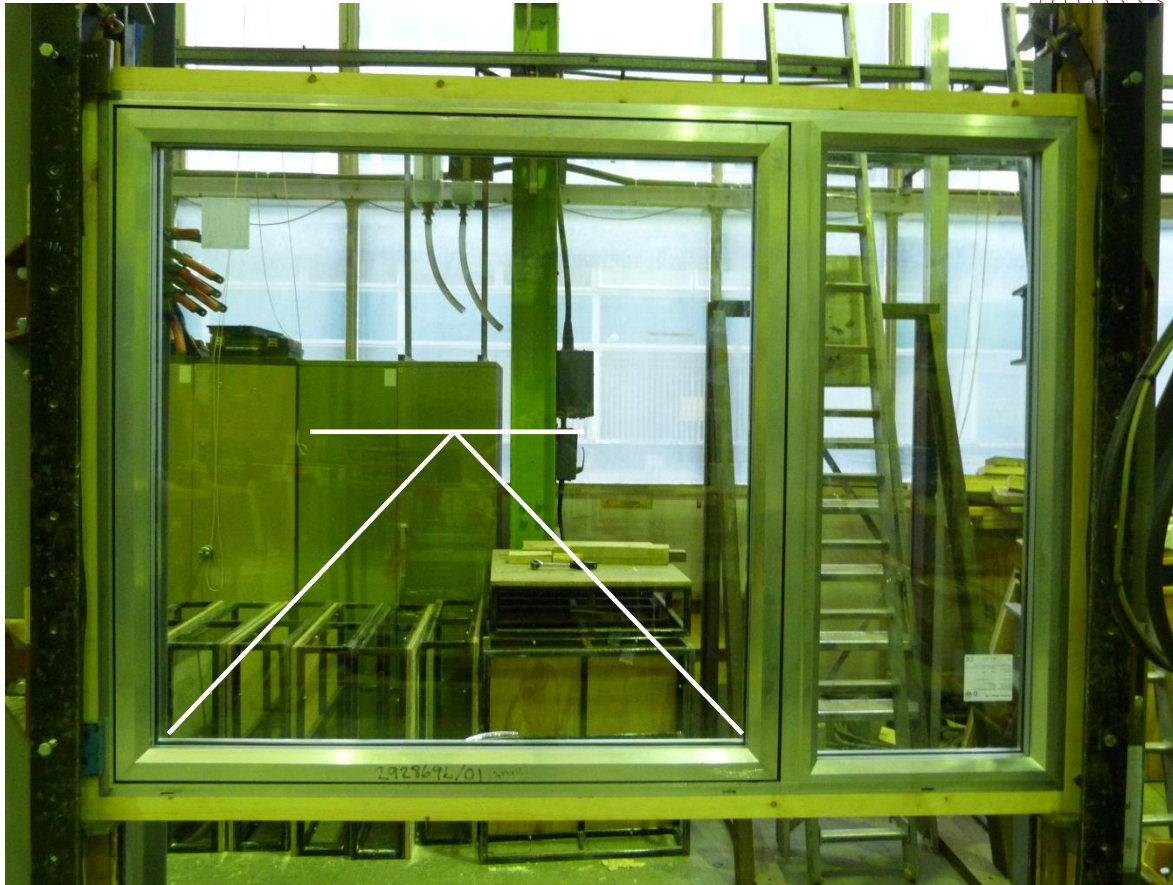
**Figure 6** External view of specimen 292869b/01

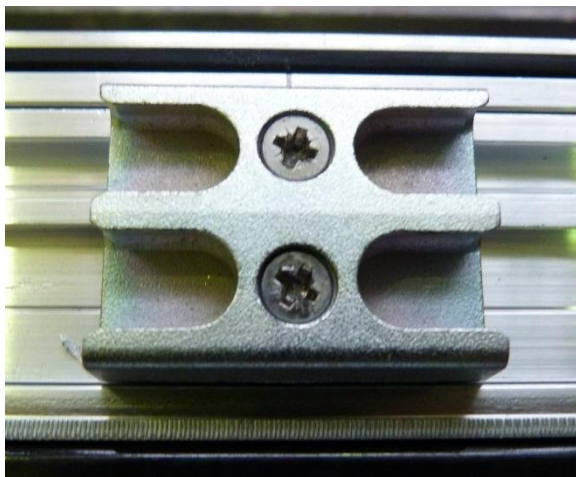
**Figure 7** View of keep

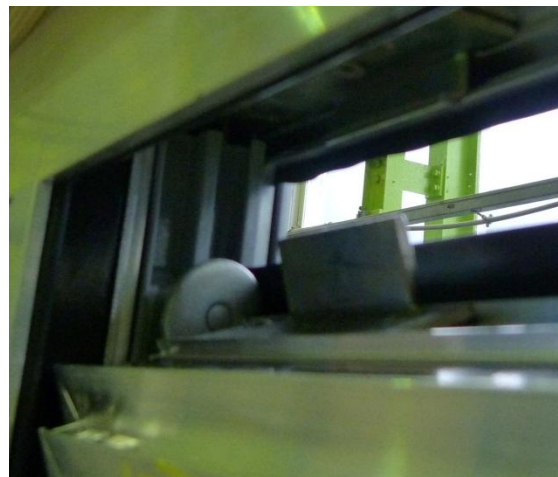
**Figure 8** View of security claw

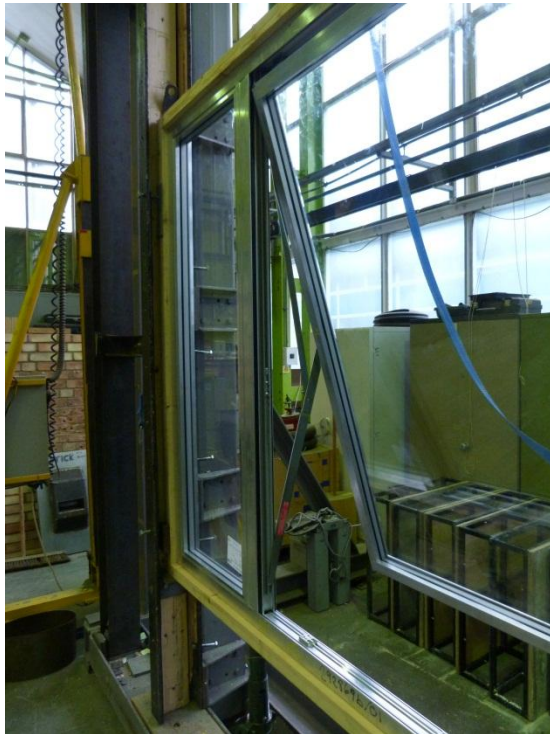
**Figure 9** View of reversible hinge

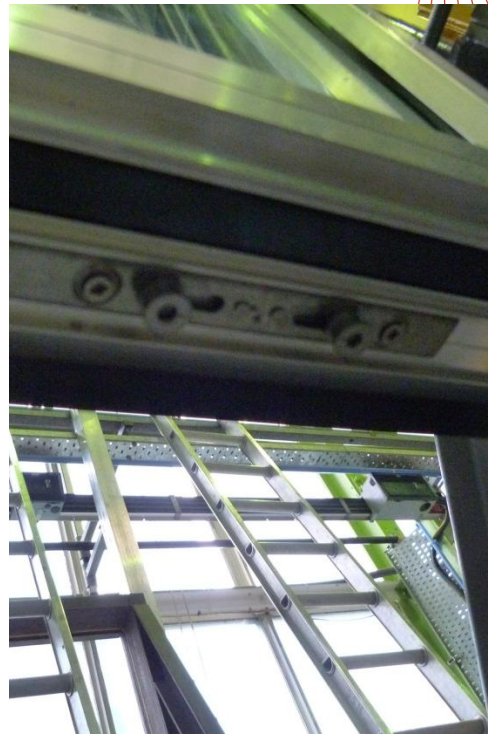
**Figure 10** View of mushroom cam bolts

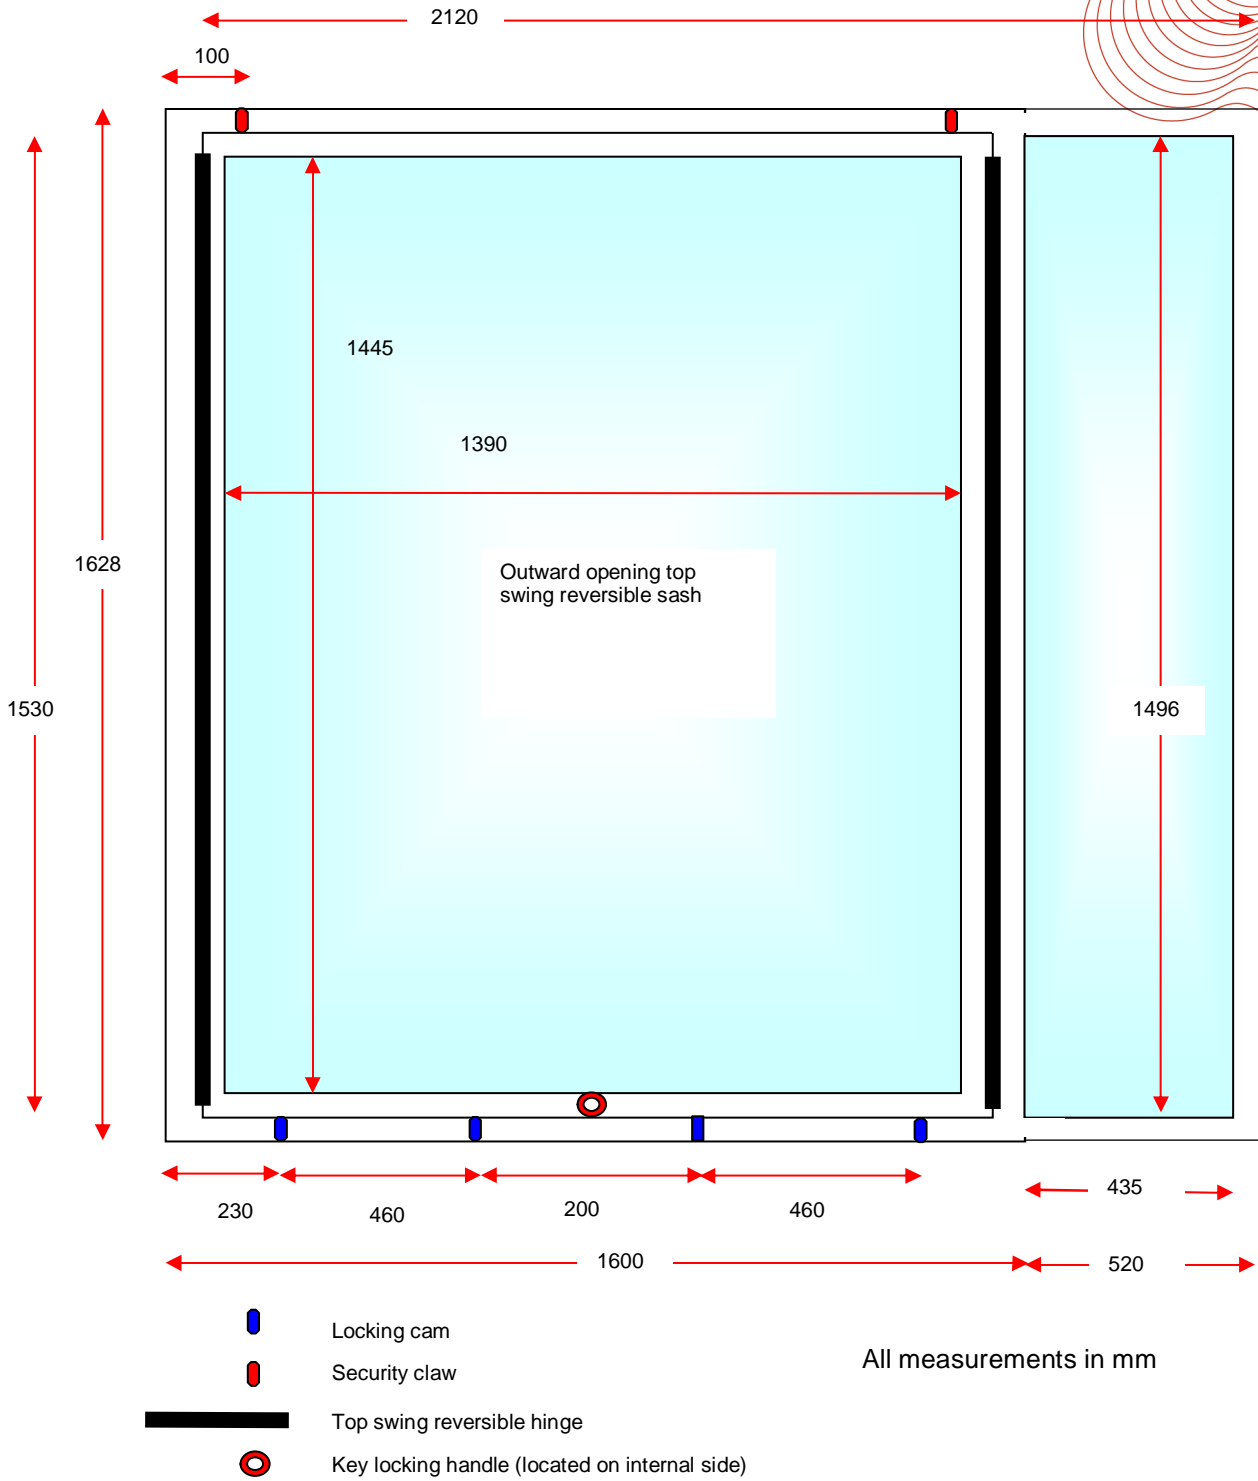
Figure 11 Specimen 292869b/02 (external view)

Specimen 292869b/02 was generally identical to specimen 292869b/01 but with the following exceptions:

- The width and height of the specimen were greater. Specimen 292869b/02 was 2120 mm wide by 1628 mm high.
- The double glazed units incorporated within the opening light incorporated 6 mm thick toughened panes in place of the 4 mm thick toughened panes.
