Test Report 8421006.

Smart Systems Limited incorporating Smart Extrusions

Type test for product certification

Eco Futural Aluminium Alloy Double Doors

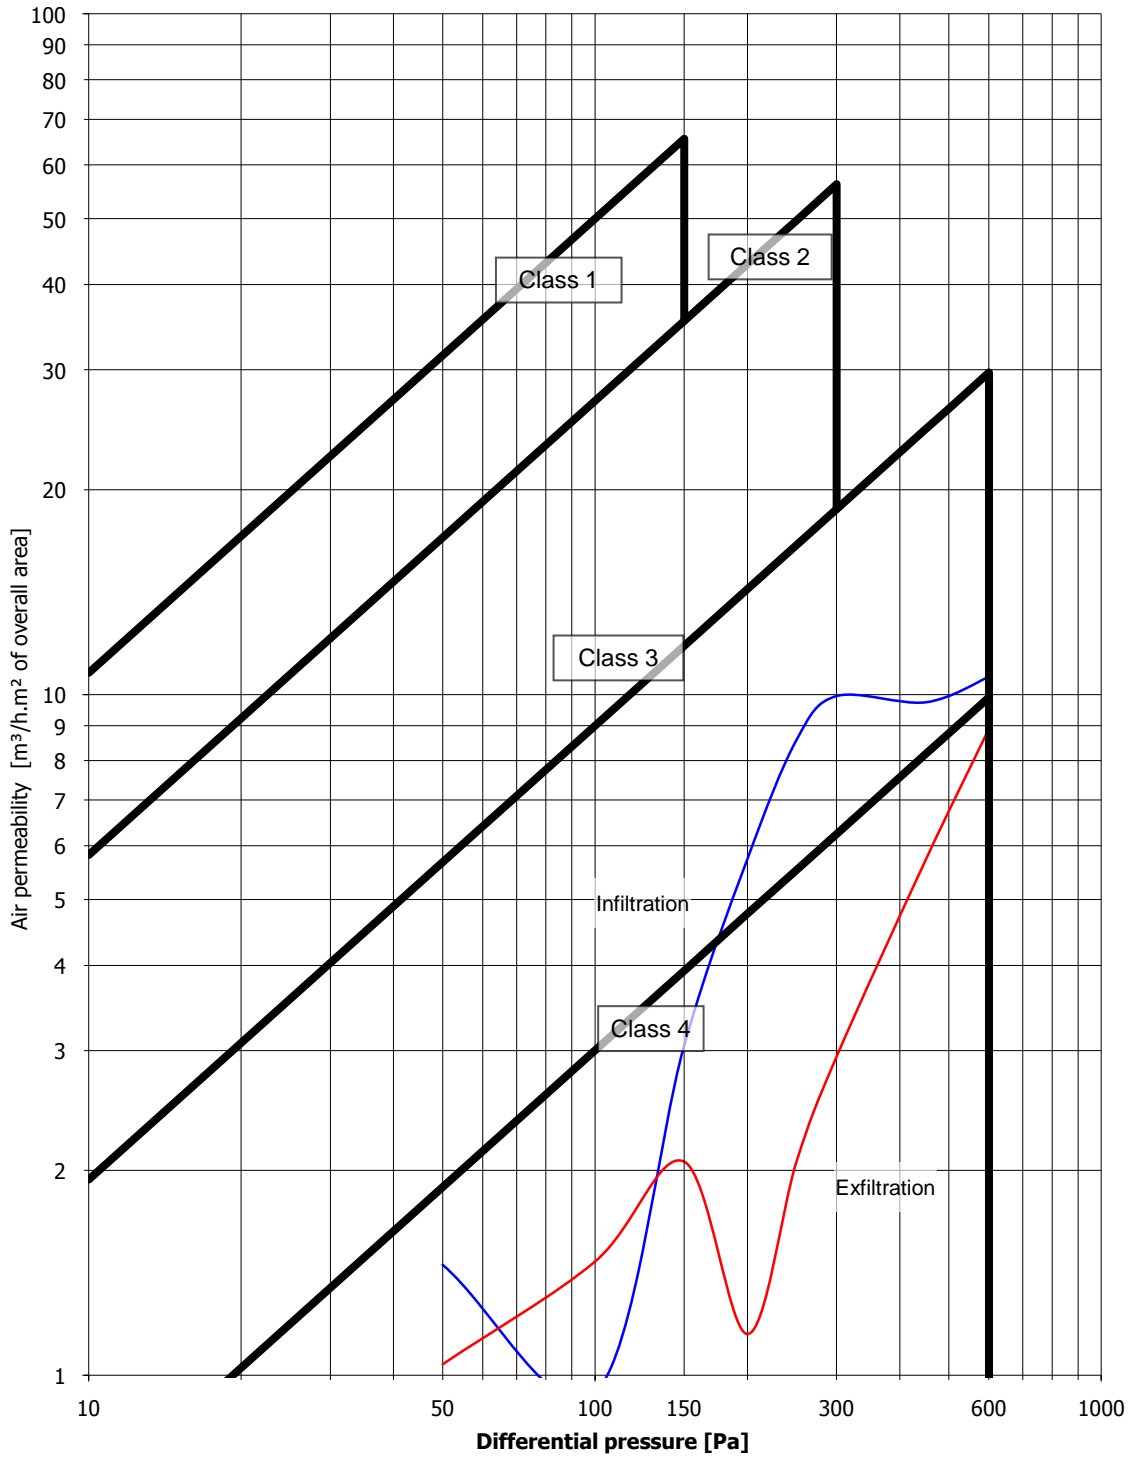
GRAPH OF AIR PERMEABILITY BEFORE GUSTING

AIR PERMEABILITY TEST RESULTS - BS 6375-1:2009 Clause 6 / BS EN 1026:2000

Air Pressure [Pa]	Average rate of air leakage [m ³ /h]	Average rate of air leakage relative to area of sample [m ³ /h.m ²]
50	7.7	1.2
100	7.5	1.2
150	15.8	2.6
200	21.3	3.4
250	33.0	5.3
300	40.0	6.4
450	47.9	7.7
600	60.5	9.8

BS 6375-1:2009 Clause 6.2 - Overall area class = 3
