**Test Report 8247857.**  
Smart Systems Limited  
incorporating Smart Extrusions

Type test for product certification

Smart Visiglide Plus aluminium sliding patio doors

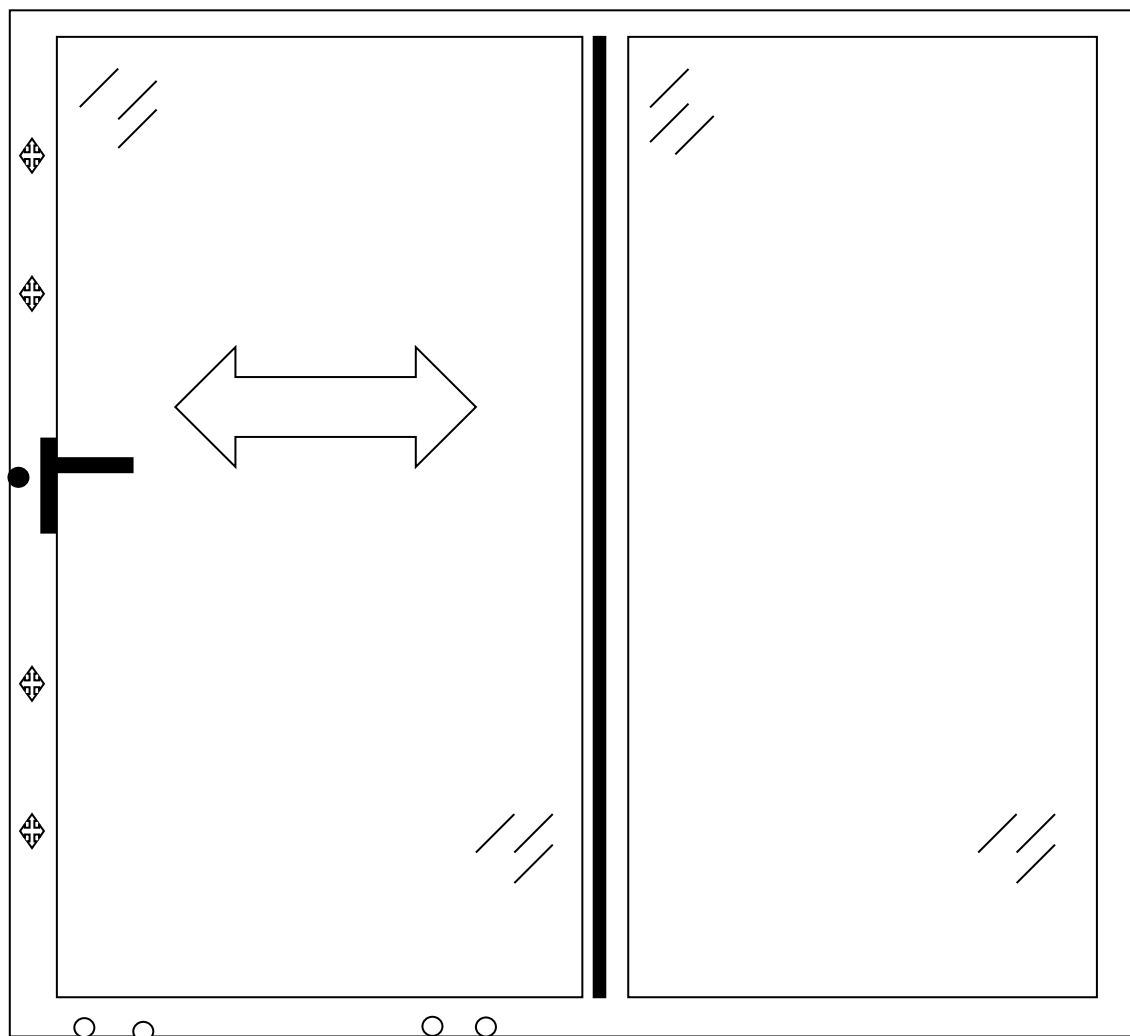
**ELEVATION DRAWING OF DOOR ASSEMBLY  
(indicating position of hardware)**

-

- hinge
-

- roller
-

- hook bolt
-

- handle
-

- Hook bolt

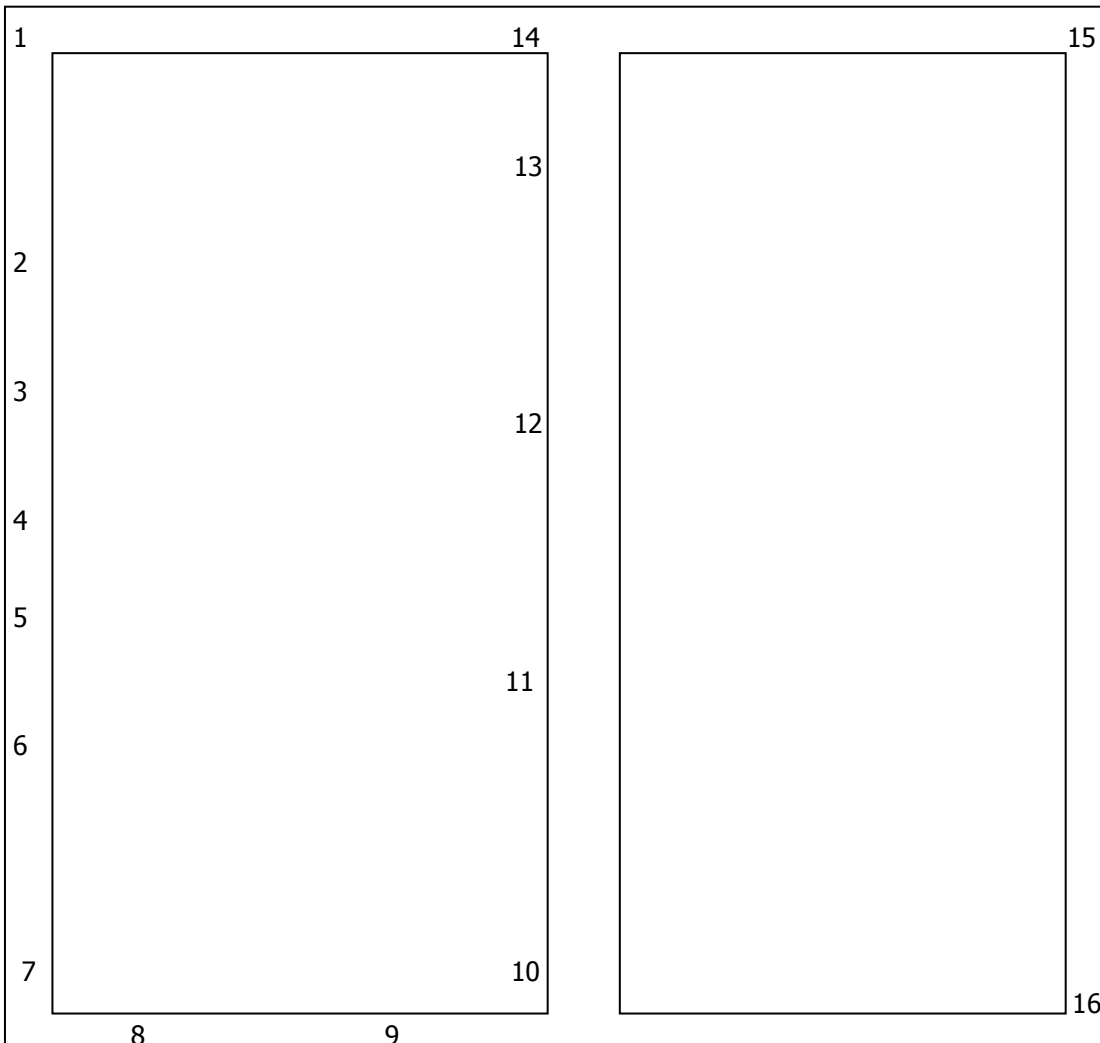
Diagram of points of application of loads

The test was carried out in accordance with the procedures detailed in B.4.5, Using loading cases B.1 to B.6 and Figures B.12 for loading sequence and using the test apparatus detailed in Figures B.6 to B.9.

1. Non meeting corner (upper left jamb)

2. Mushroom bolt (upper left jamb)

4. Hook bolt (centre left jamb)

5. Mushroom bolt (lower left jamb)

7. Non meeting corners (lower left jamb)

8. Roller / Roller (centre left active leaf)

9. Roller / Roller (centre right active leaf)

10. Meeting corner (bottom right fixed)

11. Continuous Interlock (lower false mullion)

## 14. Corner fixed (upper right fixed)

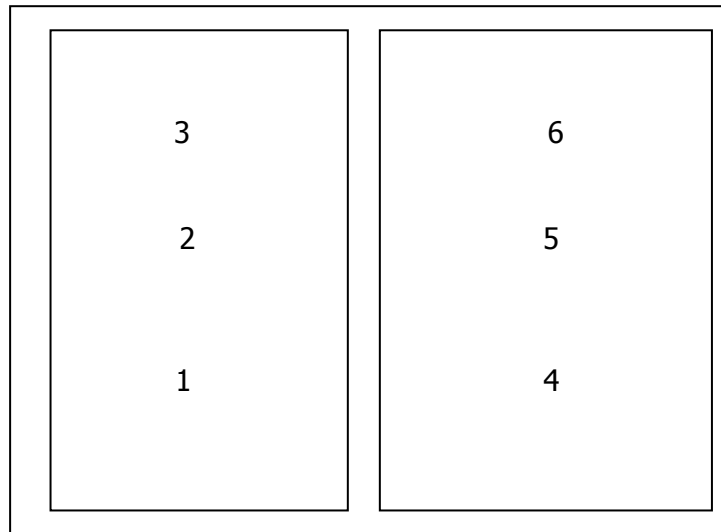
Diagram of points of application of loads

The test was carried out in accordance with the requirements, objectives and procedures detailed in B.4.8.1 using the impact point and procedure described in B.4.8.2 and B.4.8.3 and Figure B.10

Impact point	Position from floor level	Effect
1	0.80m Infill	None
2	1.25m Infill	None
3	1.7m Infill	None
4	0.80m Infill Fixed	None
5	1.25m Infill Fixed	None
6	1.7m Infill Fixed	None

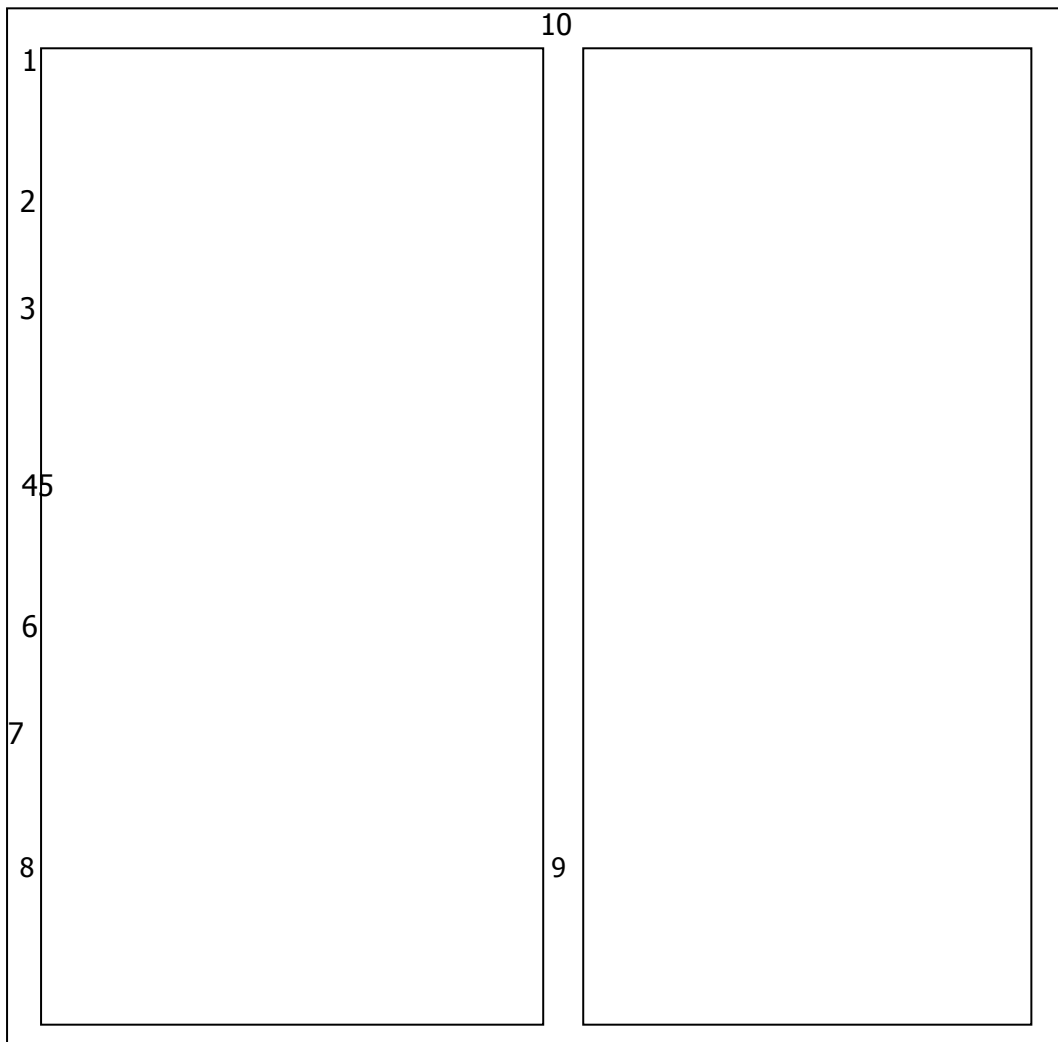
Diagram of points of application of loads

The test was carried out in accordance with the requirements, objectives and procedures detailed in B.4.9.1, B.4.9.2.1, B.4.9.2.2, B.4.9.2.3 using procedure B.4.9.3, using the test apparatus detailed in B.11 using the impact sequence in figure B.14.

Impact point	Position	Effect
1	Corner	None
2	Mushroom Bolt	None
3	Mushroom Bolt	
4	Hook bolt	None
5	Cylinder	None
6	Hook bolt	None
7	Mushroom bolt	None
8	Mushroom bolt	None
9	Corner	None
10	Corner	None

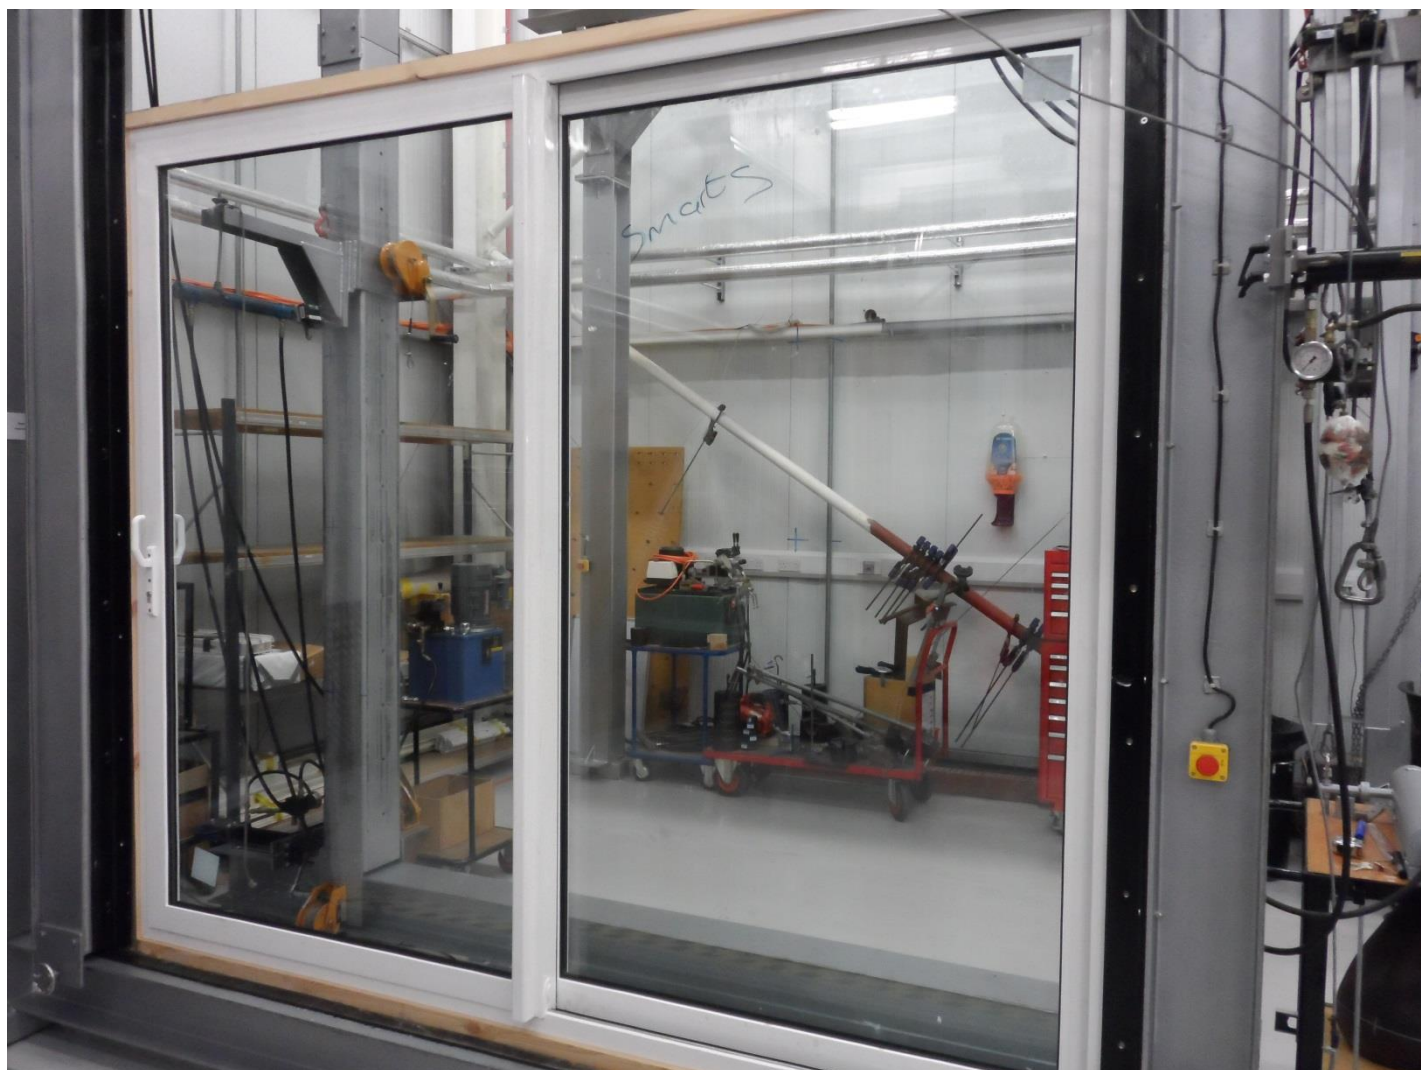
Photograph of Sample.

1 off sliding patio door with one fixed pane and two sliding panes fully glazed in door assembly with standard threshold

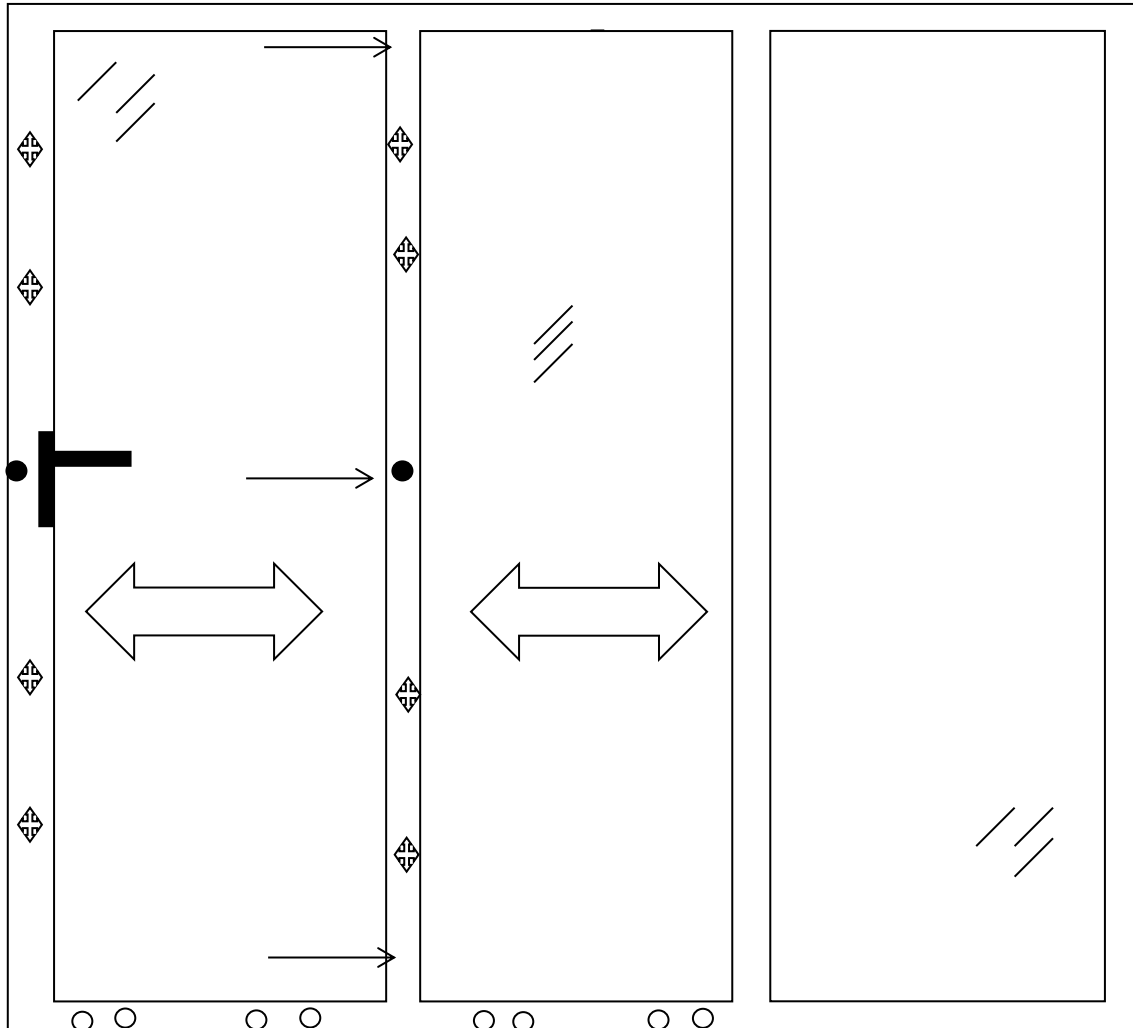
**ELEVATION DRAWING OF DOOR ASSEMBLY  
(indicating position of hardware)**

water leakage

- Transducer placement

Air pressure (Pa)	Point at which water leakage occurred
150	water ran out and over threshold from the threshold opening joint

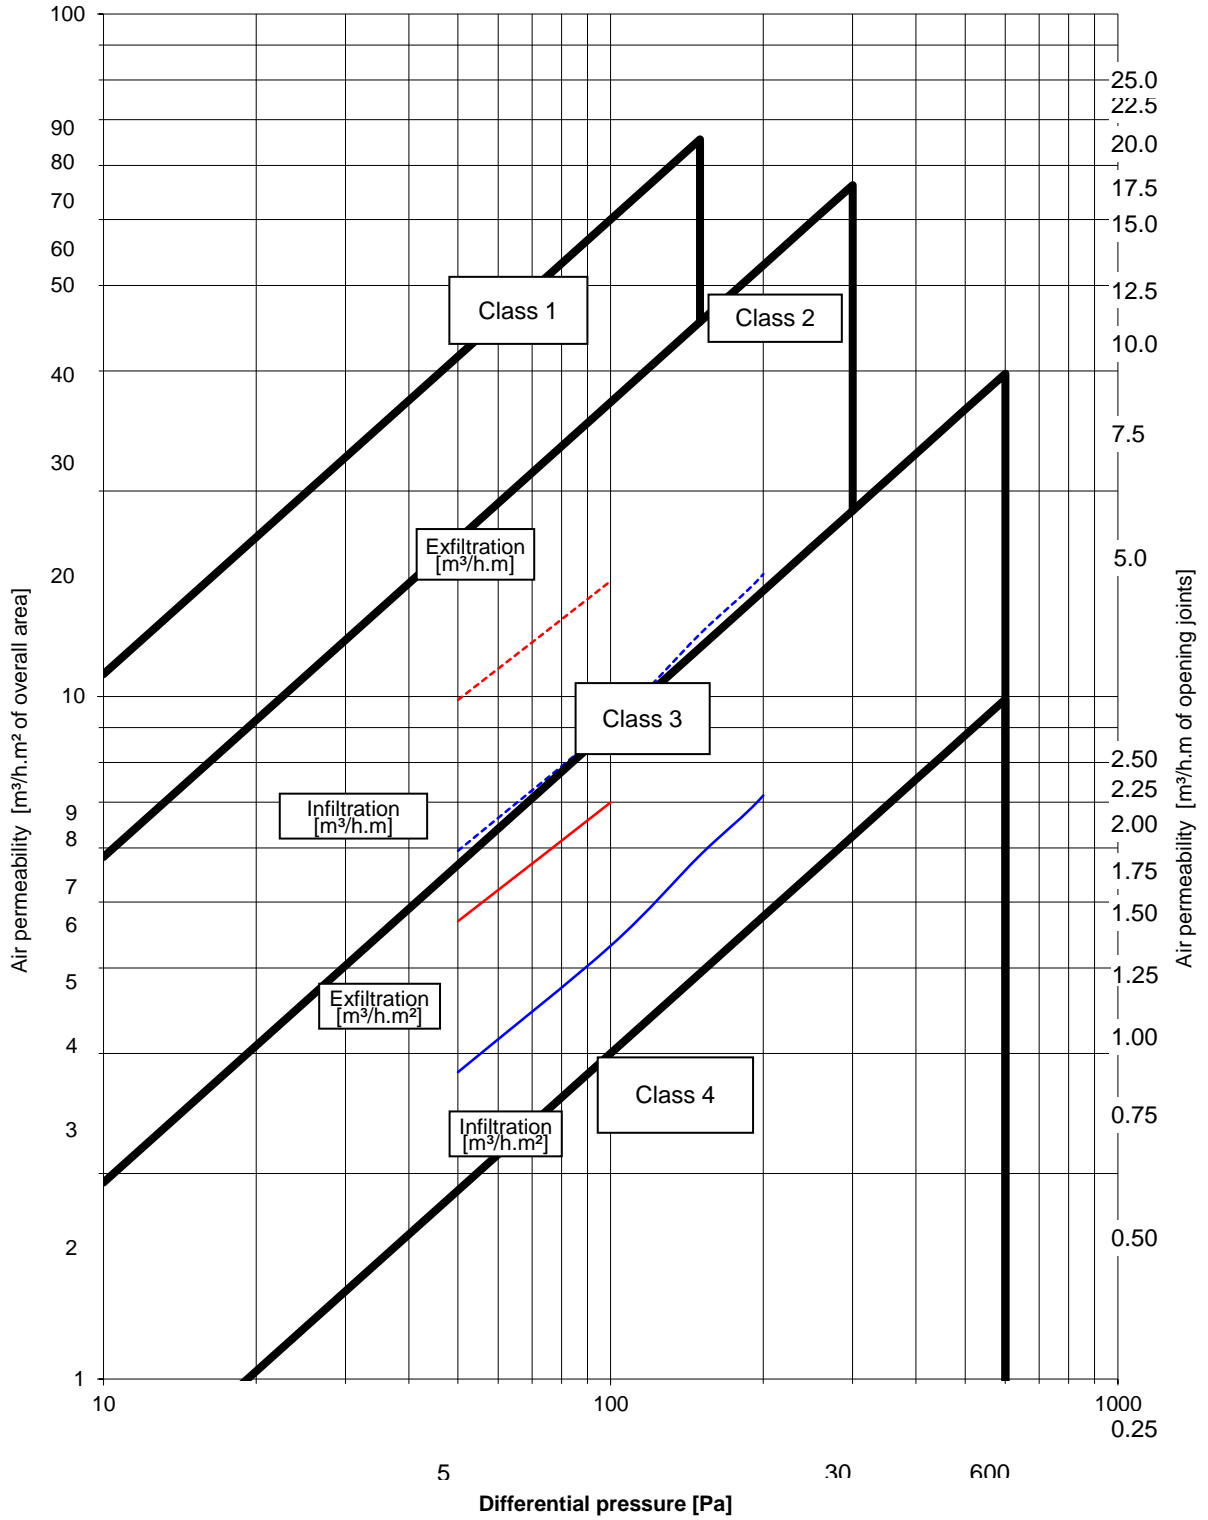
GRAPH OF AIR PERMEABILITY BEFORE GUSTING

Three positive pressure pulses of 660Pa were applied prior to testing

Air Pressure [Pa]	Average rate of air leakage [m <sup>3</sup> /h]	Average rate of air leakage per meter length of opening joint [m <sup>3</sup> /h.m]	Average rate of air leakage relative to area of sample [m <sup>3</sup> /h.m <sup>2</sup> ]
50	32.4	1.98	3.75
100	48.8	2.98	5.65
150	63.8	3.90	7.39
200	-	-	-
250	-	-	-
300	-	-	-
450	-	-	-
600	-	-	-

BS 6375-1:2009 Clause 6.2 - Joint class = 2

BS 6375-1:2009 Clause 6.2 - Area class = 3

BS 6375-1:2009 Clause 6.2 - Overall class = 3

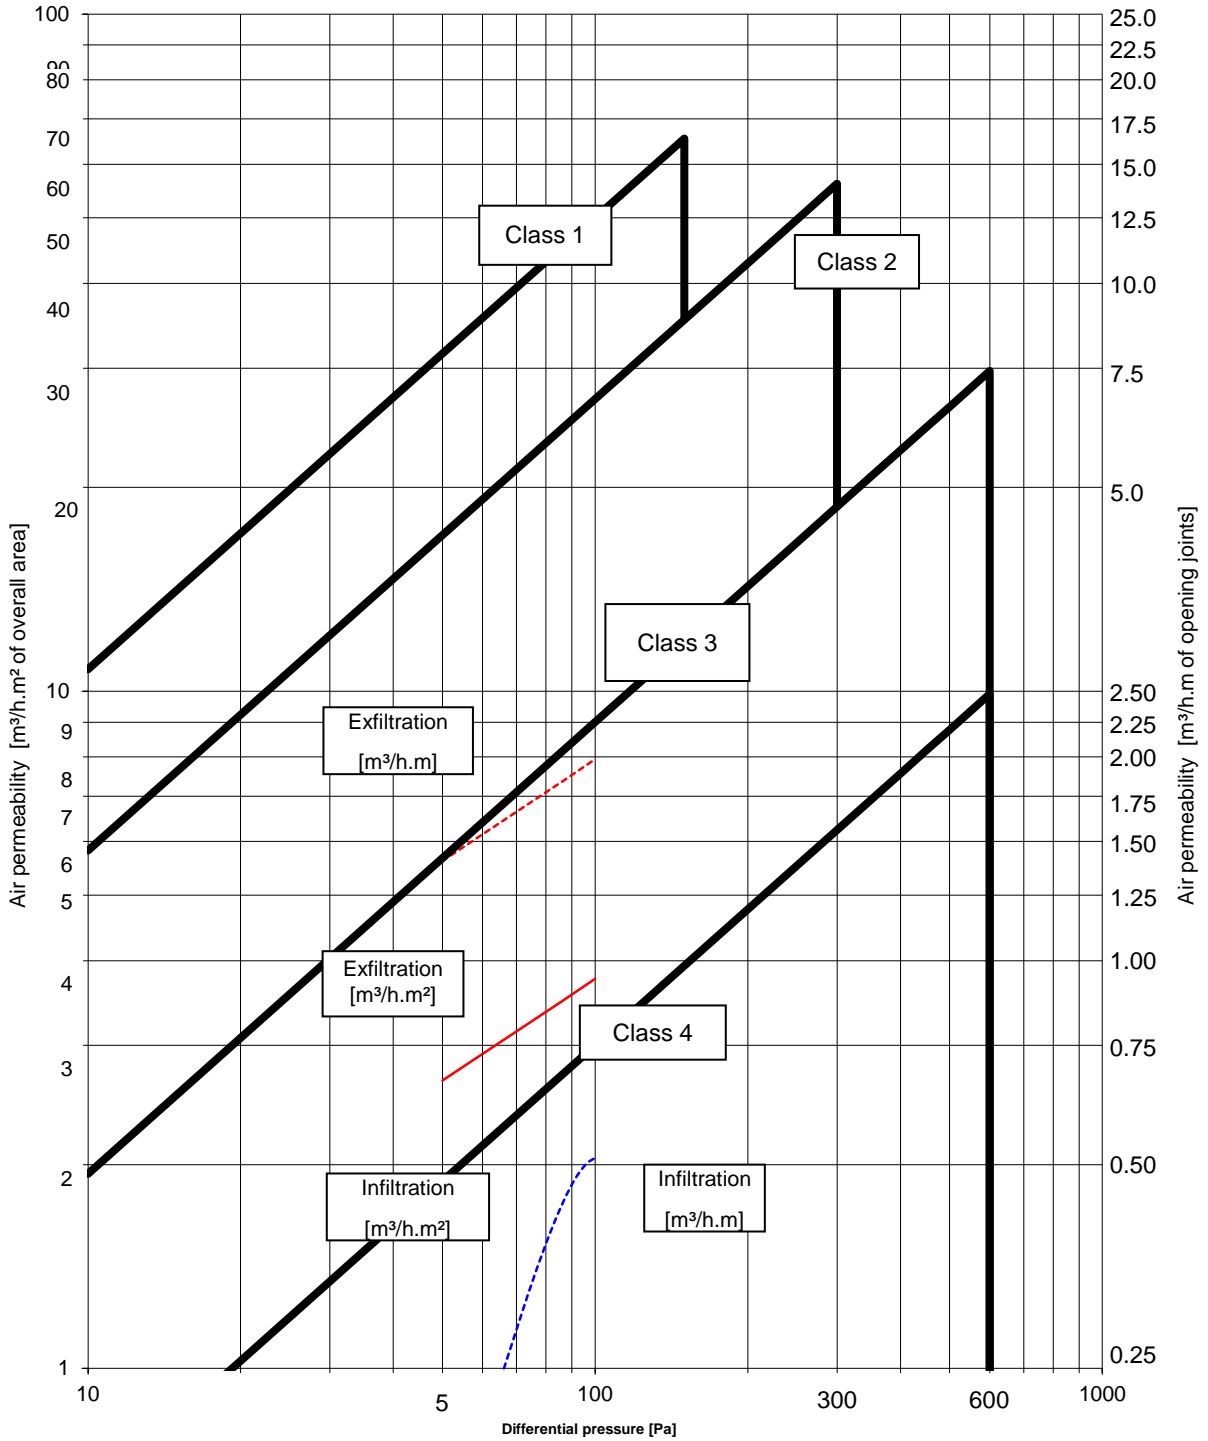
GRAPH OF AIR PERMEABILITY AFTER GUSTING

Air Pressure [Pa]	Average rate of air leakage [m <sup>3</sup> /h]	Average rate of air leakage per meter length of opening joint [m <sup>3</sup> /h.m]	Average rate of air leakage relative to area of sample [m <sup>3</sup> /h.m <sup>2</sup> ]
50	12.6	0.77	1.46
100	20.4	1.25	2.36
150	21.5	1.31	2.49
200	-	-	-
250	-	-	-
300	-	-	-
450	-	-	-
600	-	-	-

In accordance with BS 6375-1:2009 Clause 6.5, although the classification after the resistance to wind load tests is greater than the classification before the resistance to wind load tests, the resulting classification for the sample is Class 3.
