Test Report No: TR 251-14  
Date: 9<sup>th</sup> September 2014

Test of:  
Smart Systems Ltd single pivot hinged  
door set with 2 x Adams Rite Sentinel 6  
locks and low aluminium threshold

Tested to: PAS 24:2012

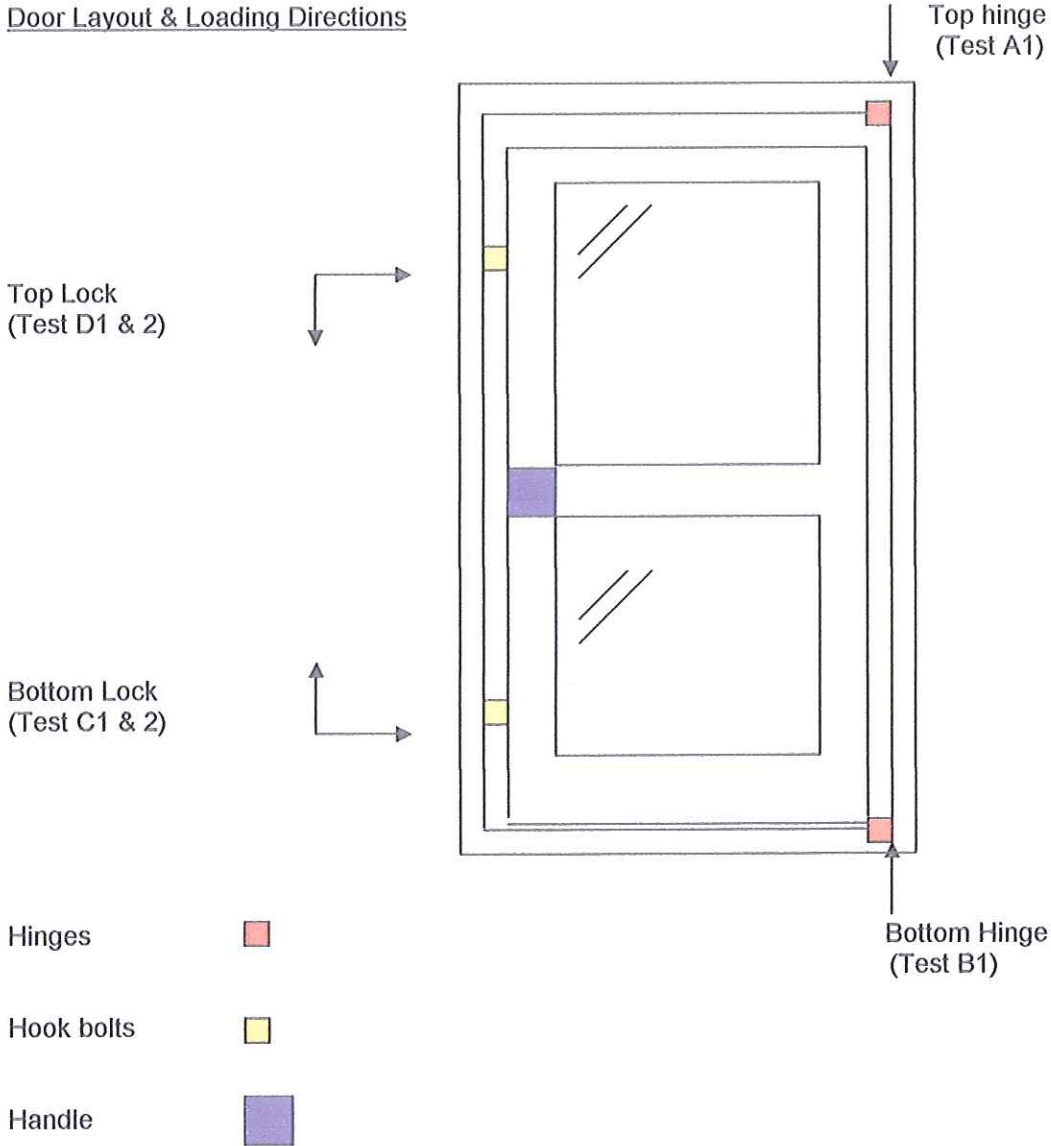
Door Layout & Loading Directions

Load Positions	Requirement	Actual	Assessment
Parallel to plane at right angles to the edge	1.5kN (153Kg)	153Kg	----
Perpendicular to plane	4.5kN	4.517kN	Pass

Load Positions	Requirement	Actual	Assessment
Parallel to plane at right angles to the edge	1.5kN (153Kg)	153Kg	----
Perpendicular to plane	4.5kN	4.508kN	Pass

Load Positions	Requirement	Actual	Assessment
Parallel to plane along the edge	1.5kN (153Kg)	153Kg	----
Perpendicular to plane	4.5kN	4.509kN	Pass

Load Positions	Requirement	Actual	Assessment
Parallel to plane at right angles to the edge	1.5kN (153Kg)	153Kg	----
Perpendicular to plane	4.5kN	4.510kN	Pass

Load Positions	Requirement	Actual	Assessment
Parallel to plane along the edge	1.5kN (153Kg)	153Kg	----
Perpendicular to plane	4.5kN	4.514kN	Pass

Load Positions	Requirement	Actual	Assessment
Parallel to plane at right angles to the edge	1.5kN (153Kg)	153Kg	----
Perpendicular to plane	4.5kN	4.512kN	Pass

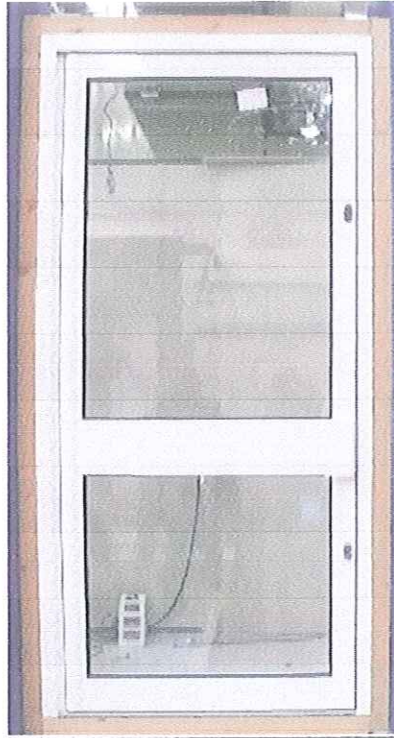
Samples received in a good condition

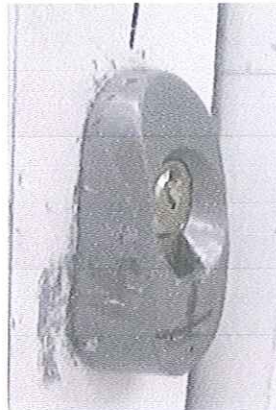
An attempt was made to create a gap behind the escutcheon so the torque bar could be used but this was unsuccessful – 3 minutes

Total test time 3 minutes. Cylinder remained secure. Pass

Sample following clause A.3.2 part 1

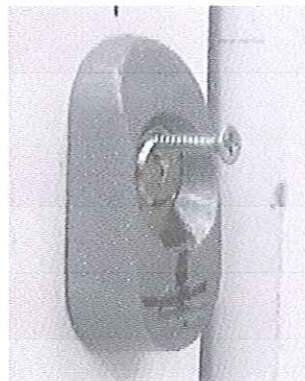
A 3.9mm self cutting screw was inserted into the keyway – 1 minute 27seconds

The screw was then levered with the torque wrench until the screw lost traction and pulled clear of the cylinder – 1 minute 33 seconds

Total test time 1 minute 22 seconds. The door remained secure

Sample during clause A.3.3 Part 2
