**Test Report 8421003.**  
Smart Systems Limited  
incorporating Smart Extrusions

Type test for product certification

Smart Systems Eco Futural Aluminium alloy windows

PAS24 Type window testing

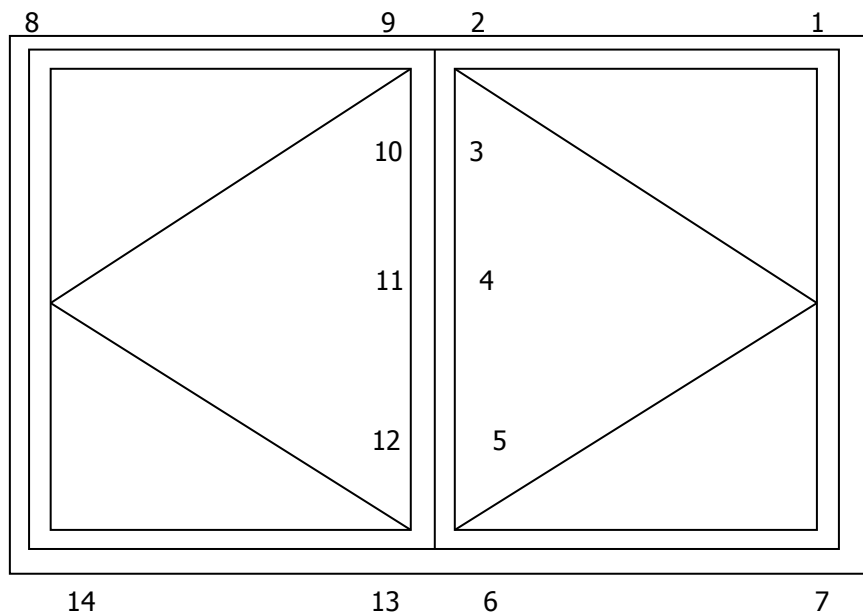
Diagram of points of application of loads

The test was carried out in accordance with the procedures detailed in Clause 4.5.2 using the test apparatus detailed in Clause 3.

1 - Hinge protector/Hinge (right head)

### 2 - Corner (mullion head)

### 3 - Mushroom bolt/Mushroom bolt (upper mullion)

### 4 - Mushroom bolt/Mushroom bolt (centre mullion)

### 5 - Mushroom bolt/Mushroom bolt (lower mullion)

#### 6 - Corner (mullion sill)

#### 7 - Hinge protector/Hinge (right sill)

#### 8 - Hinge protector/Hinge (left head)

#### 9 - Corner (mullion head)

#### 10 - Mushroom bolt/Mushroom bolt (upper mullion)

#### 11 - Mushroom bolt/Mushroom bolt (centre mullion)

#### 12 - Mushroom bolt/Mushroom bolt (lower mullion)

13 - Corner (mullion sill)

14 - Hinge protector/Hinge (left sill)

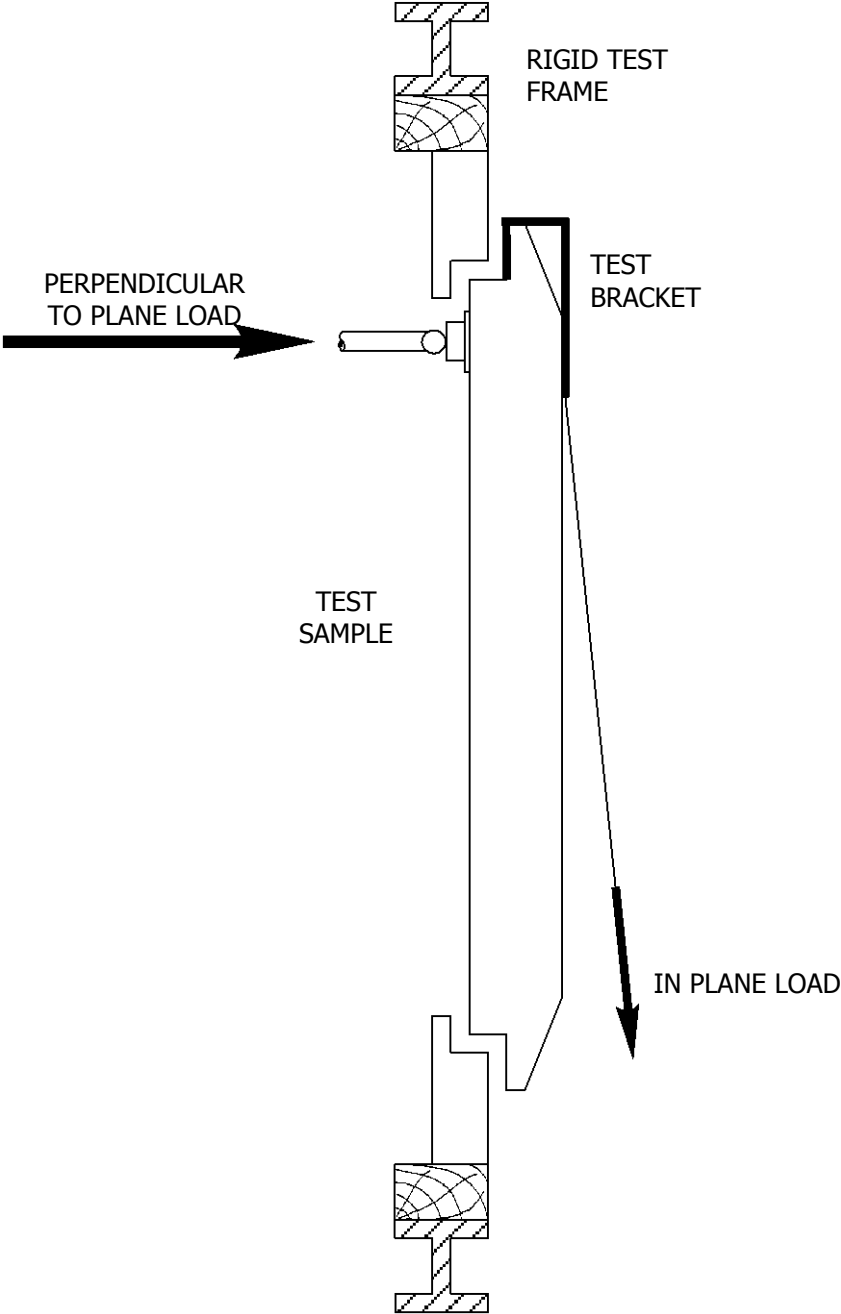
**FIGURE 2**

The test apparatus used for the manual and mechanical tests is shown in figure 2 of this Report. This apparatus meets the requirements of the Specification.

The test sample was submitted for test mounted in a 50 x 100mm timber subframe in accordance with the manufacturer's installation requirements.

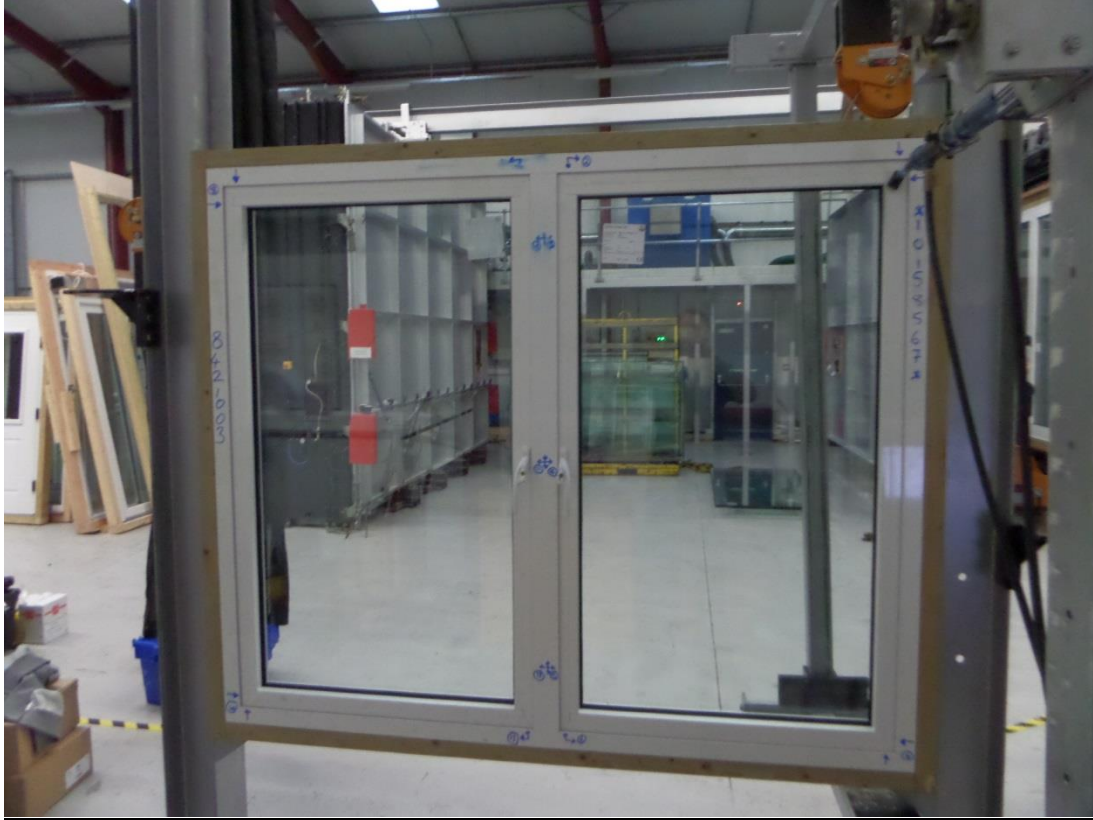
## Photograph of Sample.

<b>Sample type -</b>	Projecting side hung next to projecting side hung
<b>Material -</b>	Aluminium alloy
<b>Construction -</b>	Cleated
<b>Fittings (each sash) -</b>	Hinge: 16" Securistyle side hung stays Locking: A six point locking (six mushroom bolts) ERA espagnolette system operated by a (W KB) key locking handle 5 of run up blocks 2 of pairs of Vector hinge protectors
<b>Glass -</b>	Double glazed, 6-18-6mm toughened glass sealed units
<b>Glazing system -</b>	Internal beads and gaskets
<b>Sample dimensions -</b>	For information only (nominal sizes)  Overall size Length: 1730mm      Height: 1440mm  Sash size Length: 840mm      Height: 1410mm

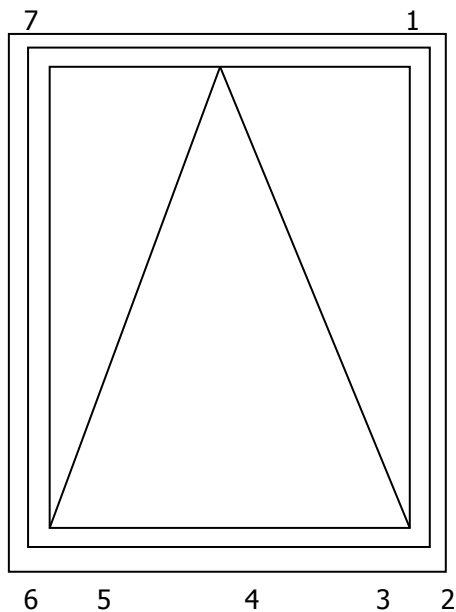
Diagram of points of application of loads

The test was carried out in accordance with the procedures detailed in Clause 4.5.2 using the test apparatus detailed in Clause 3.

1 - Hinge protector/Hinge (right head)

### 2 - Corner (right sill)

### 3 - Mushroom bolt/Mushroom bolt (right sill)

### 4 - Mushroom bolt/Mushroom bolt (centre sill)

### 5 - Mushroom bolt/Mushroom bolt (left sill)

6 - Corner (left sill)

7 - Hinge protector/Hinge (left head)

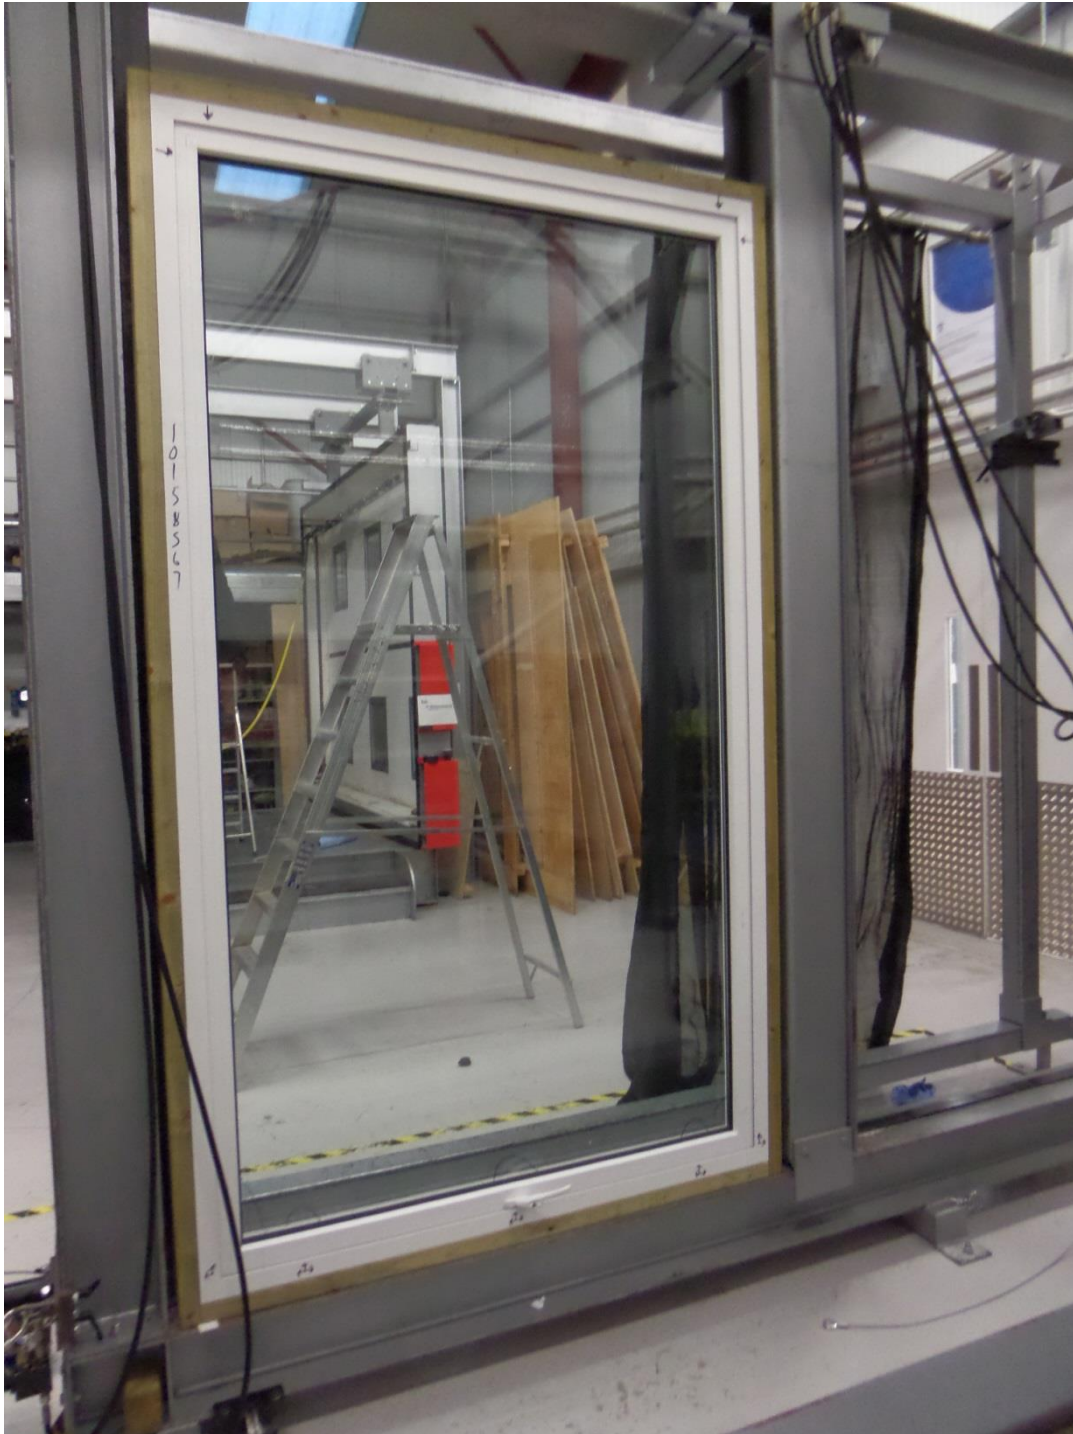
Photograph of Sample.

<b>Sample type -</b>	Projecting top hung window
<b>Material -</b>	Aluminium alloy
<b>Construction -</b>	Cleated
<b>Fittings -</b>	Hinge: 21" Securistyle top hung stays Locking: A six point locking (six mushroom bolts) ERA espagnolette system operated by a (W KB) key locking handle 6 of run up blocks 2 of pairs of Vector hinge protectors
<b>Glass -</b>	Double glazed, 6-18-6mm toughened glass sealed unit
<b>Glazing system -</b>	Internal beads and gaskets
<b>Sample dimensions -</b>	For information only (nominal sizes)  Overall size Length: 1480mm      Height: 2530mm  Sash size Length: 1440mm      Height: 1410mm

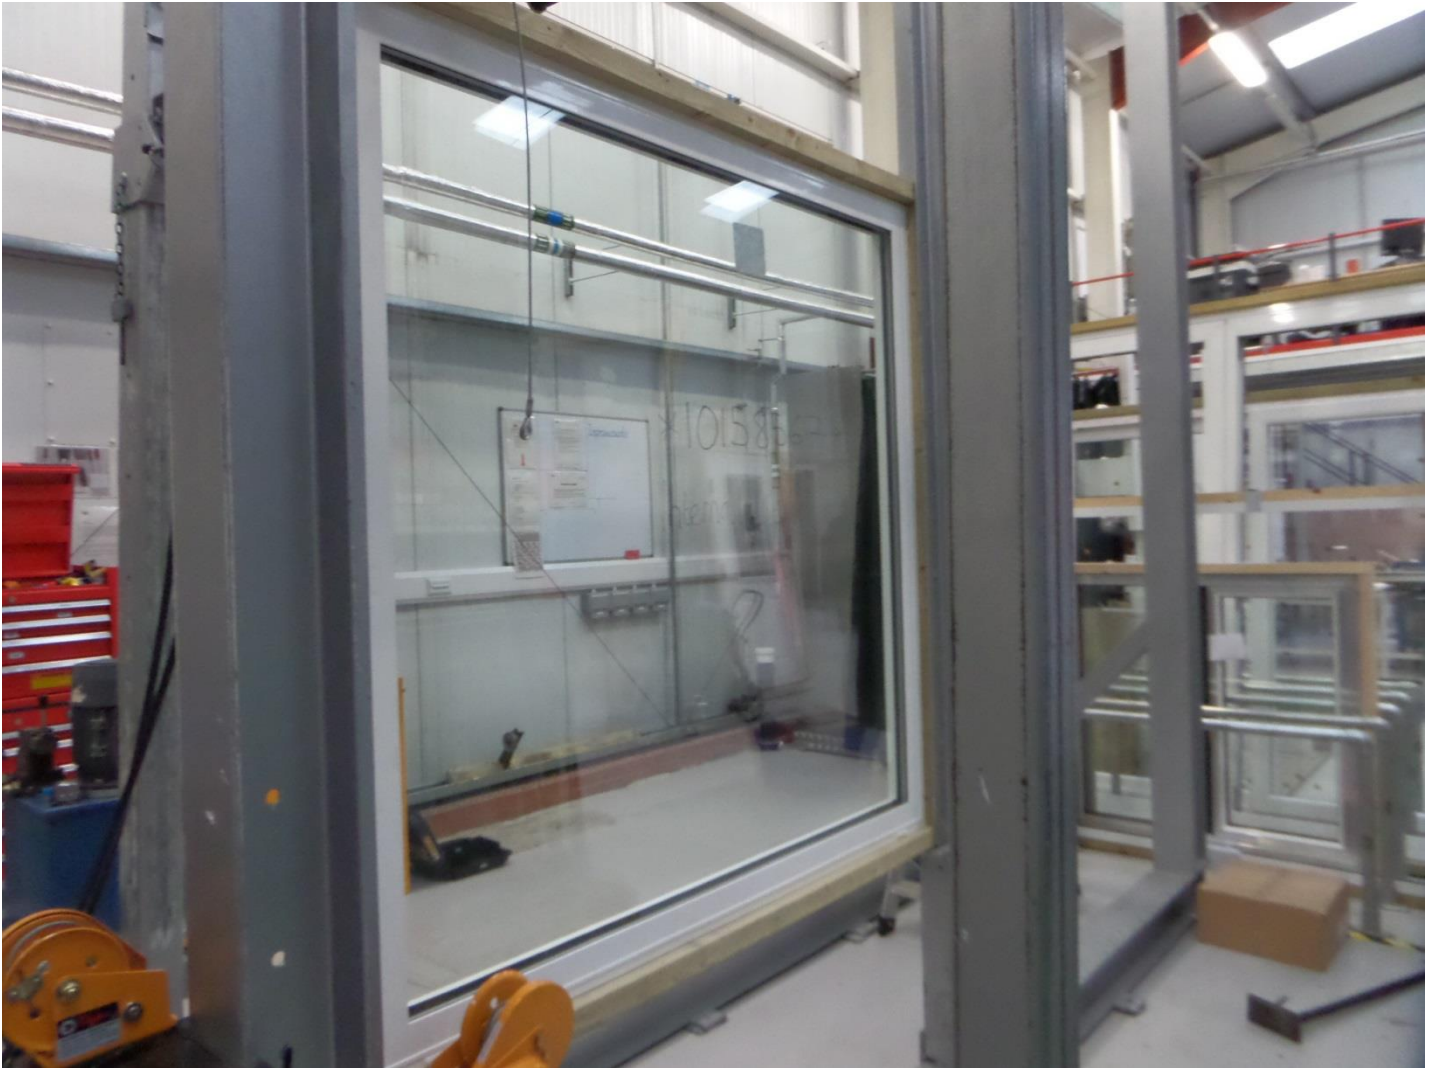
## Photograph of Sample.

<b>Sample type -</b>	Fixed
<b>Material -</b>	Aluminium alloy
<b>Construction -</b>	Cleated
<b>Glass -</b>	Double glazed, 6-18-6mm toughened glass sealed unit
<b>Glazing system -</b>	External beads, gaskets and GT security glazing clips
<b>Sample dimensions -</b>	For information only (nominal sizes) Overall size Length: 1500mm      Height: 1500mm

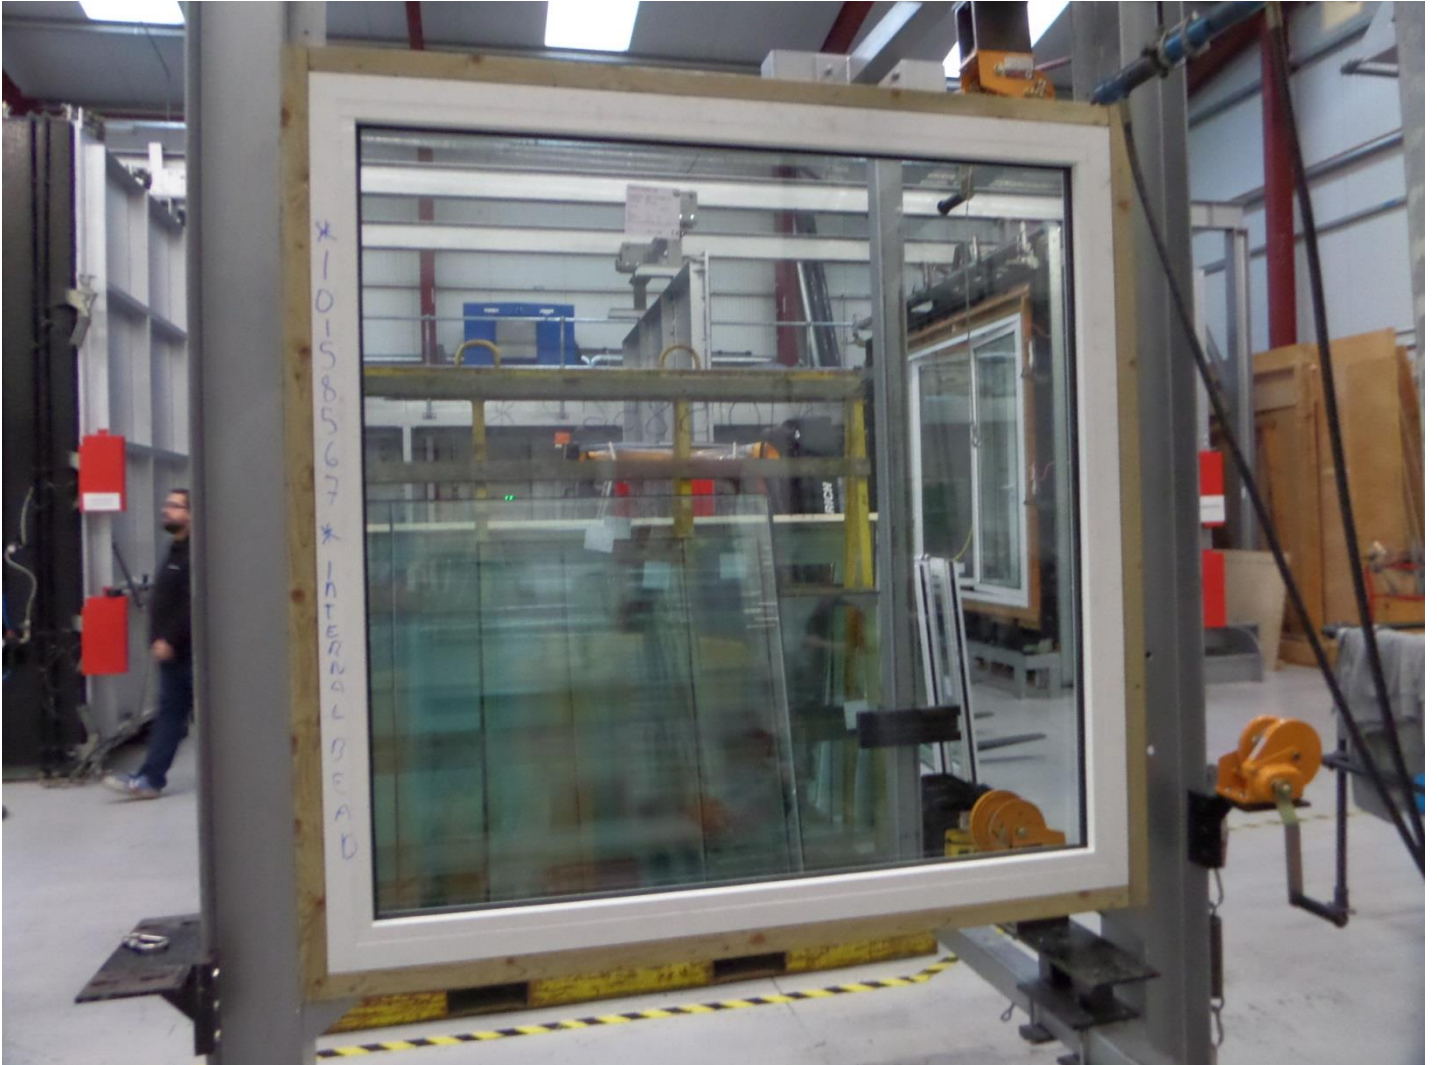
## Photograph of Sample.

<b>Sample type -</b>	Fixed
<b>Material -</b>	Aluminium alloy
<b>Construction -</b>	Cleated
<b>Glass -</b>	Double glazed, 6-18-6mm toughened glass sealed unit
<b>Glazing system -</b>	Internal beads and gaskets
<b>Sample dimensions -</b>	For information only (nominal sizes) Overall size Length: 1500mm      Height: 1500mm
