Weathertightness test to BS 6375: Part 1: 2009 on a Smart Systems Ltd Eco Futural tilt and turn and fixed light window

Smart Systems Ltd

11 July 2009

Test report number 254792

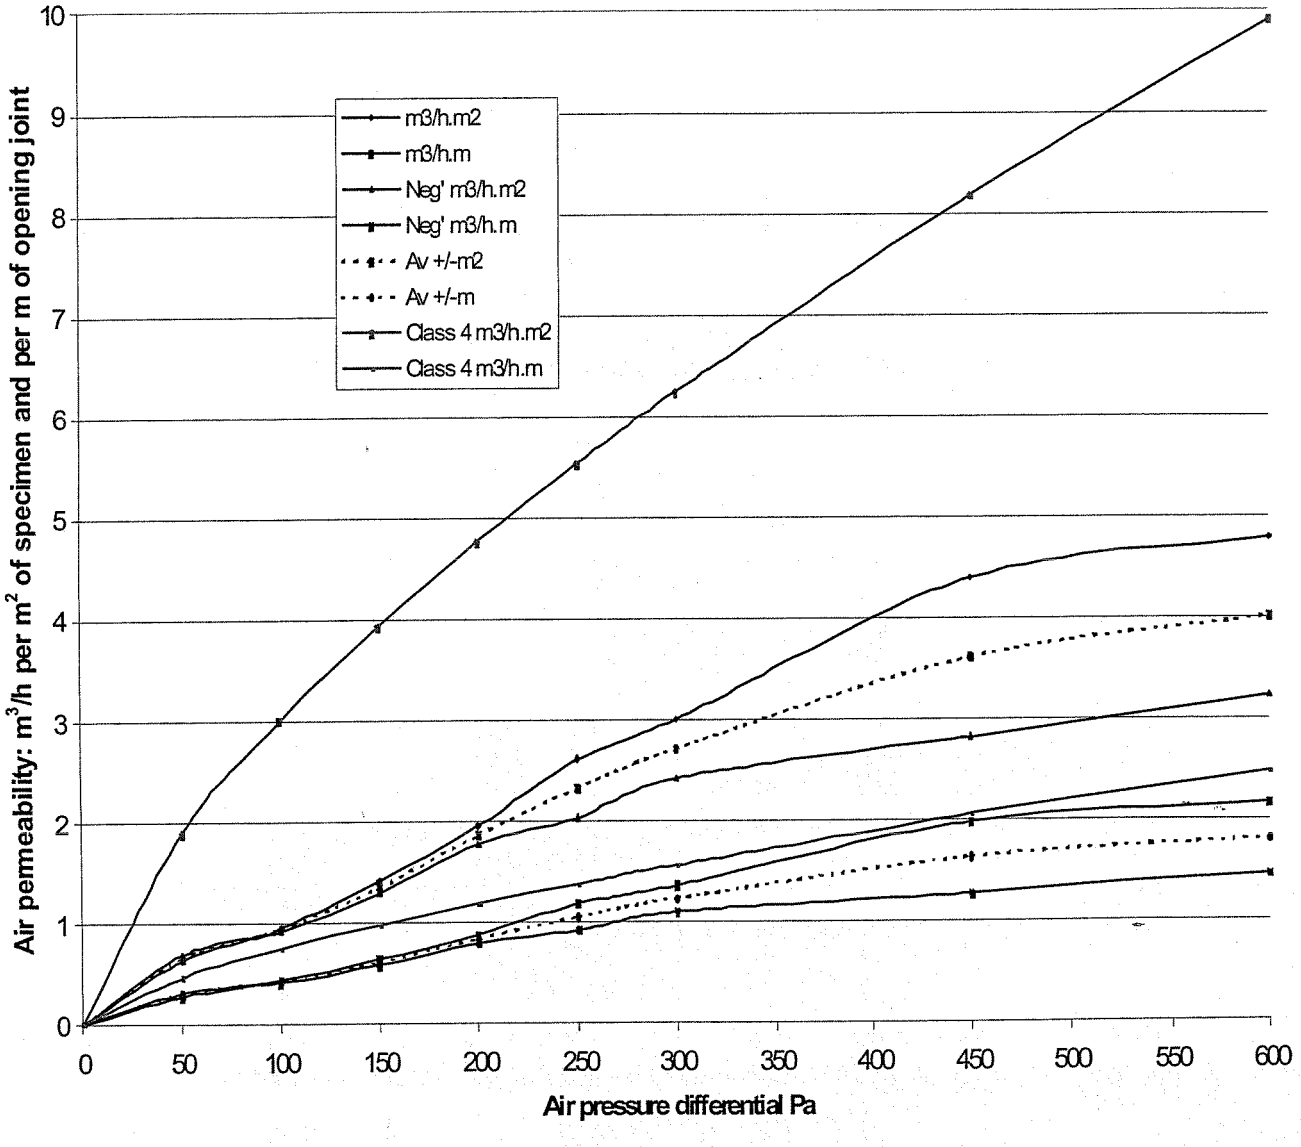
Figure A1. Air permeability under positive and negative air pressure; test results

- Sufficiently airtight to attain Class 4 when the averages of the readings under positive and negative test pressures were considered, thus **meeting** the BS 6375: Part 1: 2009 requirements.
- Resistant to water penetration using method 1A to Class E900 up to and at 900 Pa thus **meeting and exceeding** the BS 6375: Part 1: 2009 requirements.
- Resistant to wind loads of ±2400 Pa causing deflections less than 1/150 of the span of a window stile. Resistant to repeated pressure cycles of ±1200 Pa and able to sustain the corresponding safety test pressure of ±3600 Pa. The overall classification for resistance to wind load is Class AE2400 **meets** the requirements of BS 6375: Part 1: 2009.

Pressure differential Pa	Average air flow per unit area of the specimen $m^3/h.m^2$	Average air flow per metre of opening joint $m^3/h.m$
50	0.66	0.30
100	0.94	0.42
150	1.35	0.61
200	1.86	0.84
250	2.32	1.05
300	2.71	1.23
450	3.61	1.63
600	4.01	1.81

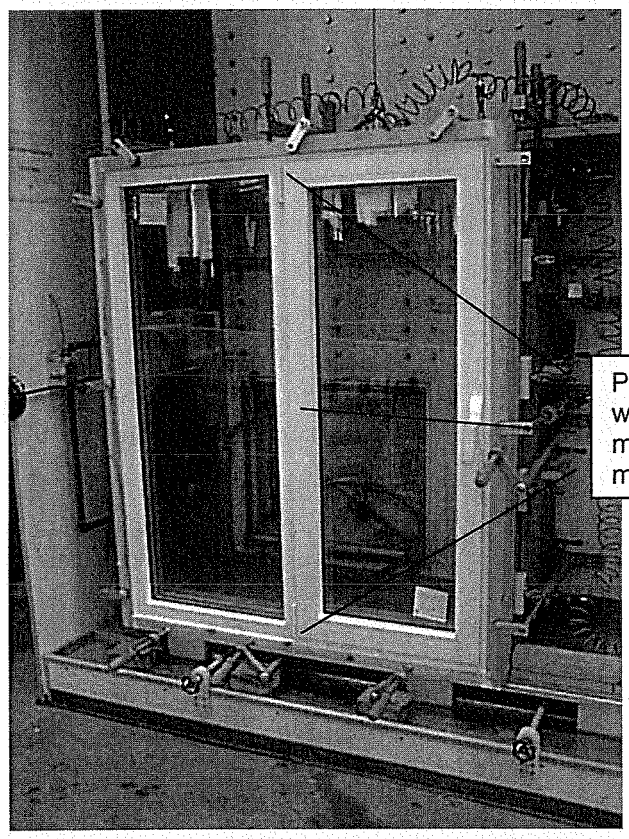
Figure 2. The Smart System Eco Futural window showing points where deflections were measured

Position deflection measured	Positive pressure P1 to +2400 Pa		Negative pressure P1 to - 2400 Pa	
	Deflection		Deflection	
	mm	defl./span	mm	defl./span
Mid height of left hand side stile on opening light	1.11	1/1293	1.38	1/1040

Table A5. Deflections measured on left hand stile on opening in the resistance to wind load test at ±2400Pa.
