Test Report 8420999.
Smart Systems Limited
Incorporating Smart Extrusions

Type Test for Product Certification

Smart Systems Eco Futural Aluminium Alloy Windows

BS4873:2009 Weather Type.

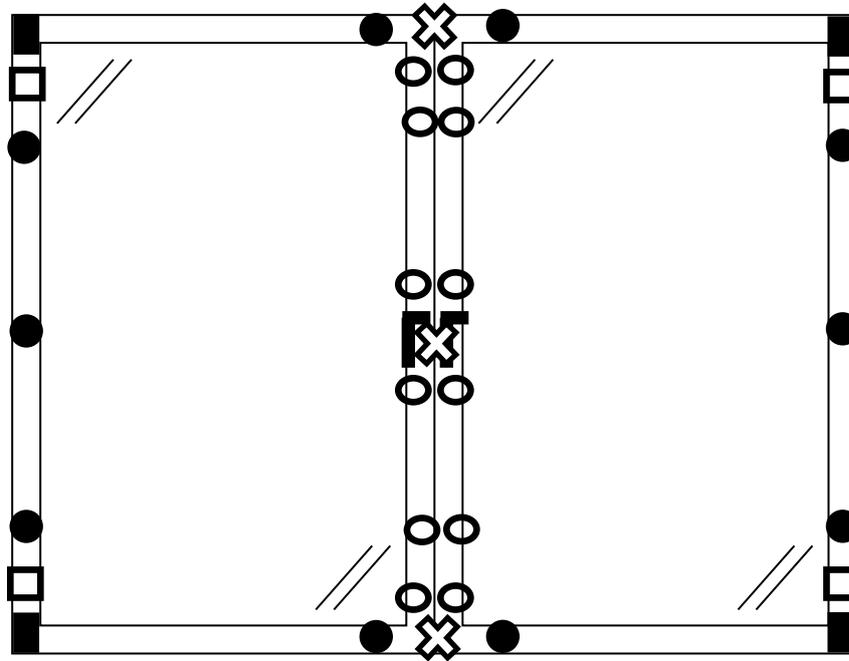
Elevation Drawing Showing Position of Hardware.

-

- Hinge
-

- Hinge Protector
-

- Mushroom Bolt
-

- Handle
-

- transducer
-

- Run Up Block

Manufacturer -	Smart Systems
Window type -	Projecting side hung next to projecting side hung
Material -	Aluminium
Finish -	White
Construction -	Outerframe: Cleated Sash: Cleated
Fittings (Each sash) -	Hinge: 16" Securistyle side hung stays Locking: A six point locking (six mushroom bolt) ERA locking system operated by a key locking handle 5 off run up blocks 2 of pairs of Vector hinge protectors
Glass -	Double glazed, 6-18-6mm toughened glass sealed units
Glazing system -	Internal beads and gaskets
Sample dimensions -	For information only (nominal sizes) Overall size Length: 1730mm Height: 1440mm Each sash size Length: 840mm Height: 1410mm
Date of test -	16 December 2015
Laboratory temperature -	18.6°C
Laboratory humidity -	48.4%
Atmospheric pressure:	100.1kPa

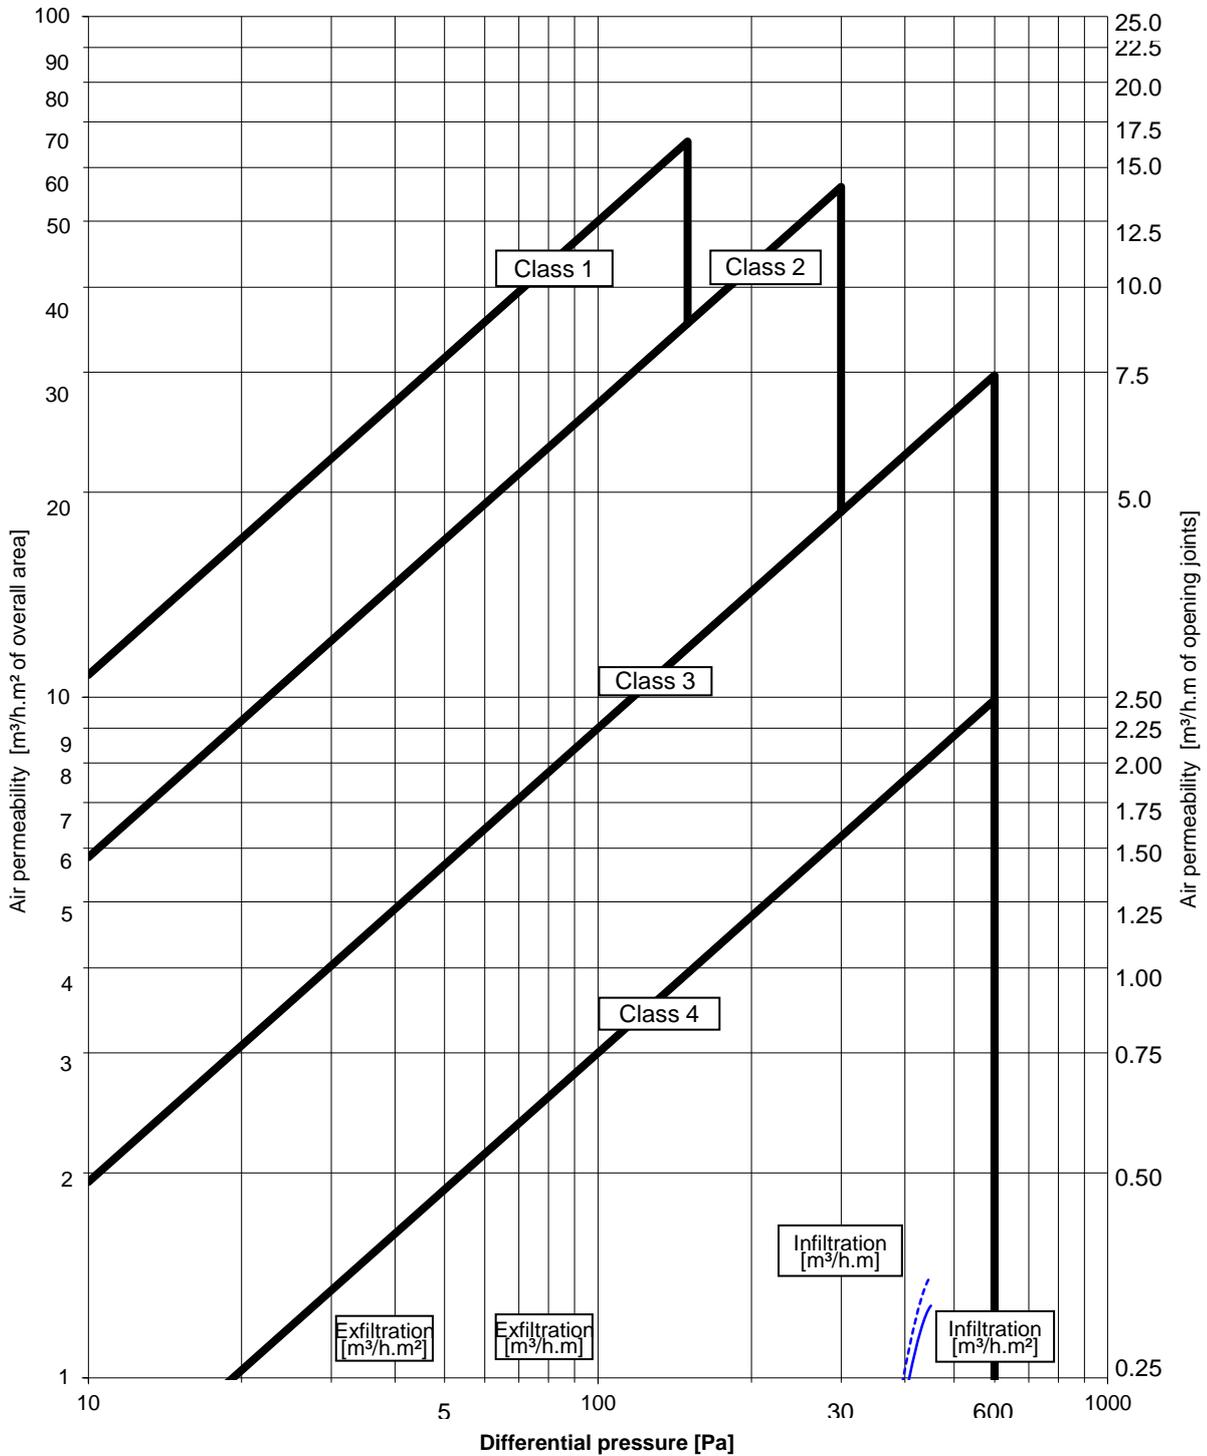
Graph of Air Permeability Before Gusting.

Air Pressure [Pa]	Average rate of air leakage [m ³ /h]	Average rate of air leakage per meter length of opening joint [m ³ /h.m]	Average rate of air leakage relative to area of sample [m ³ /h.m ²]
50	0.6	0.07	0.24
100	0.8	0.09	0.34
150	0.8	0.09	0.34
200	0.4	0.05	0.18
250	0.9	0.10	0.36
300	1.3	0.14	0.52
450	2.5	0.28	1.00
600	1.0	0.11	0.40

BS 6375-1:2015 Clause 6.2 - Joint class = 4

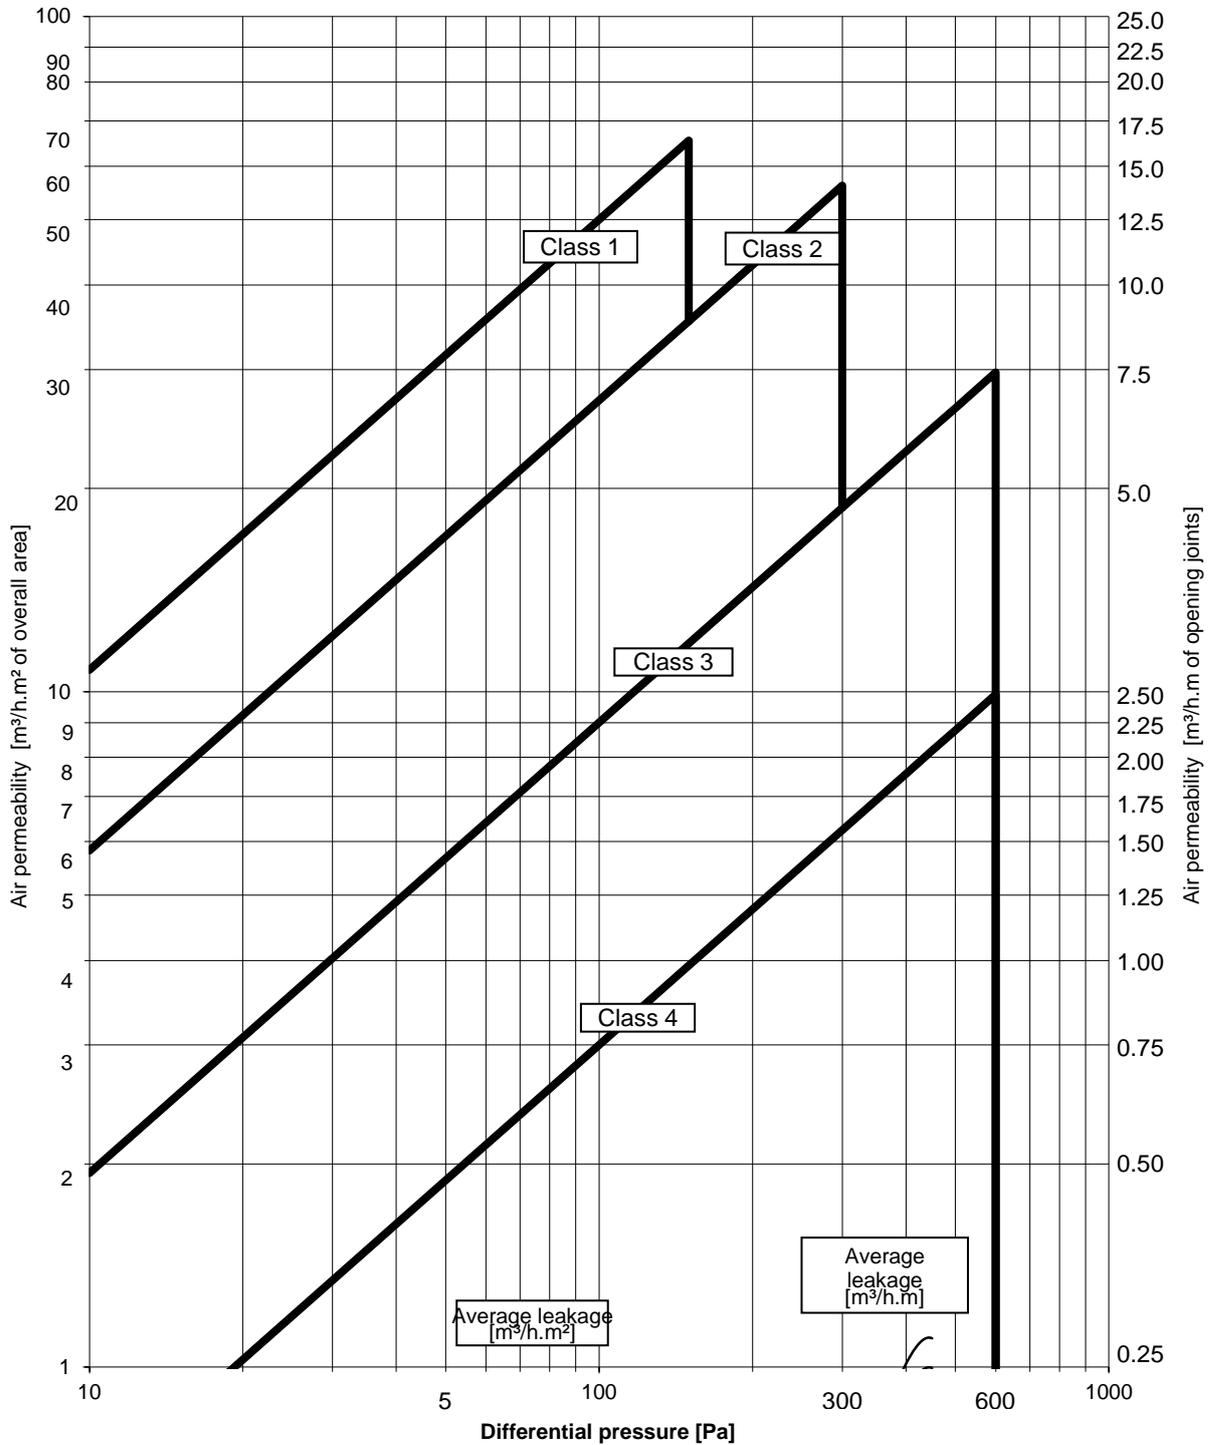
Graph of Average Air Permeability Before Gusting.

BS 6375-1:2015 Clause 6.2 - Overall class = 4

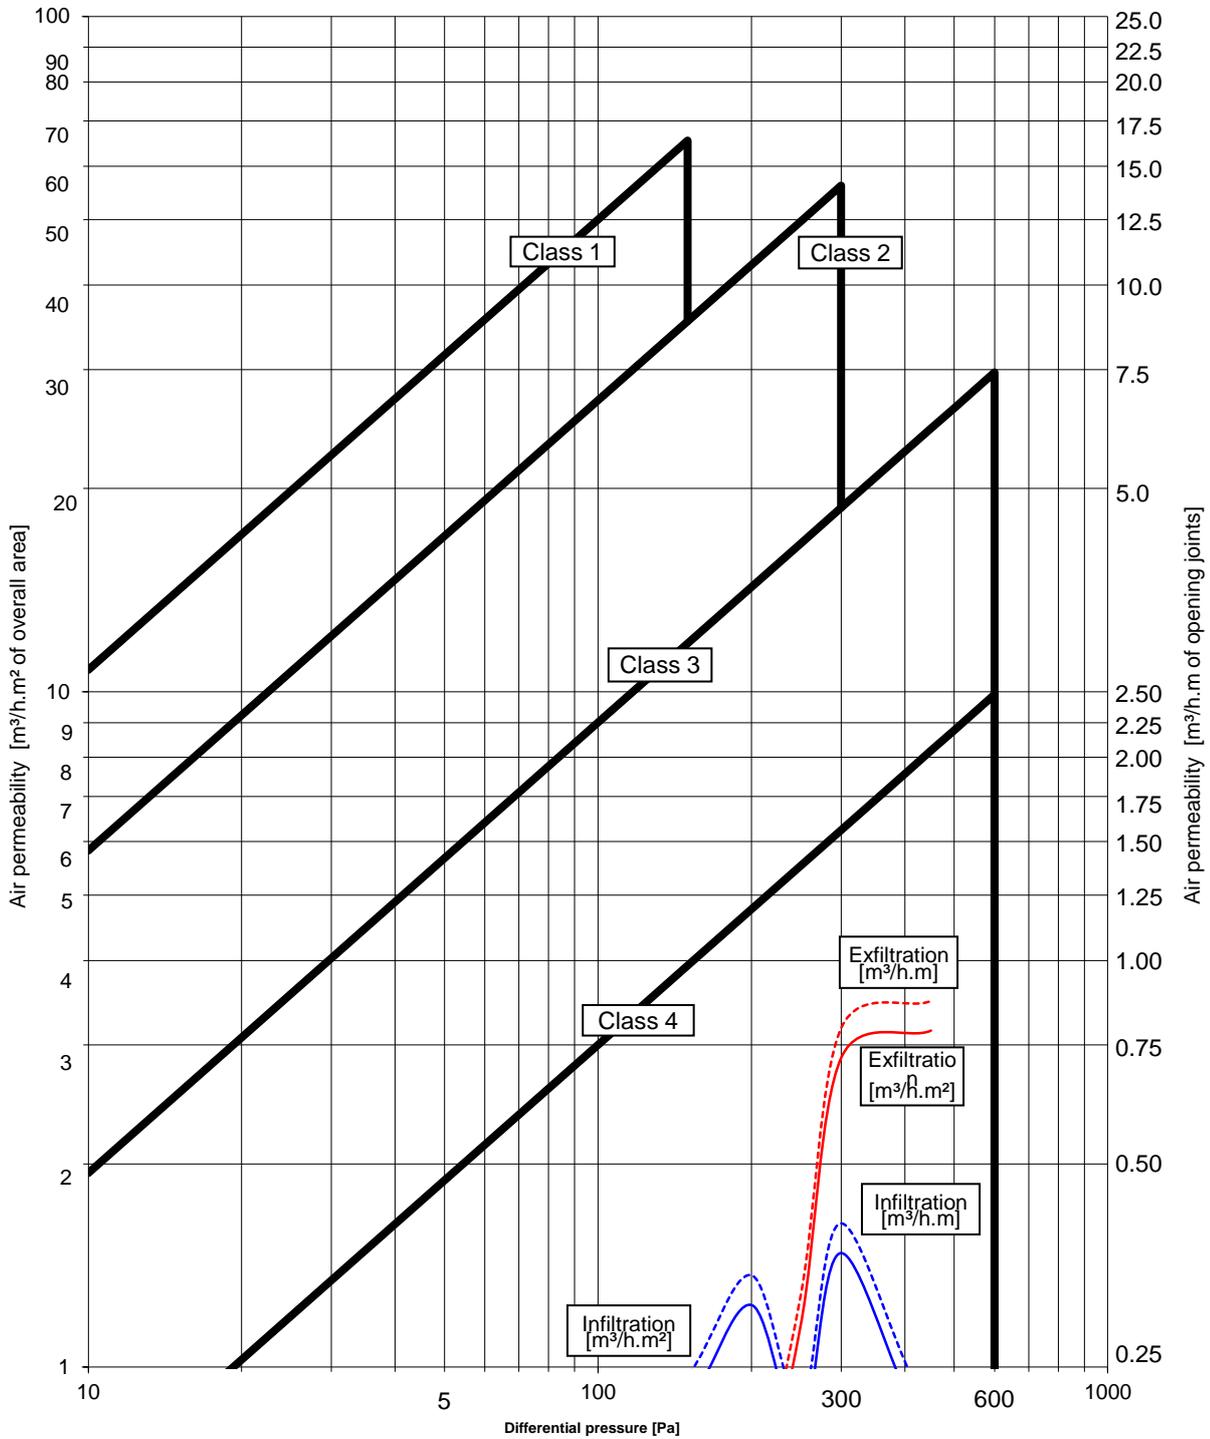
Graph of Air Permeability After Gusting.

Air Pressure [Pa]	Average rate of air leakage [m ³ /h]	Average rate of air leakage per meter length of opening joint [m ³ /h.m]	Average rate of air leakage relative to area of sample [m ³ /h.m ²]
50	1.1	0.13	0.46
100	0.9	0.10	0.38
150	1.5	0.17	0.60
200	2.2	0.25	0.90
250	2.4	0.27	0.98
300	5.4	0.60	2.17
450	4.9	0.55	1.97
600	6.1	0.67	2.43

BS 6375-1:2015 Clause 6.5 - Overall class = 4

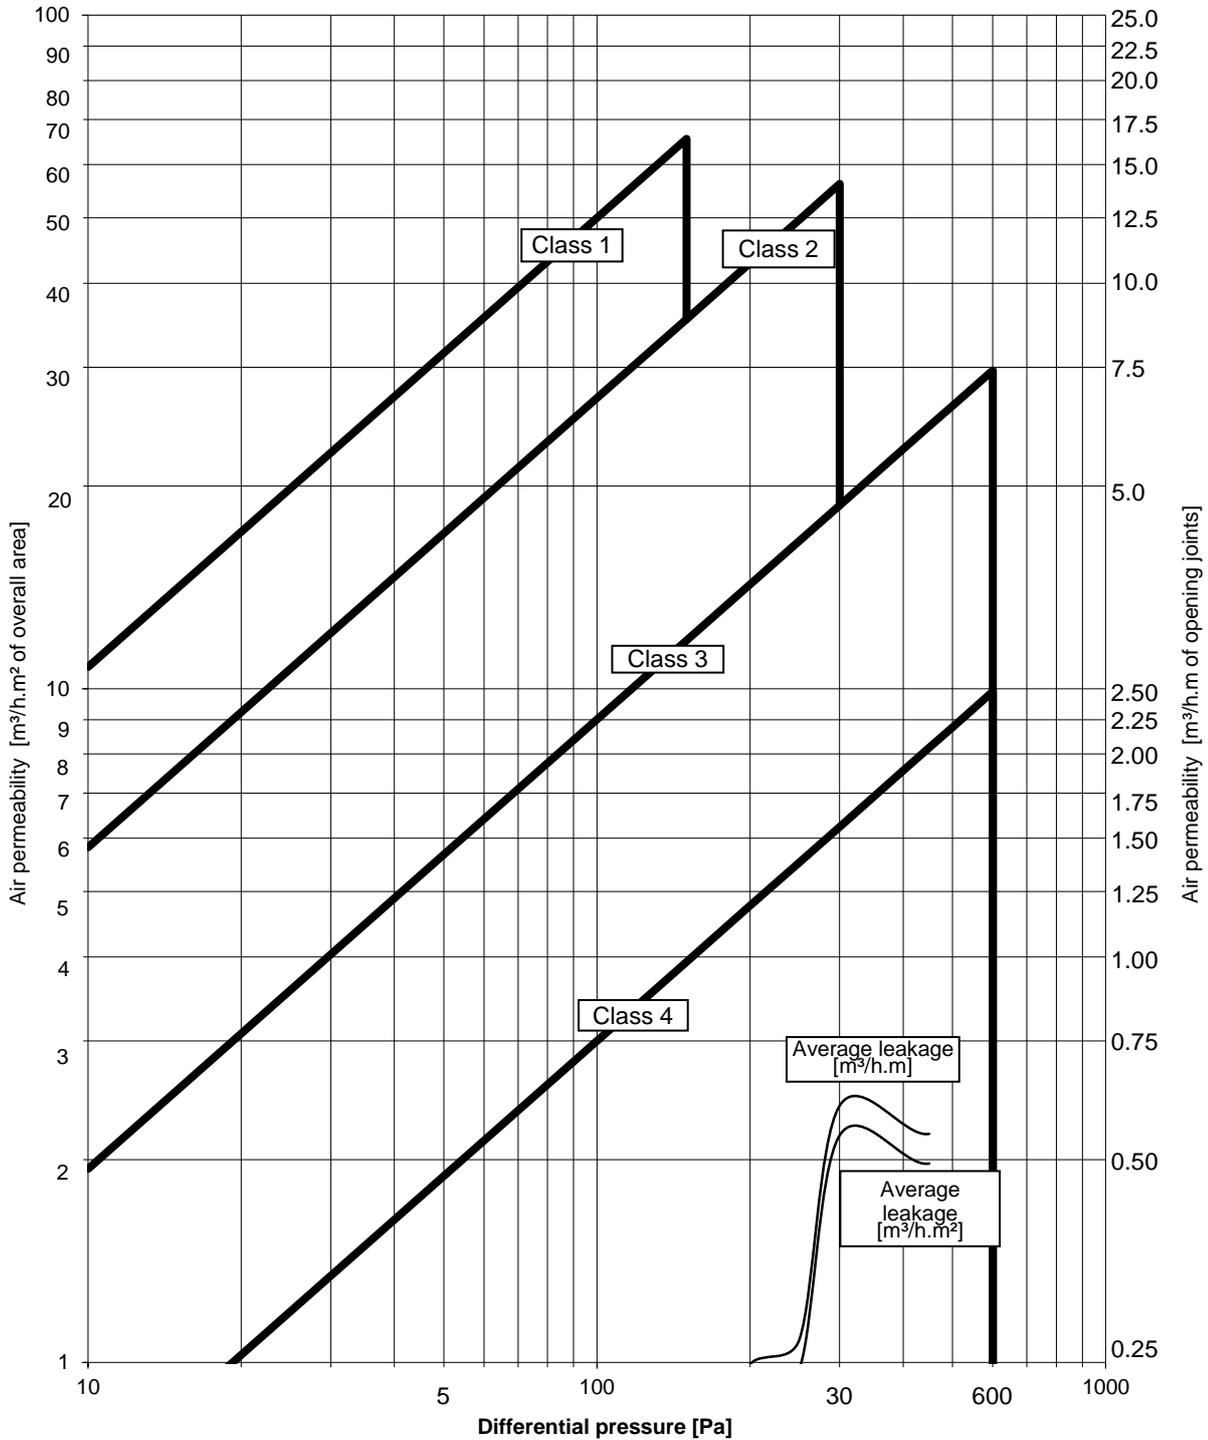
Average Graph of Air Permeability After Gusting.

In accordance with BS 6375-1:2015 Clause 6.5, as the classification after the resistance to wind load tests is the same as the classification before the resistance to wind load tests, the resulting classification for the sample is Class 4.

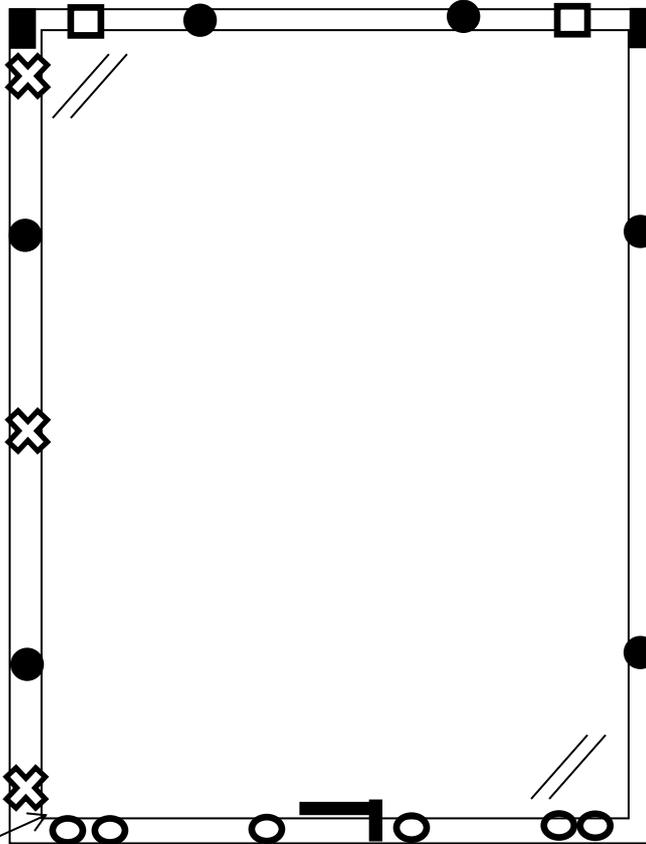
Elevation Drawing Showing Position of Hardware.

- Run Up Block

Manufacturer -	Smart Systems
Window type -	Projecting top hung
Material -	Aluminium
Finish -	White
Construction -	Outerframe: Cleated Sash: Cleated
Fittings -	Hinge: 22" Securistyle top hung stays Locking: A six point locking (six mushroom bolt) ERA locking system operated by a key locking handle 6 off run up blocks 2 of pairs of Vector hinge protectors
Glass -	Double glazed, 6-18-6mm toughened glass sealed unit
Glazing system -	Internal beads and gaskets
Sample dimensions -	For information only (nominal sizes) Overall size Length: 1480mm Height: 2530mm Sash size Length: 1440mm Height: 2500mm
Date of test -	18 December 2015
Laboratory temperature -	19.2°C
Laboratory humidity -	45.6%
Atmospheric pressure:	100.3kPa

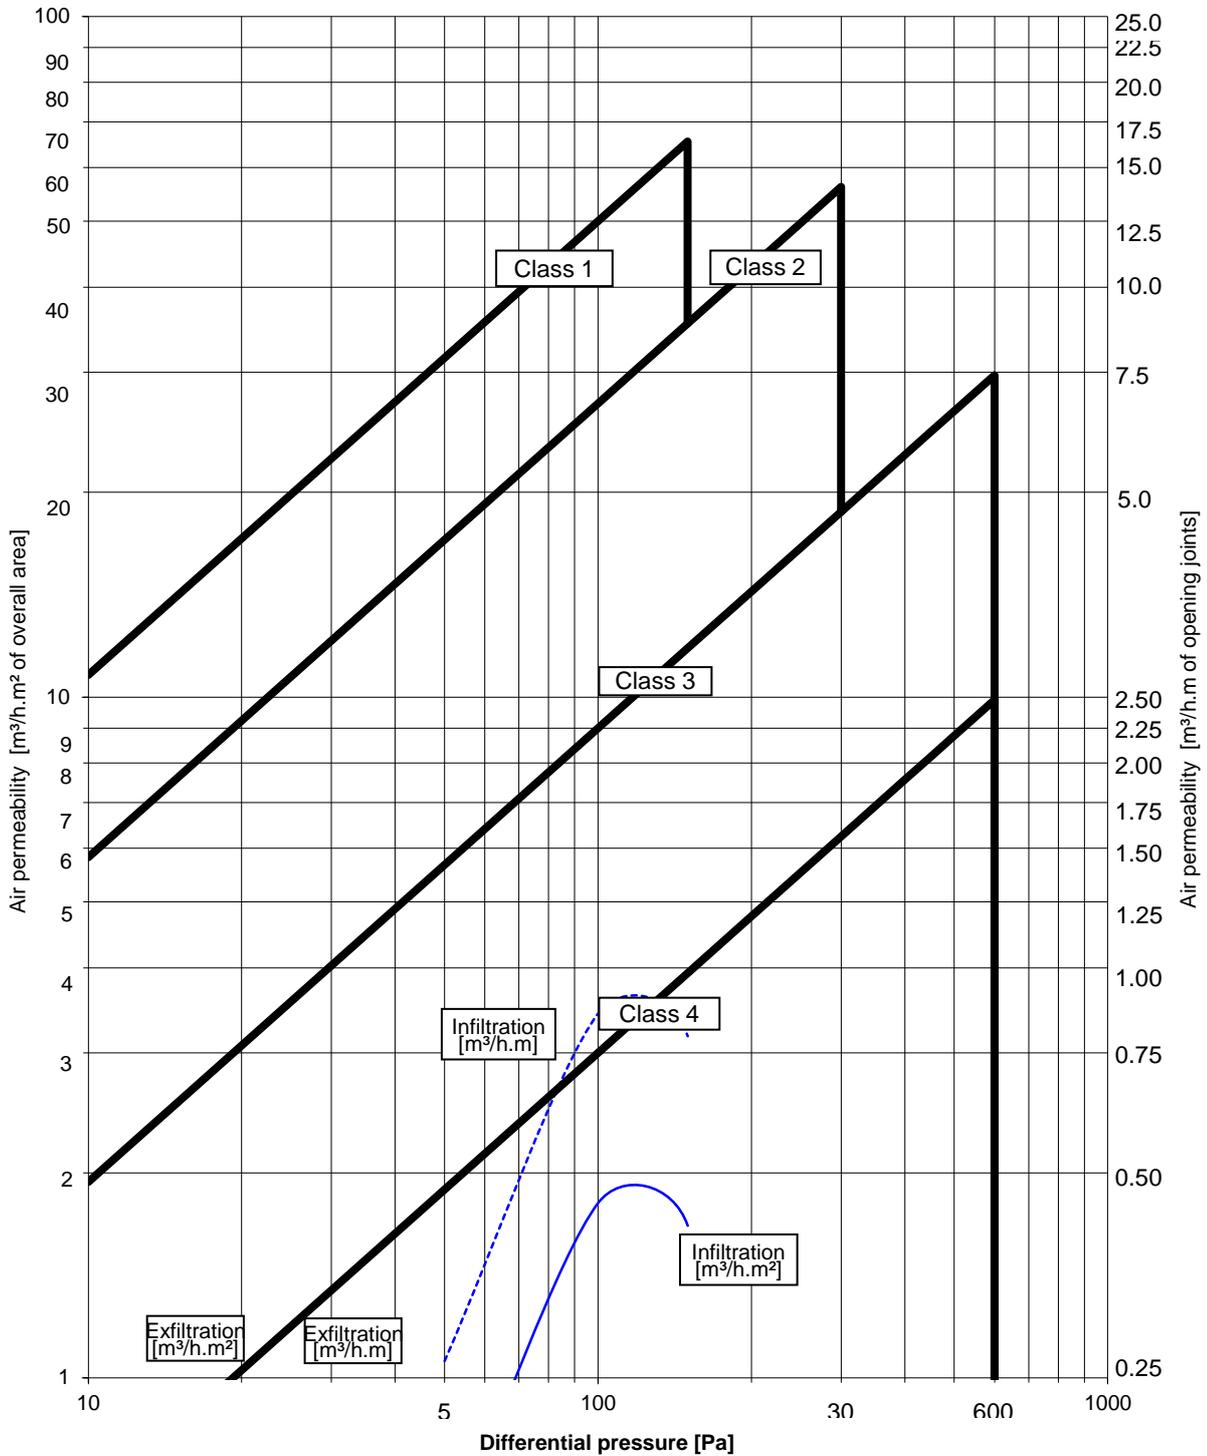
Graph of Air Permeability Before Gusting.

Air Pressure [Pa]	Average rate of air leakage [m ³ /h]	Average rate of air leakage per meter length of opening joint [m ³ /h.m]	Average rate of air leakage relative to area of sample [m ³ /h.m ²]
50	1.0	0.13	0.28
100	4.6	0.58	1.22
150	3.1	0.40	0.84
200	15.8	2.00	4.22
250	39.8	5.05	10.65
300	-	-	-
450	-	-	-
600	-	-	-

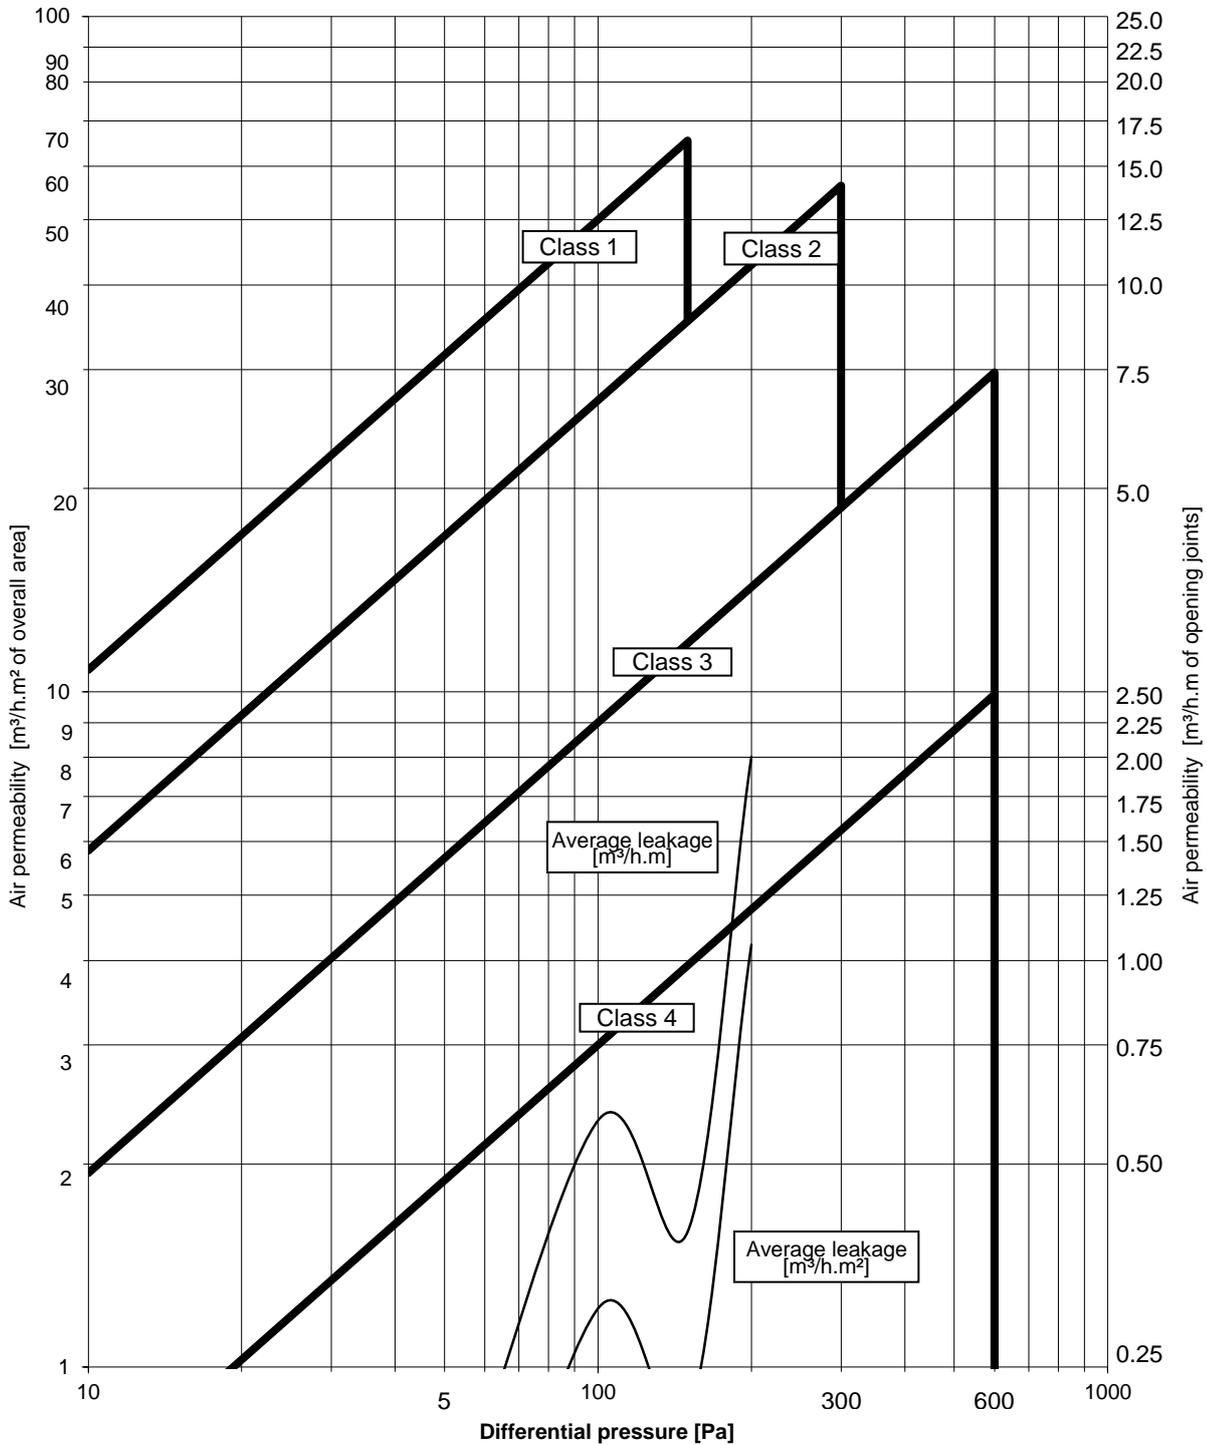
Graph of Average Air Permeability Before Gusting.

BS 6375-1:2015 Clause 6.2 - Overall class = 2

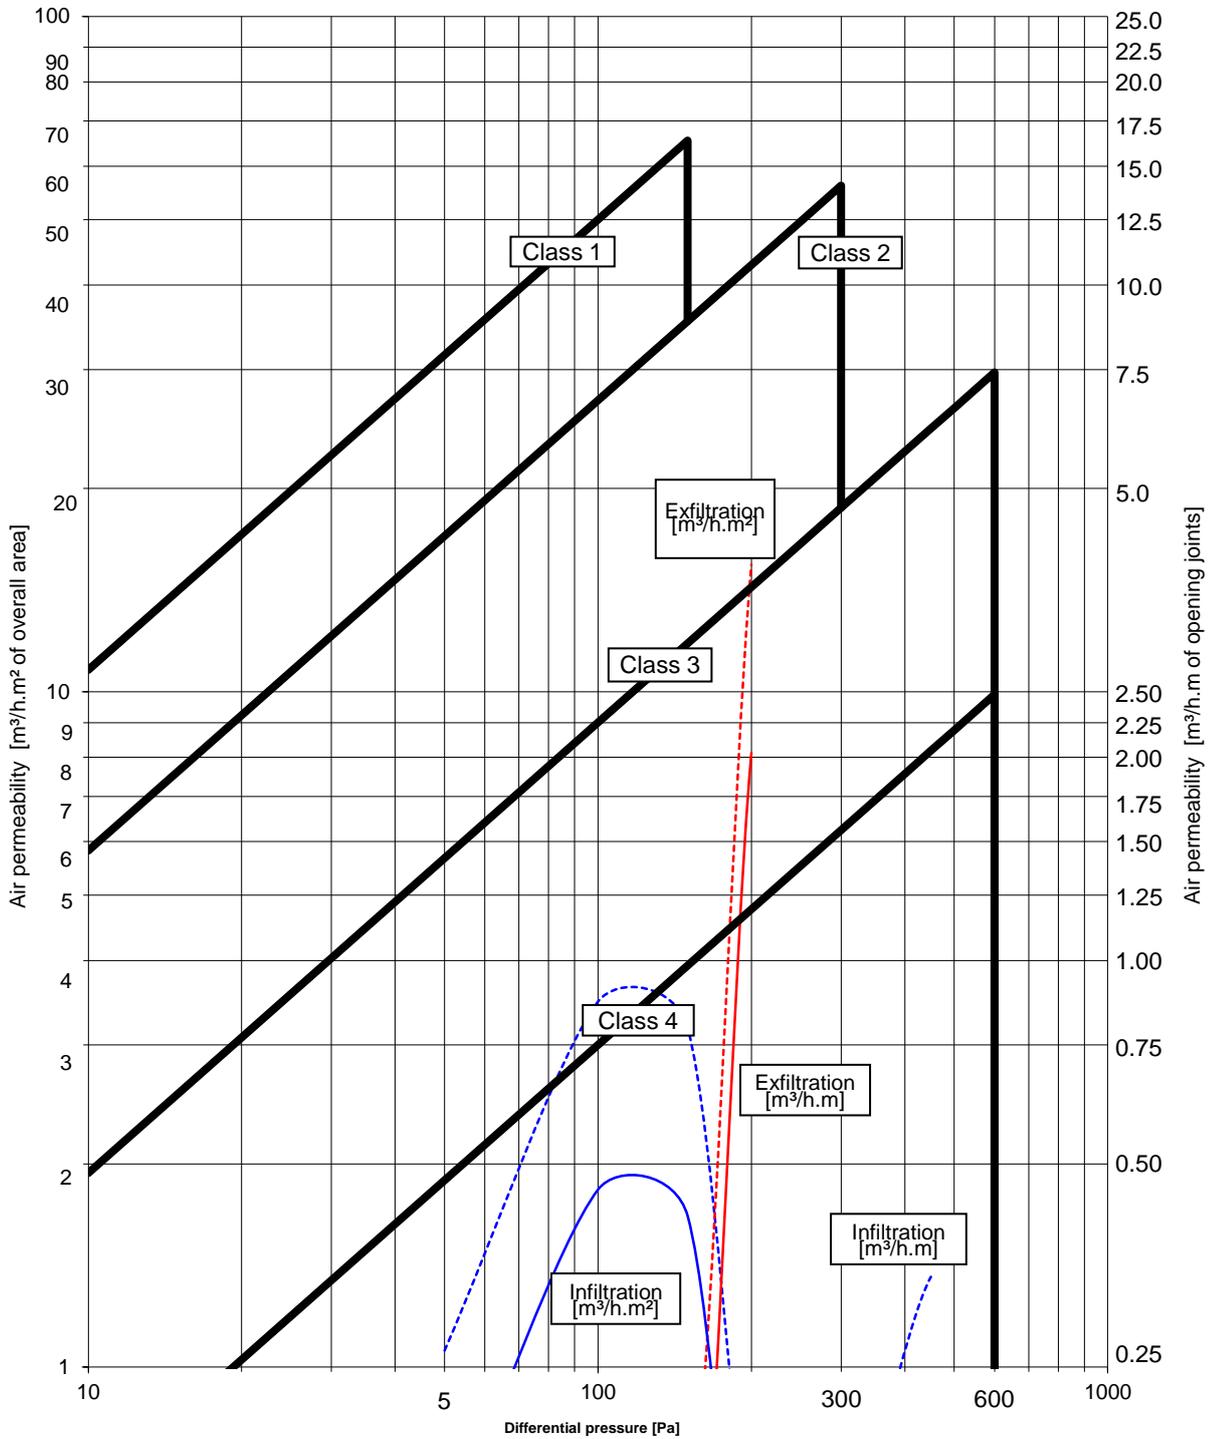
Graph of Air Permeability After Gusting.

Air Pressure [Pa]	Average rate of air leakage [m ³ /h]	Average rate of air leakage per meter length of opening joint [m ³ /h.m]	Average rate of air leakage relative to area of sample [m ³ /h.m ²]
50	1.3	0.17	0.36
100	4.4	0.55	1.17
150	3.7	0.47	0.98
200	15.7	1.99	4.19
250	38.8	4.92	10.37
300	-	-	-
450	-	-	-
600	-	-	-

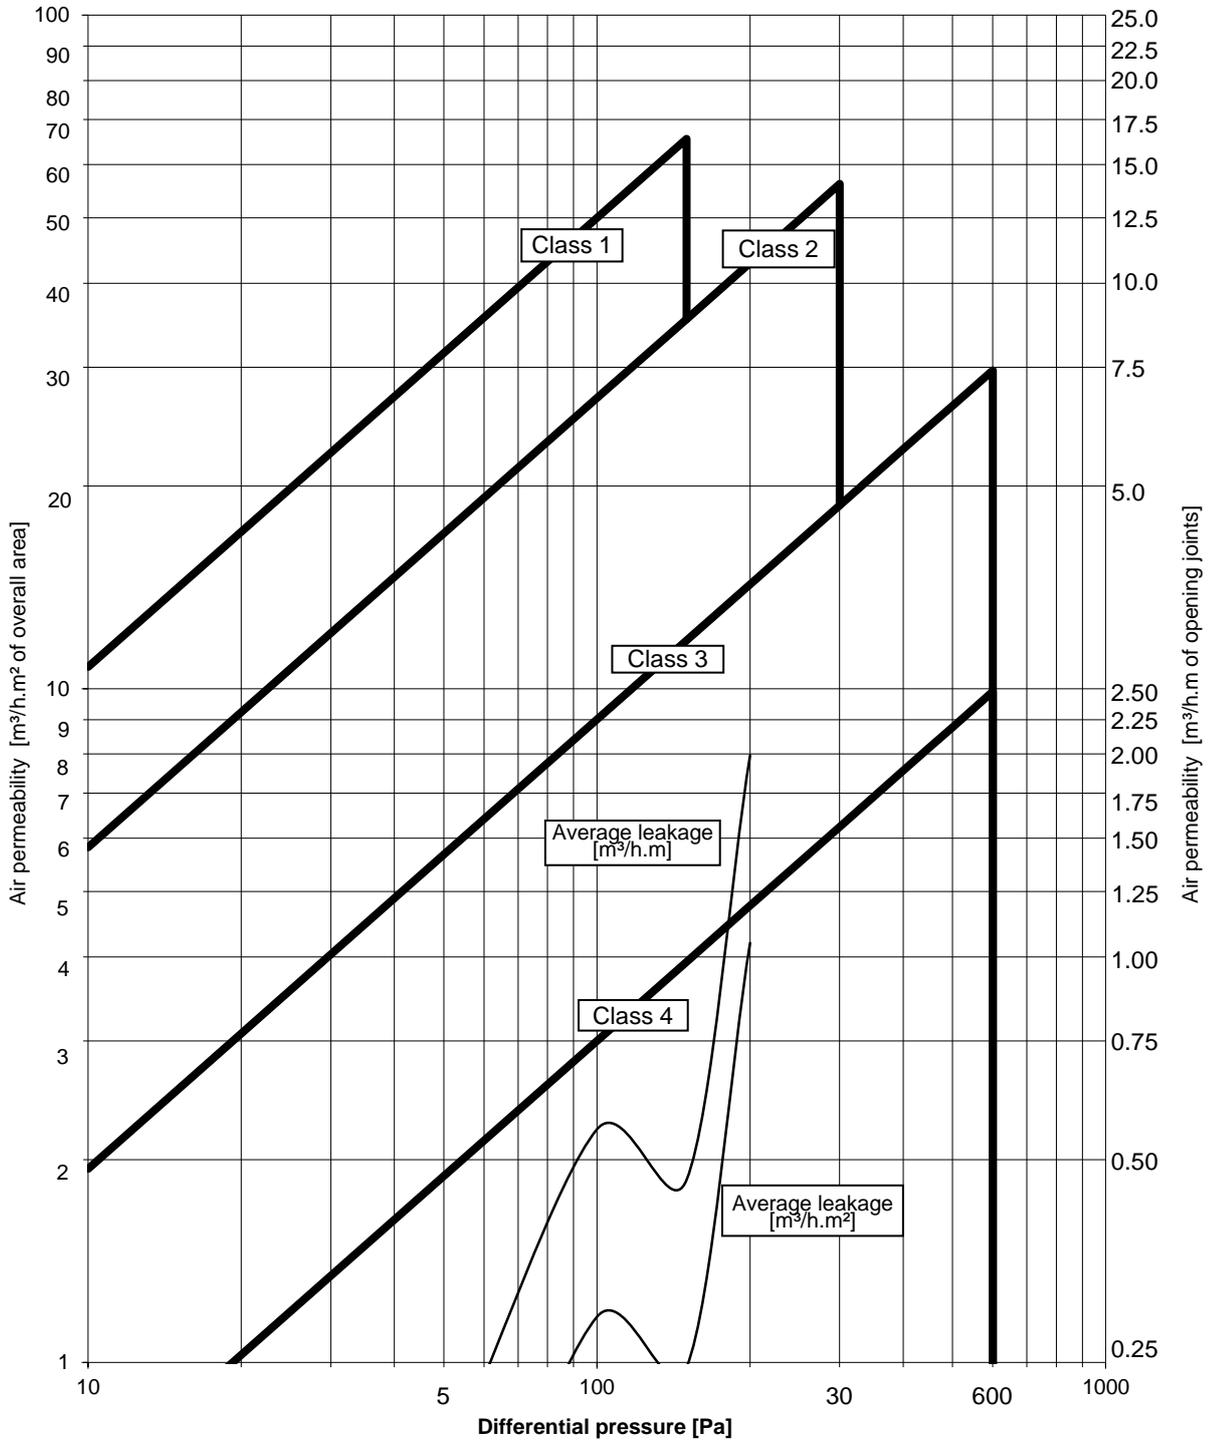
Graph of Average Air Permeability After Gusting.

In accordance with BS 6375-1:2015 Clause 6.5, as the classification after the resistance to wind load tests is the same as the classification before the resistance to wind load tests, the resulting classification for the sample is Class 2.

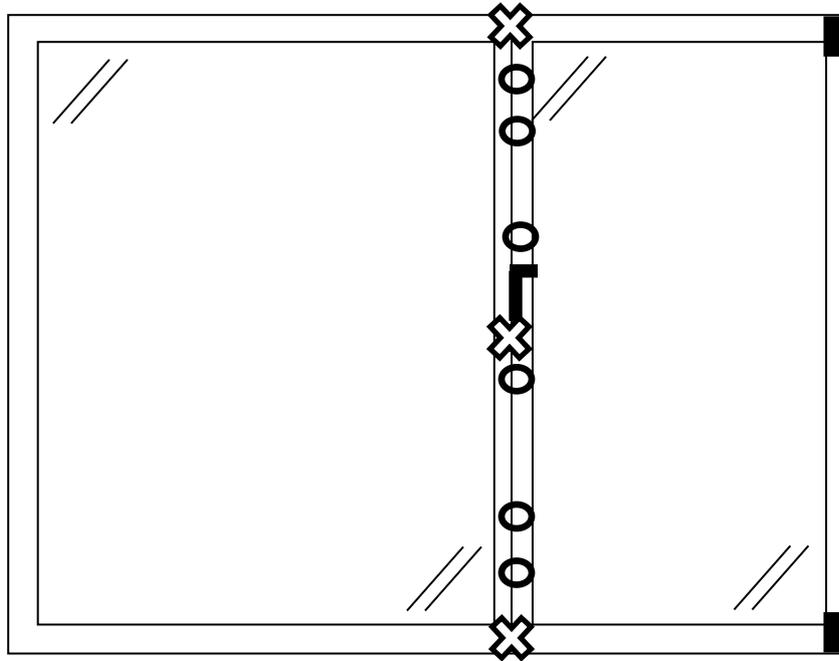
Elevation Drawing Showing Position of Hardware.

- transducer

Manufacturer -	Smart Systems	
Window type -	Projecting side hung next to fixed window	
Material -	Aluminium	
Finish -	White	
Construction -	Outerframe:	Cleated
	Sash:	Cleated
Fittings -	Hinge:	16" Securistyle side hung stays
	Locking:	A six point locking (six mushroom bolt) ERA locking system operated by a key locking handle
Glass -	Double glazed, 6-18-6mm toughened glass sealed unit	
Glazing system -	Internal beads and gaskets	
Sample dimensions -	For information only (nominal sizes)	
	Overall size	
	Length: 2400mm	Height: 1405mm
	Sash size	
	Length: 840mm	Height: 1345mm
Date of test -	19 December 2015	
Laboratory temperature -	18.6°C	
Laboratory humidity -	44.7%	
Atmospheric pressure:	99.9kPa

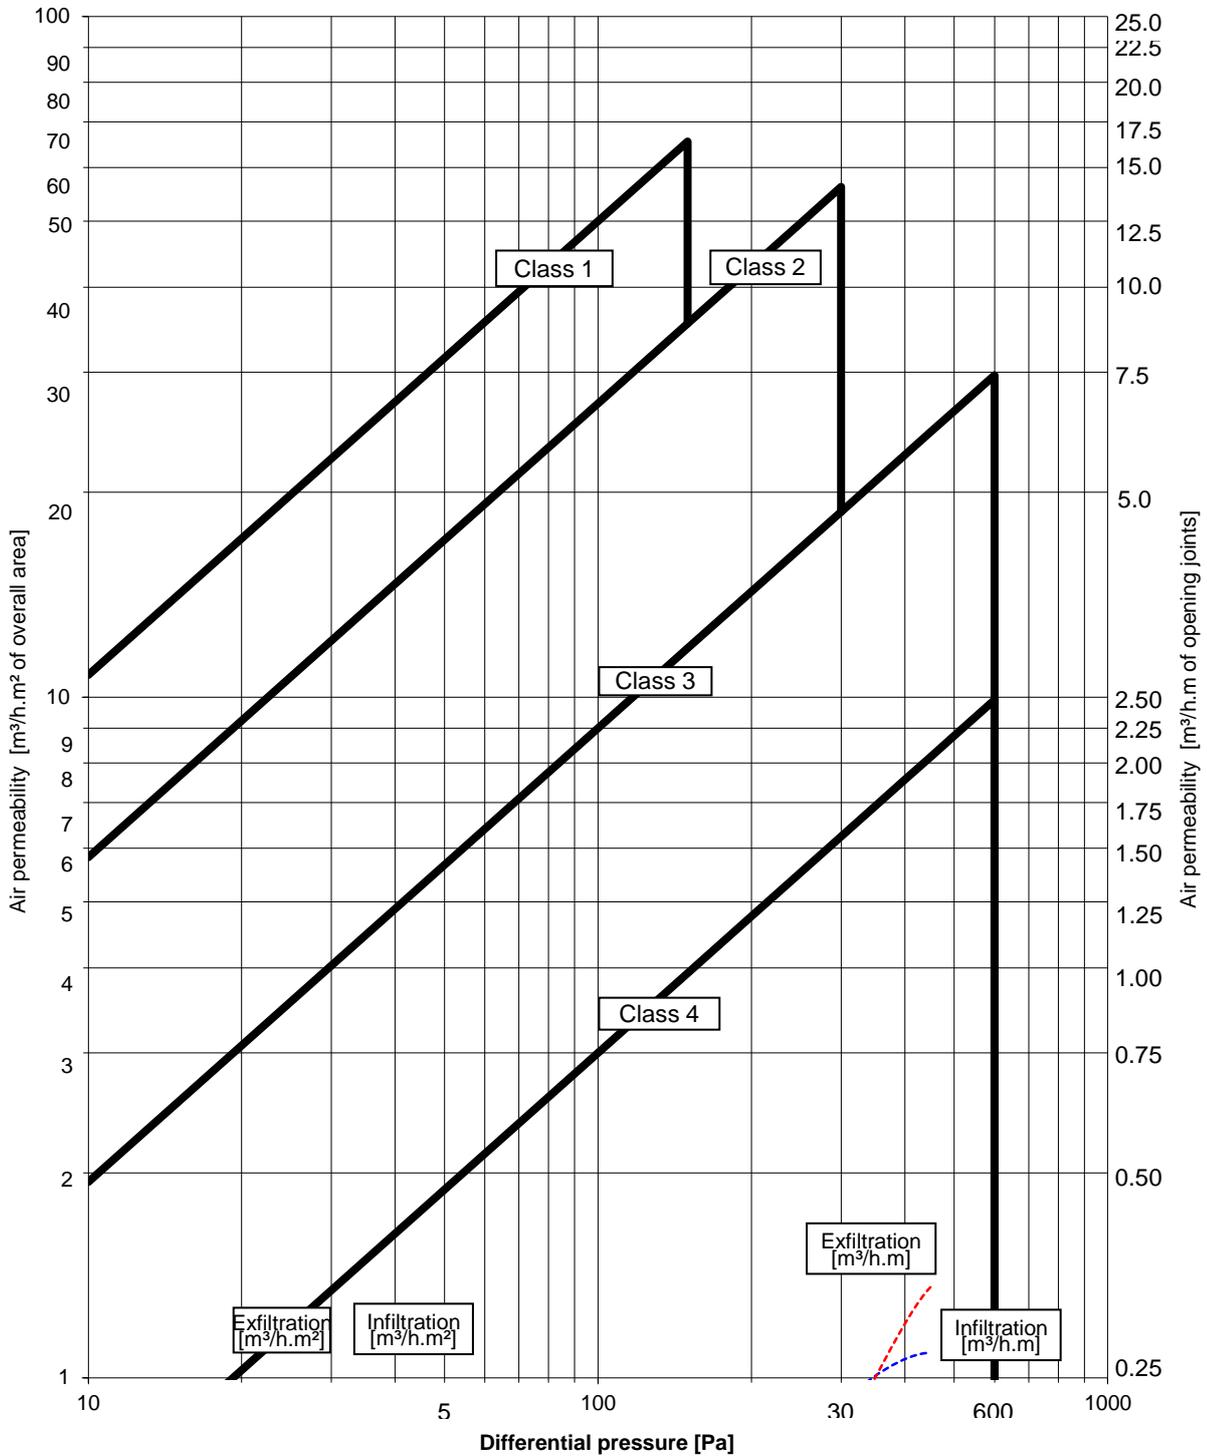
Graph of Air Permeability Before Gusting.

Air Pressure [Pa]	Average rate of air leakage [m ³ /h]	Average rate of air leakage per meter length of opening joint [m ³ /h.m]	Average rate of air leakage relative to area of sample [m ³ /h.m ²]
50	0.4	0.10	0.13
100	0.6	0.14	0.18
150	0.7	0.16	0.21
200	0.7	0.17	0.22
250	0.7	0.17	0.22
300	0.9	0.22	0.28
450	1.3	0.31	0.40
600	1.2	0.28	0.37

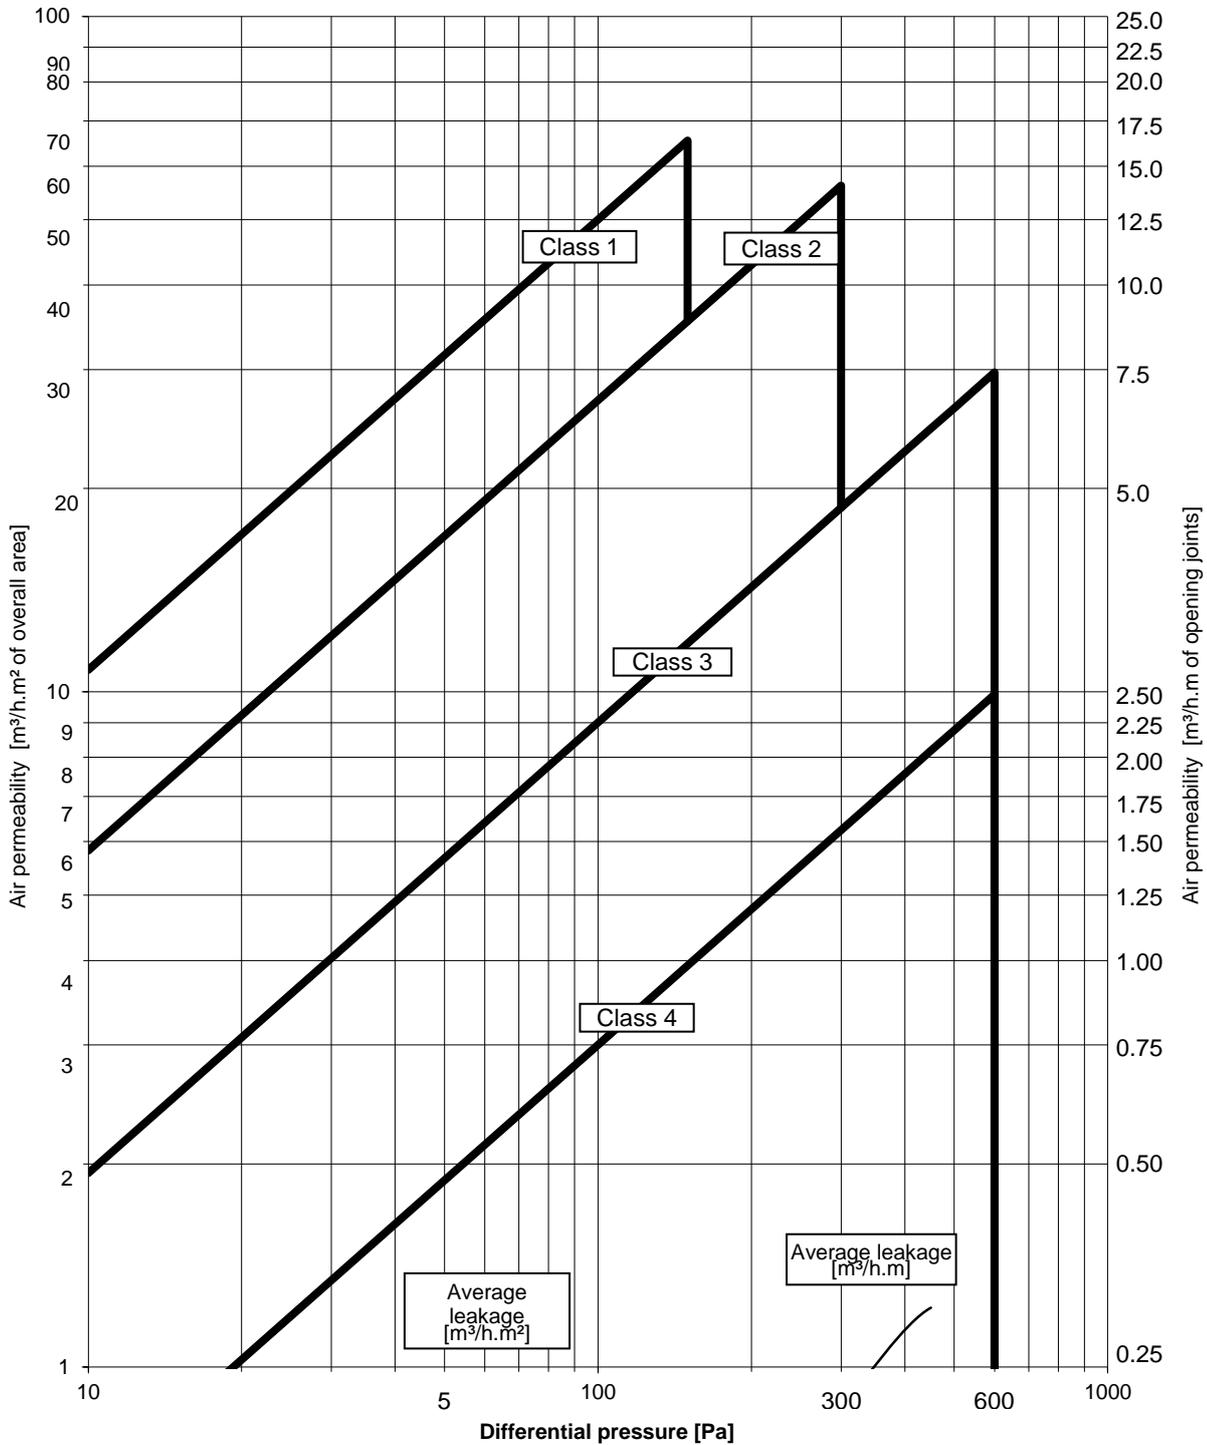
Graph of Average Air Permeability Before Gusting.

BS 6375-1:2015 Clause 6.2 - Overall class = 4

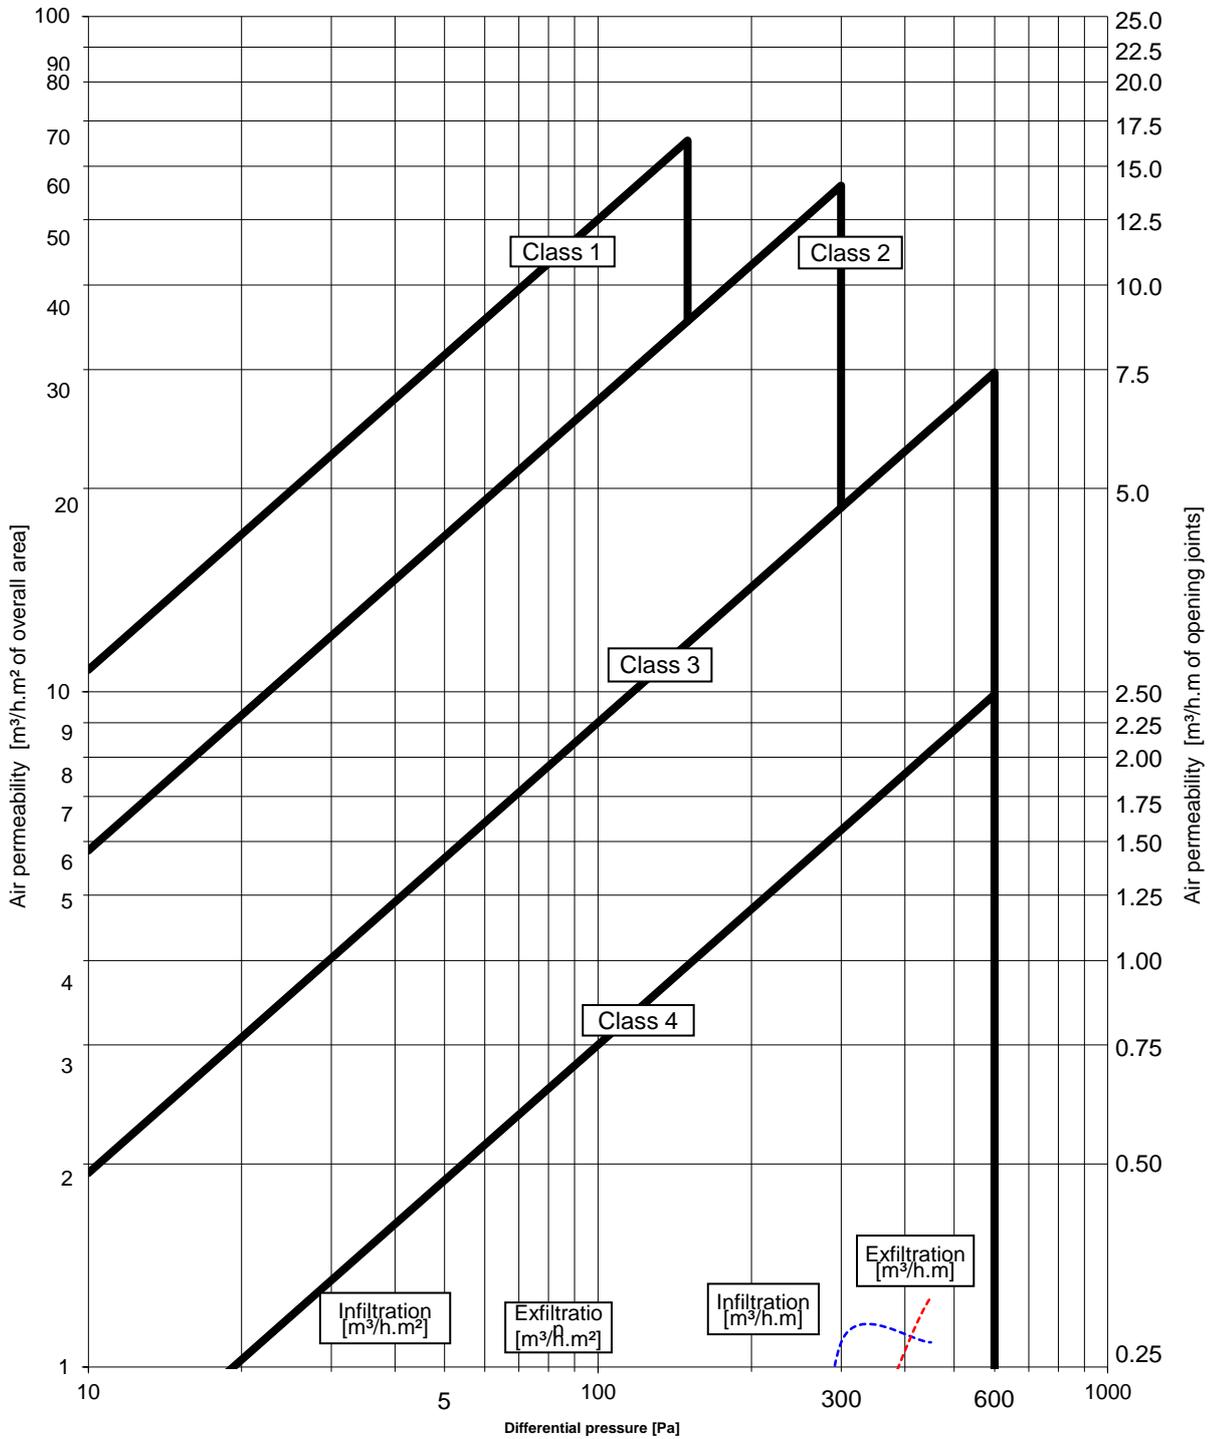
Graph of Air Permeability After Gusting.

Air Pressure [Pa]	Average rate of air leakage [m ³ /h]	Average rate of air leakage per meter length of opening joint [m ³ /h.m]	Average rate of air leakage relative to area of sample [m ³ /h.m ²]
50	0.5	0.11	0.15
100	0.5	0.12	0.16
150	0.6	0.15	0.19
200	0.7	0.16	0.21
250	0.6	0.14	0.18
300	0.9	0.22	0.28
450	1.3	0.29	0.38
600	1.3	0.31	0.40
