Test Report 8420999.
Smart Systems Limited
Incorporating Smart Extrusions

Type Test for Product Certification

Smart Systems Eco Futural Aluminium Alloy Windows

BS4873:2009 Weather Type.

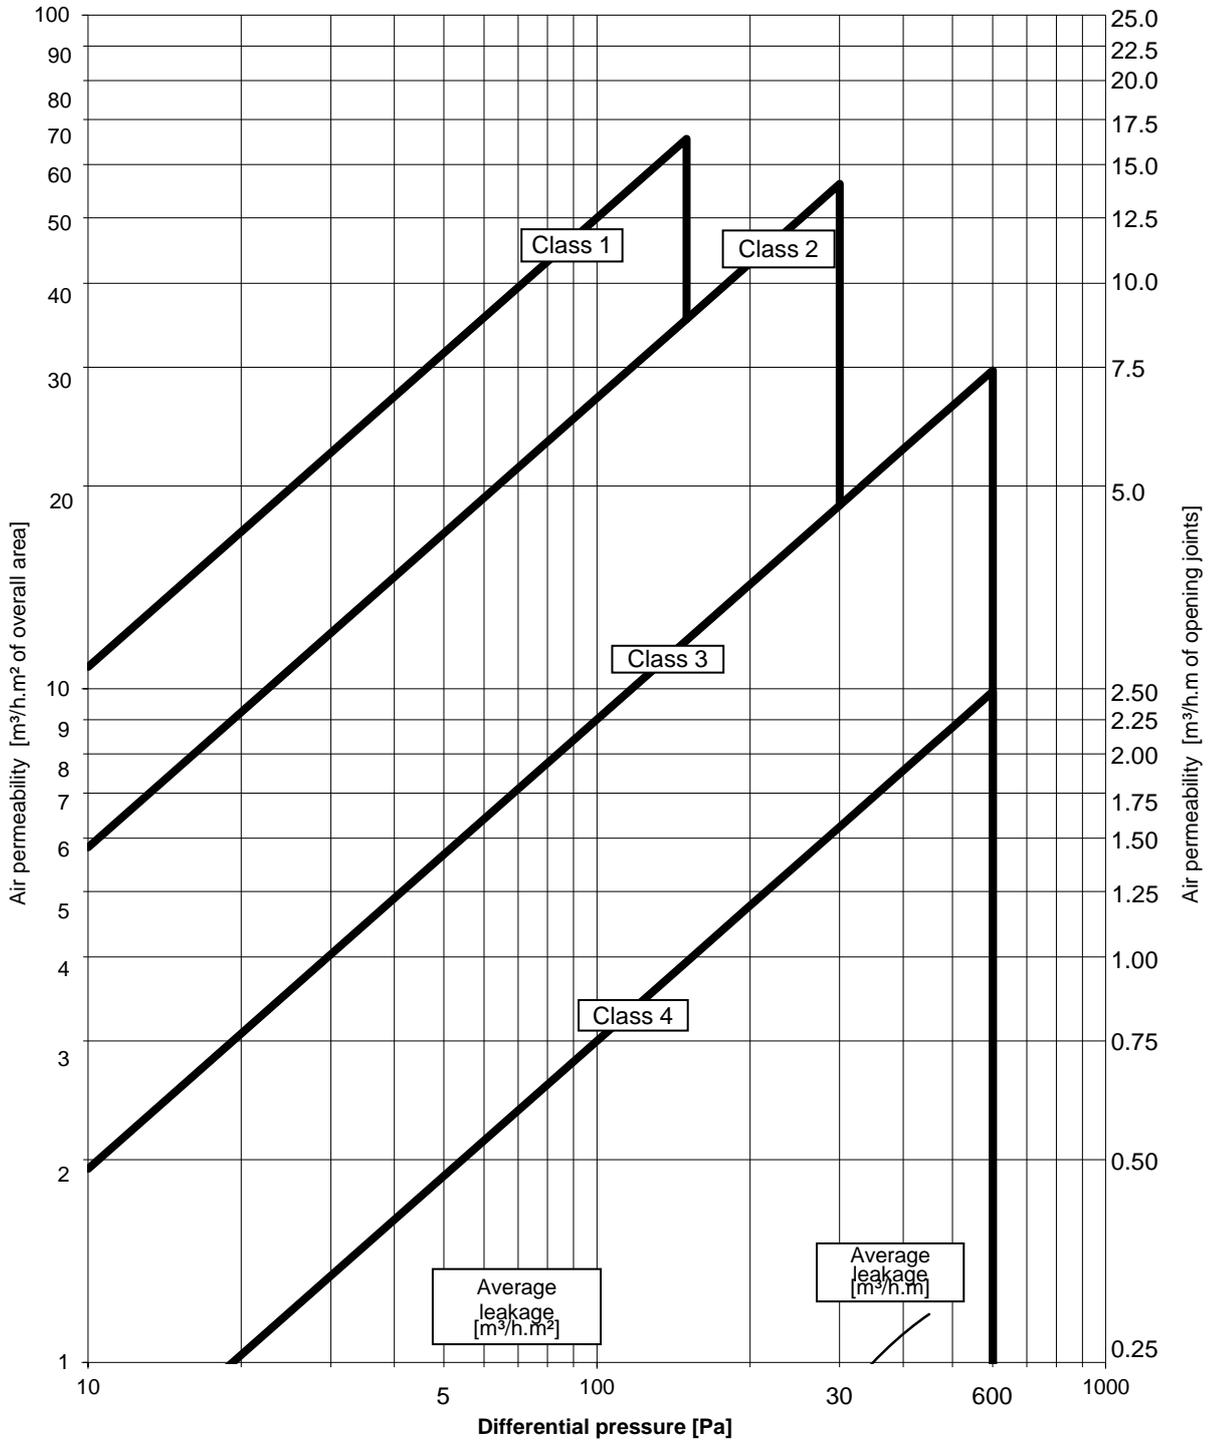
Graph of Average Air Permeability After Gusting.

In accordance with BS 6375-1:2015 Clause 6.5, as the classification after the resistance to wind load tests is the same as the classification before the resistance to wind load tests, the resulting classification for the sample is Class 4.
